**Emergency landing Bristow AS332L2
search and rescue helicopter**

North Sea, near Den Helder, 21 November 2006

The Hague, (project number M2006LV1121-07)

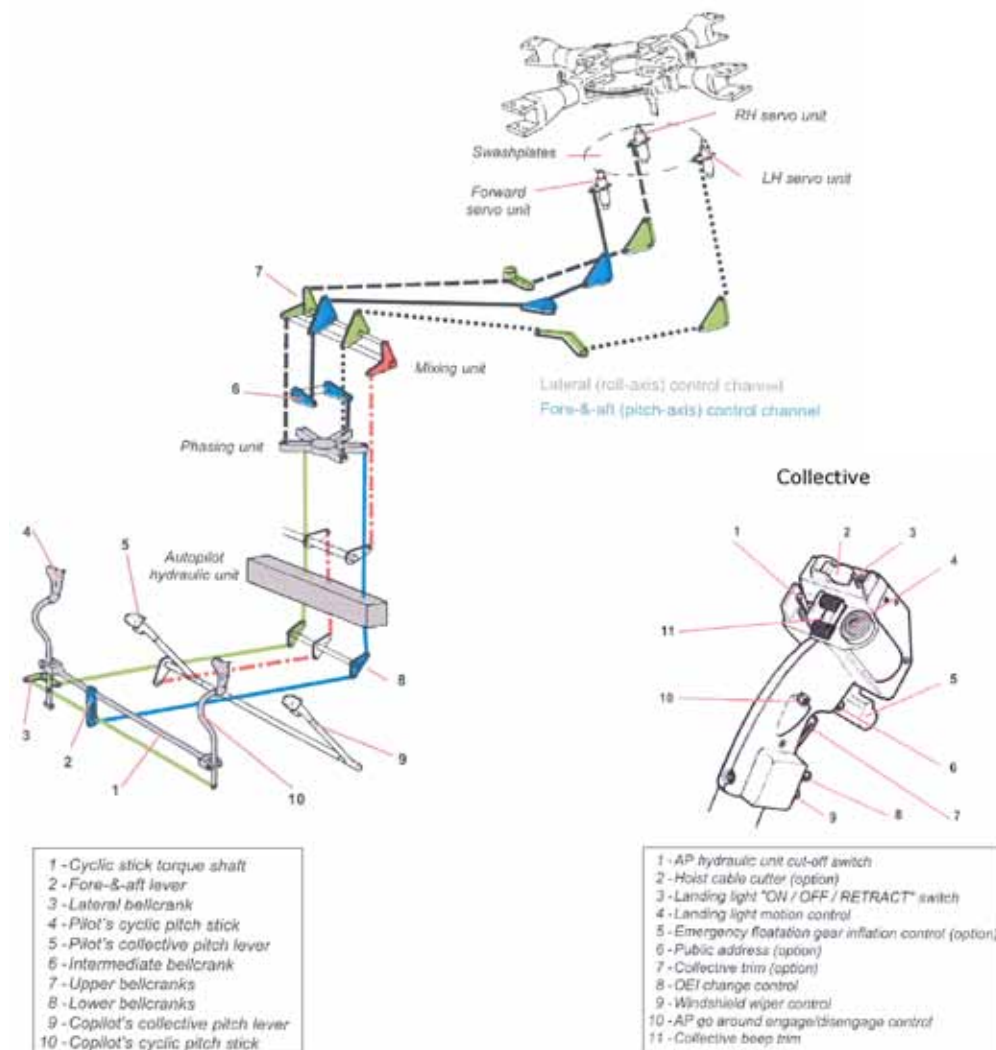
The autopilot (AP) hydraulic unit is the power control of the AFCS. The AP hydraulic system is powered by the left hydraulic system with 103 Bar. If the pressure is below 70 Bar for more than 0.8 seconds, a warning is presented to the crew. This warning is also recorded on the FDR. The system transmits and amplifies the orders elaborated by the AFCS to the flight controls. It allows manual piloting in the case of malfunctioning of the AFCS. During manual flight, the AP hydraulic system reduces the control forces and offers stabilisation. When the autopilot hydraulic system is off, the control forces increase and the stability decreases but the aircraft is still controllable.

Without a working AP hydraulic system, both upper- and basic AFCS modes are inoperative. On the AFCS control panel no warning is presented when the AP hydraulic system is inoperative. The AP hydraulic system is switched on and off by the AP hydraulic switches on both collectives. When one of these switches is in the OFF position, the system is off.

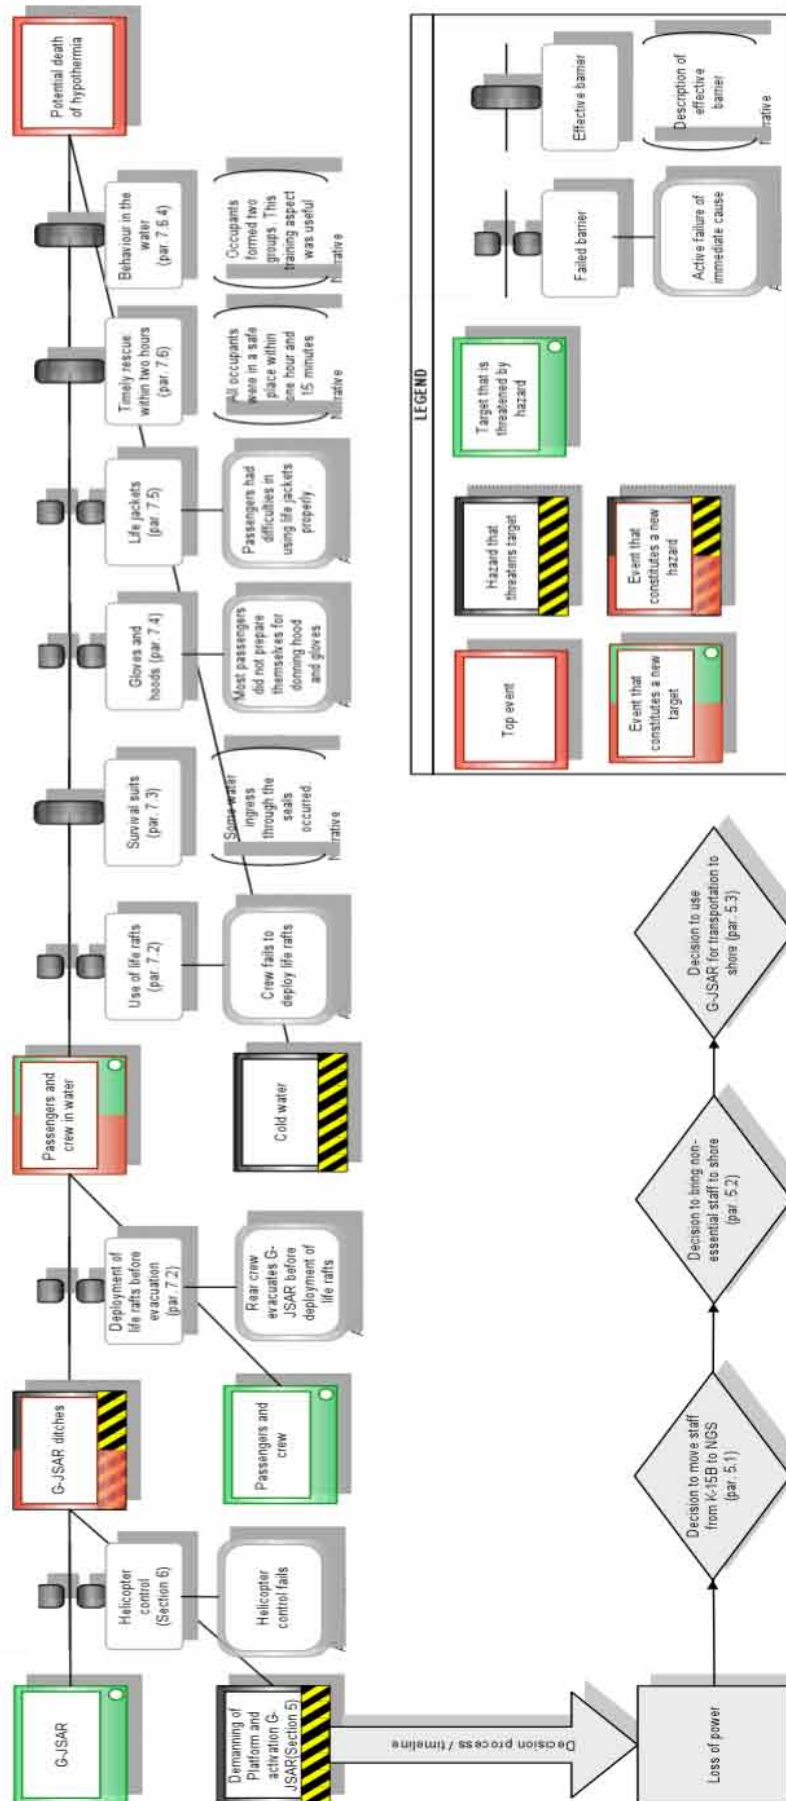
Illustration 1 (next page) depicts the results of the Tripod analysis in a simplified diagram. More specifically, the sequence of events and corresponding hazards and targets (HET-trio's) which, eventually resulted in the top event are presented. Furthermore, illustration 1 indicates which barrier could have prevented the undesirable event for each HET-trio (1) and the active failure that formed the immediate cause for the barrier to fail (2). For both barriers, the present report describes how and why these "controls" failed. In this respect, and in agreement with Tripod Beta, the report distinguishes between preconditions (mainly section 7) and latent failures at an organisational level (mainly section 8). To uphold the legibility of the diagram, the preconditions and latent failures are not included in illustration 1.

Illustration 1. Simplified diagram of the Tripod analysis of the emergency landing in the north sea made by the search and rescue helicopter G-JSAR on 21 November 2006.
