**Goods train derailment**  
**Amsterdam-Muiderpoort,**  
22 November 2008

The Hague, March 2010 (project number M2008RV1122-01)

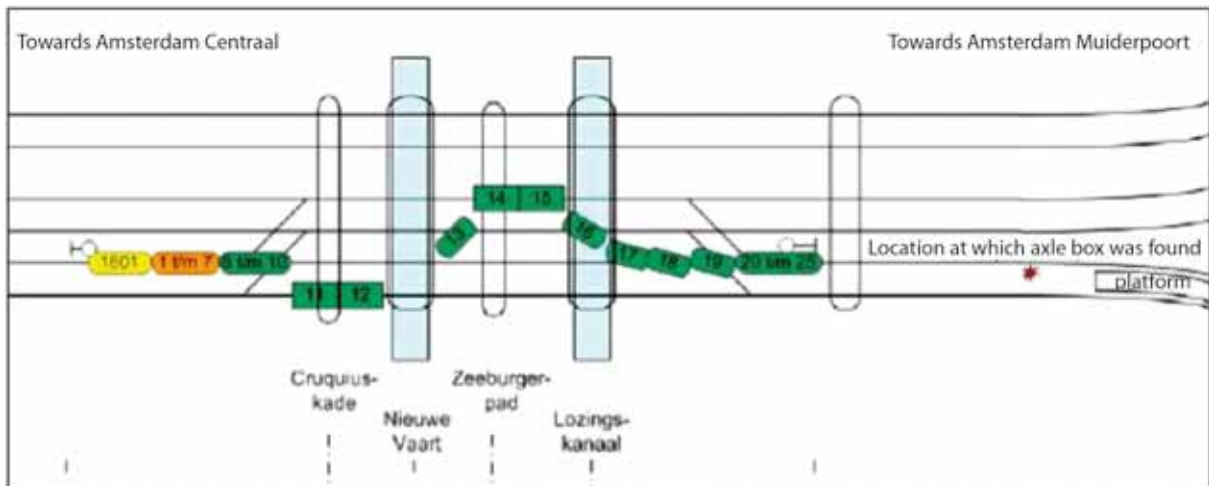
Figure 3: Diagram of the end position of the wagons.

Nine wagons derailed, four of which toppled over and shed their load of chalk. The track was damaged over a distance of 500 metres. A set of points was also destroyed. Wagon 14 came to rest against a concrete section of the bridge over the Zeeburgerpad. The derailed wagons 16 to 18 inclusive sank into the bridge. A cyclist on the Zeeburgerpad escaped with a fright when concrete rubble from the bridge fell onto the cycle track behind him.

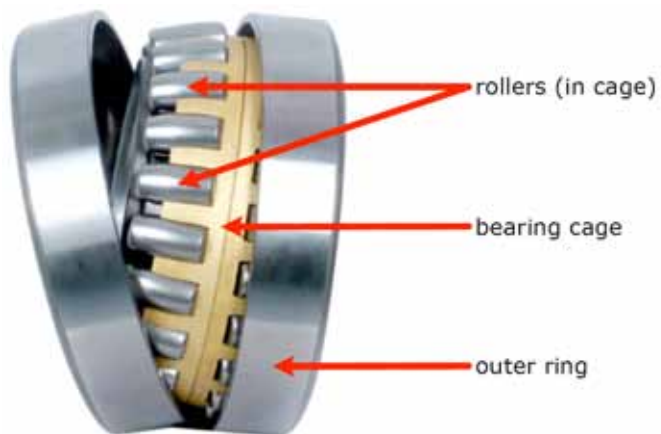
Figure 10: Example of a bearing. This outer ring has been opened to show the rollers and the bearing cage. The bearing shown in this photo (of the same as the bearing involved in the Muiderpoort derailment) is a double-row barrel bearing with a comb-shaped bearing cage.

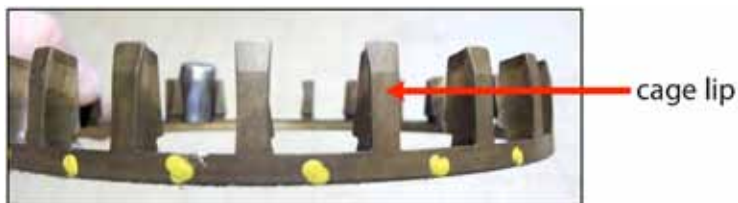
Figure 11: This photo shows a comb-shaped bearing cage as used in the bearings in question.

The breakage of a cage lip will result in friction between the rollers that are no longer held in place and can seize. If the wagon continues to move then the seized rollers begin to rub against the inner and/or outer ring. The resultant friction heats the axle box and axle journal (overheating) to an extent that the axle journal can break off or melt (as was the case in the Muiderpoort derailment).

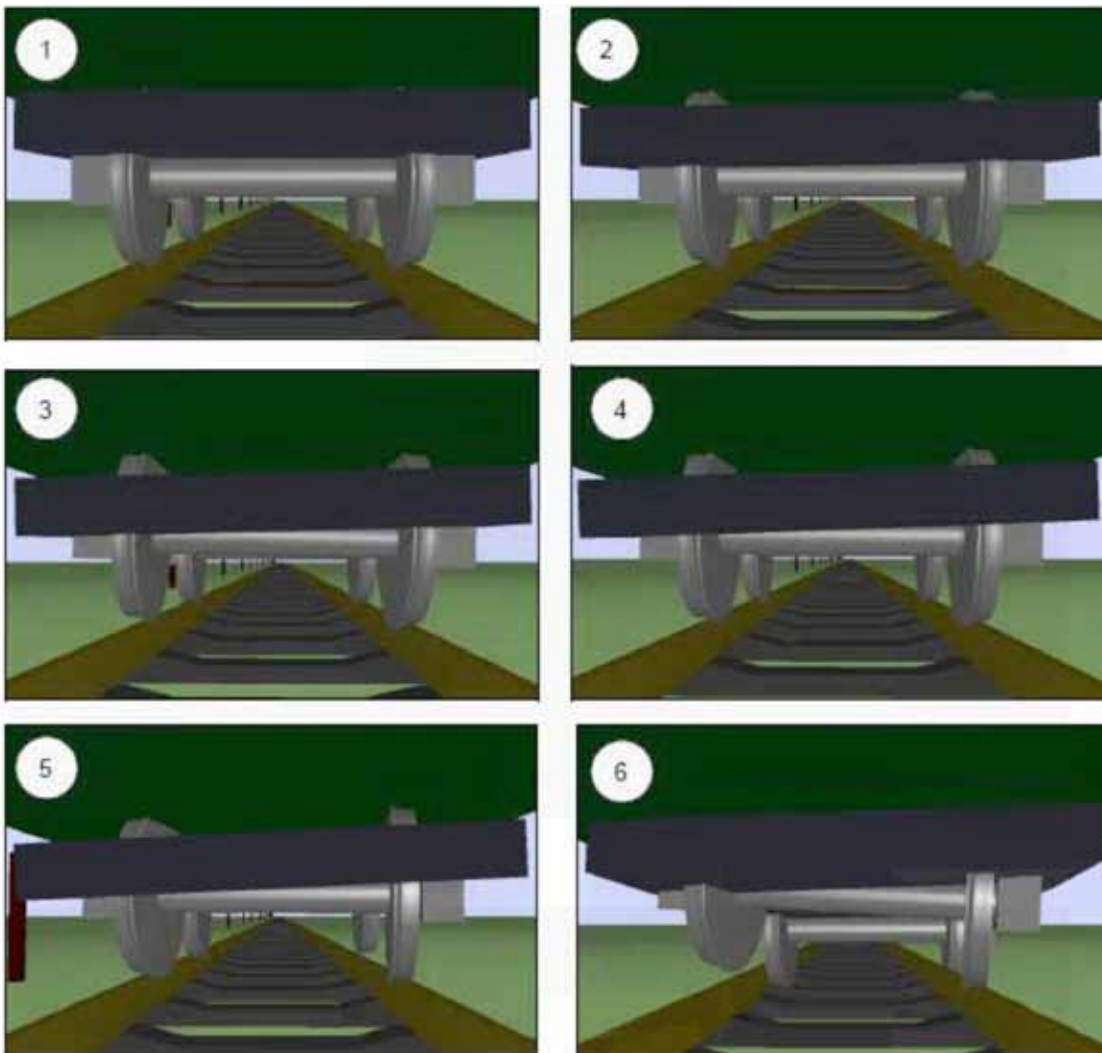
Figure 17: Simulated derailment process (seen in the direction of travel): 1 = initial situation, 2+3 = rear wheel set climbs left rail , 4+5 = front wheel set climbs right rail and 6 = derailment of front wheel set.

The simulations explained above reveal that both the derailment of the wheel set and the location at which the derailment occurred are determined by the time at which the axle journal melted completely off. The simulations also reveal that the rail alignment (both the radius of the curve and the canting) did not play a material role.

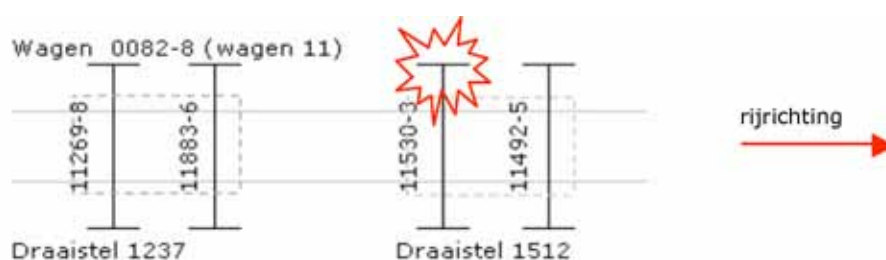
Diagram of wagon number 11 with bogie and wheel set numbers; the overheated axle box was on the left-hand side of wheel set 11530-3.
