THE DUTCH  
SAFETY BOARD

**Emergency assistance after Turkish Airlines  
aircraft accident, Haarlemmermeer**

25 February 2009

The Hague, July 2010 (project number M2009CH0225-02)

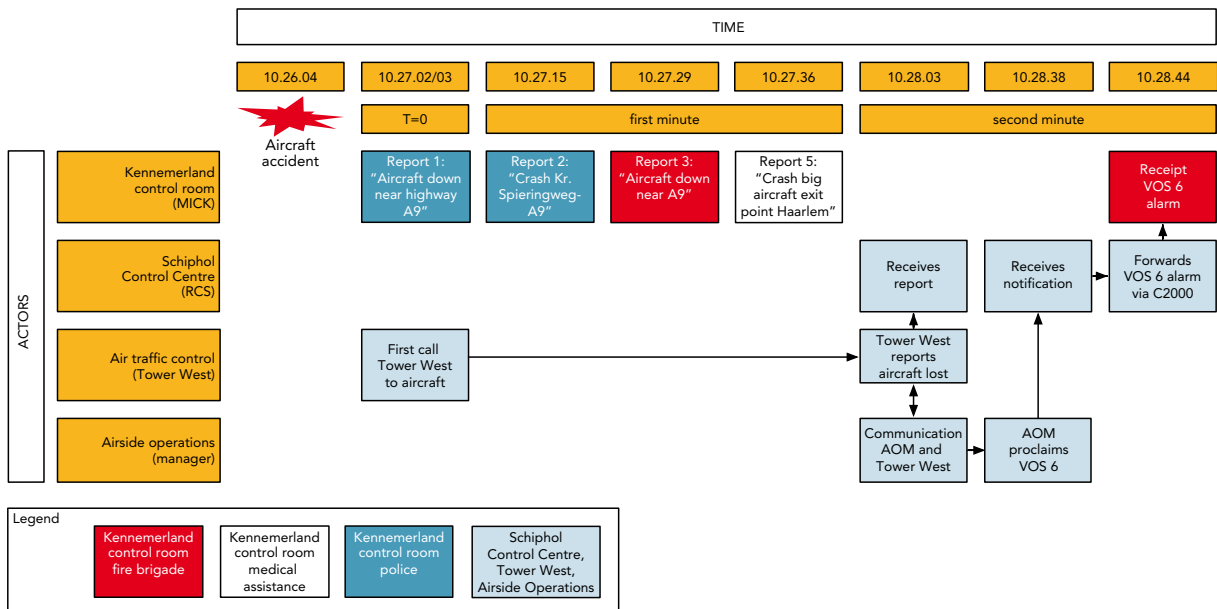
Figure 2: Summary of events in Kennemerland control room and Schiphol Control Centre during the first minutes

Figure 2 summarises the events that took place, more or less at the same time, during the first few minutes after the accident at the Kennemerland control room and at Schiphol Airport.

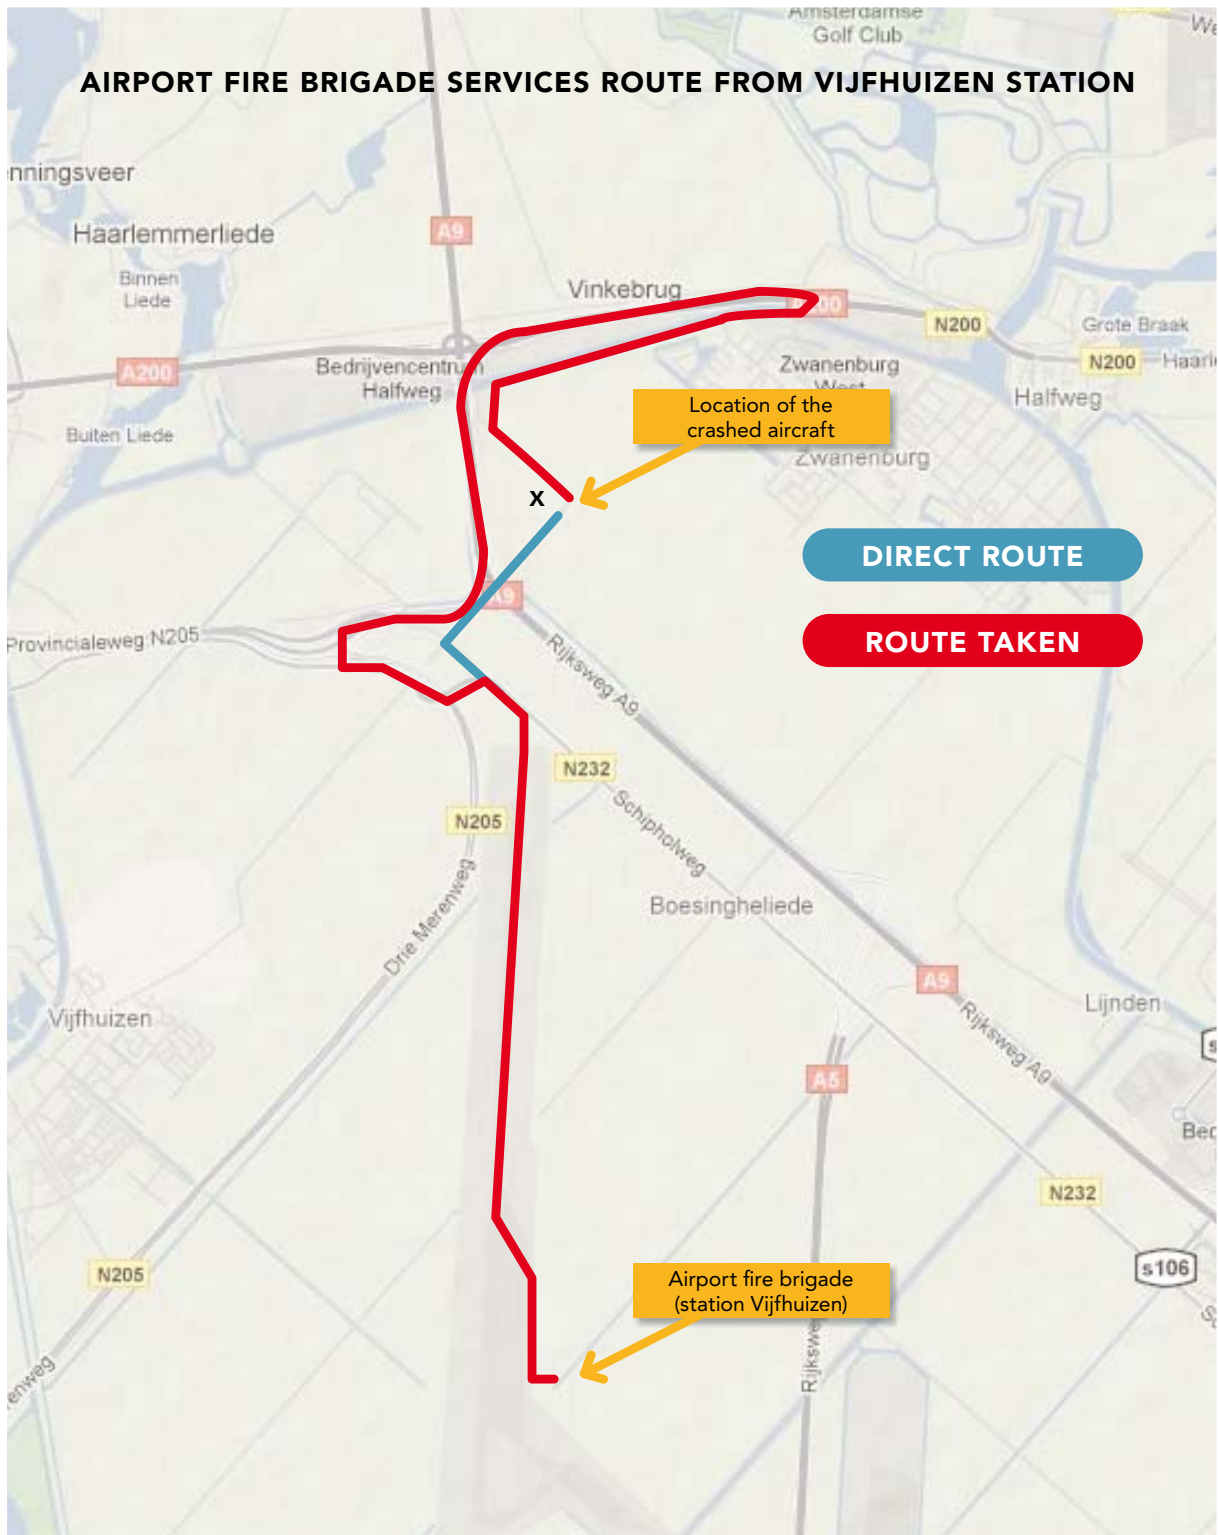
Figure 4: Airport fire brigade services route from the Vijfhuizen fire brigade station, first along the runway and subsequently to the probable accident site situated beside highway A9

The alarm aircraft accident Schiphol 6 (VOS 6) for the Polderbaan issued by the Schiphol Control Centre also raised the alarm for the Schiphol Airport fire brigade. The airport fire brigade who is stationed alongside the Polderbaan turned out directly according to the protocol. At 10:32 local time the airport fire brigade reported to the Schiphol Control Centre that they had driven along the complete runway and reached the head of the Polderbaan but had not seen an aircraft. At the same time, another Schiphol Control Centre operator was talking to a Kennemerland control room ambulance service operator. The Kennemerland control room operator was reporting (10:33 local time) the exact location of the crashed aircraft, the Kromme Spieringweg. At 10:35 local time the airport fire brigade reported to the Schiphol Control Centre that they were leaving the Schiphol site via gate 106 because the aircraft was said to be alongside the A9 motorway. At 10:44 local time they arrived at the accident site. The route is shown in Figure 4.

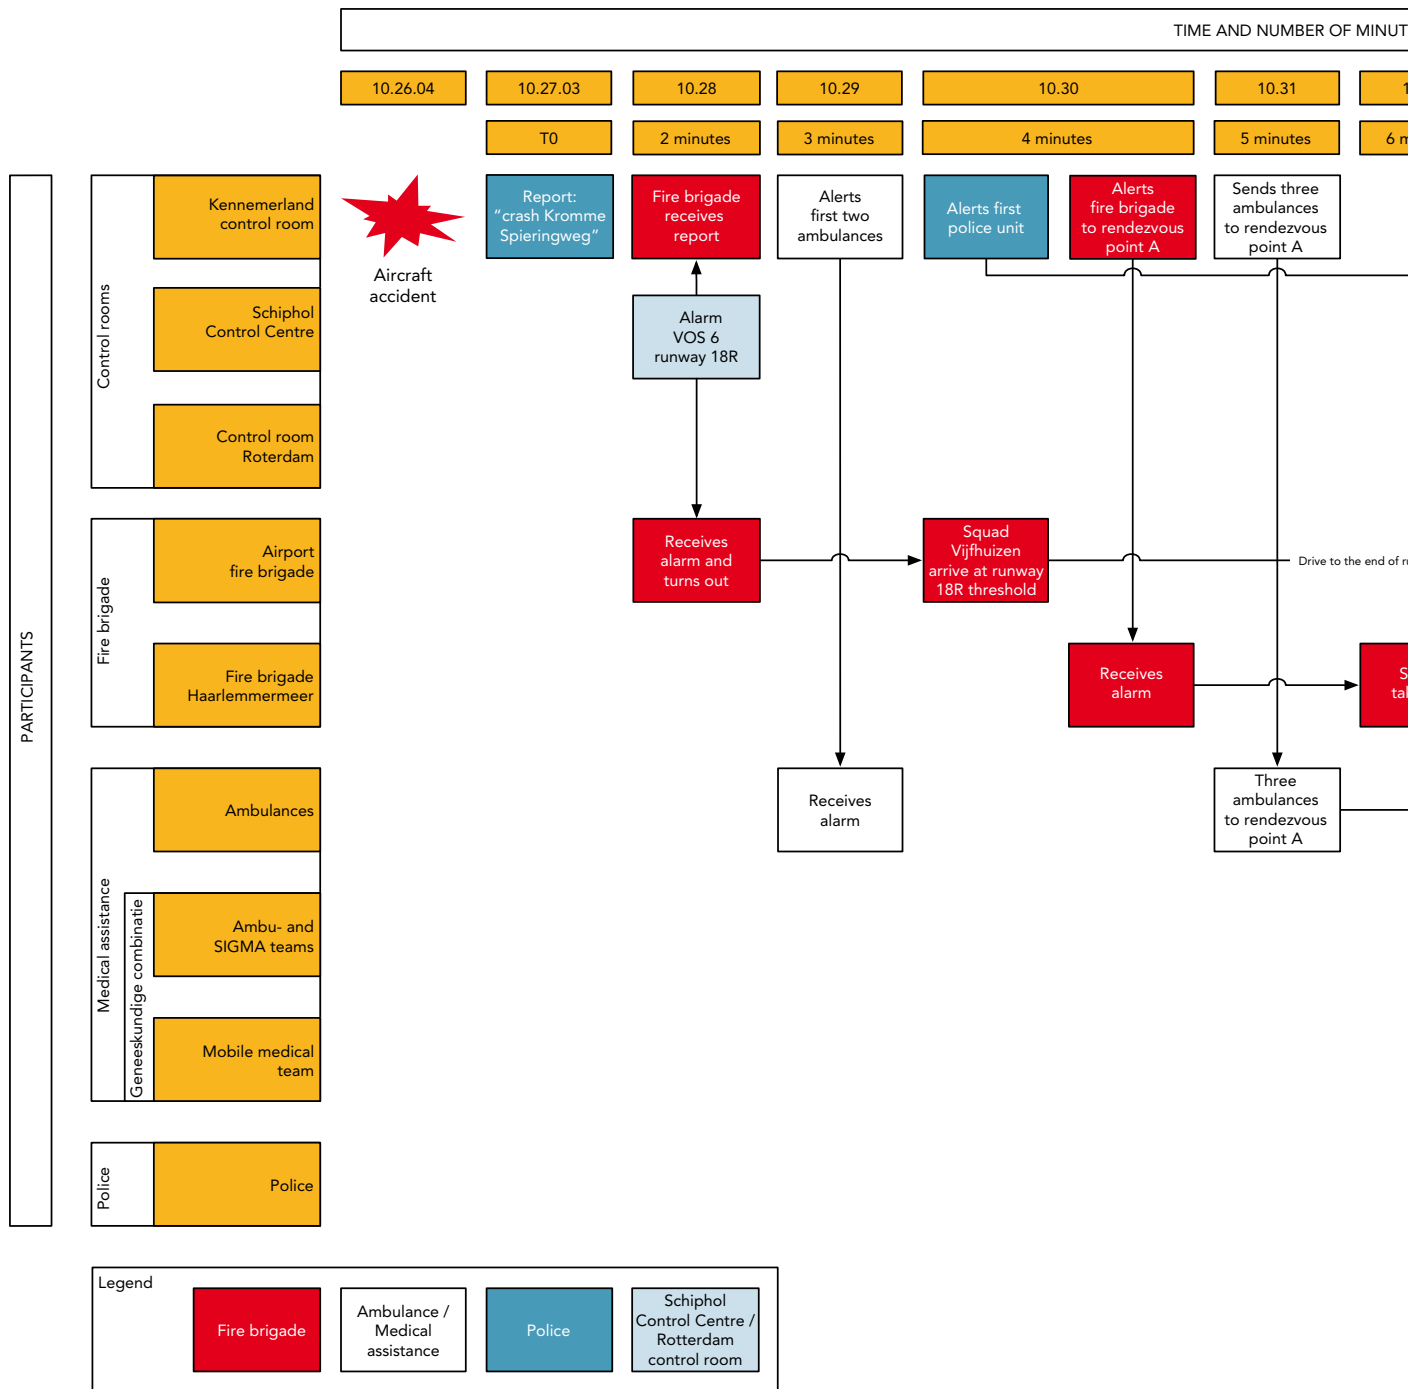
Figure 12: Timeline with regard to sounding the alarm and arrival of the emergency services units

One of the victims died after arrival of the first MMT. Causal connection between the late alerting/ arrival of the MMTs and the death of passengers has not been investigated, also because autopsies were not performed on the deceased passengers. An exploratory study regarding survival issues is included in Annex 7. This study is derived from the investigation of the Dutch Safety Board into the cause of the aircraft accident, which was published on 6 May 2010. This study provides information about the gravity of the injuries of the occupants, as a function of the aircraft seat where they were allocated.

When the (airborne) MMT of the VU Medical Centre from Amsterdam had been deployed immediately, this team could have been on site ten minutes after the first report and not after 55 minutes as was the case. One of the victims died after arrival of the first MMT. It has not been investigated whether there is a causal relationship between the late alert/arrival of the MMTs and the death of the persons who had been on-board the aircraft because an autopsy was not performed with regard to these persons.<sup>63</sup> Despite all the efforts of the nurses at the accident site, specialist knowledge that is reserved to the MMT was lacking during the first 45 minutes (after which the MMT from Rotterdam arrived) due to the late arrival of the MMTs.

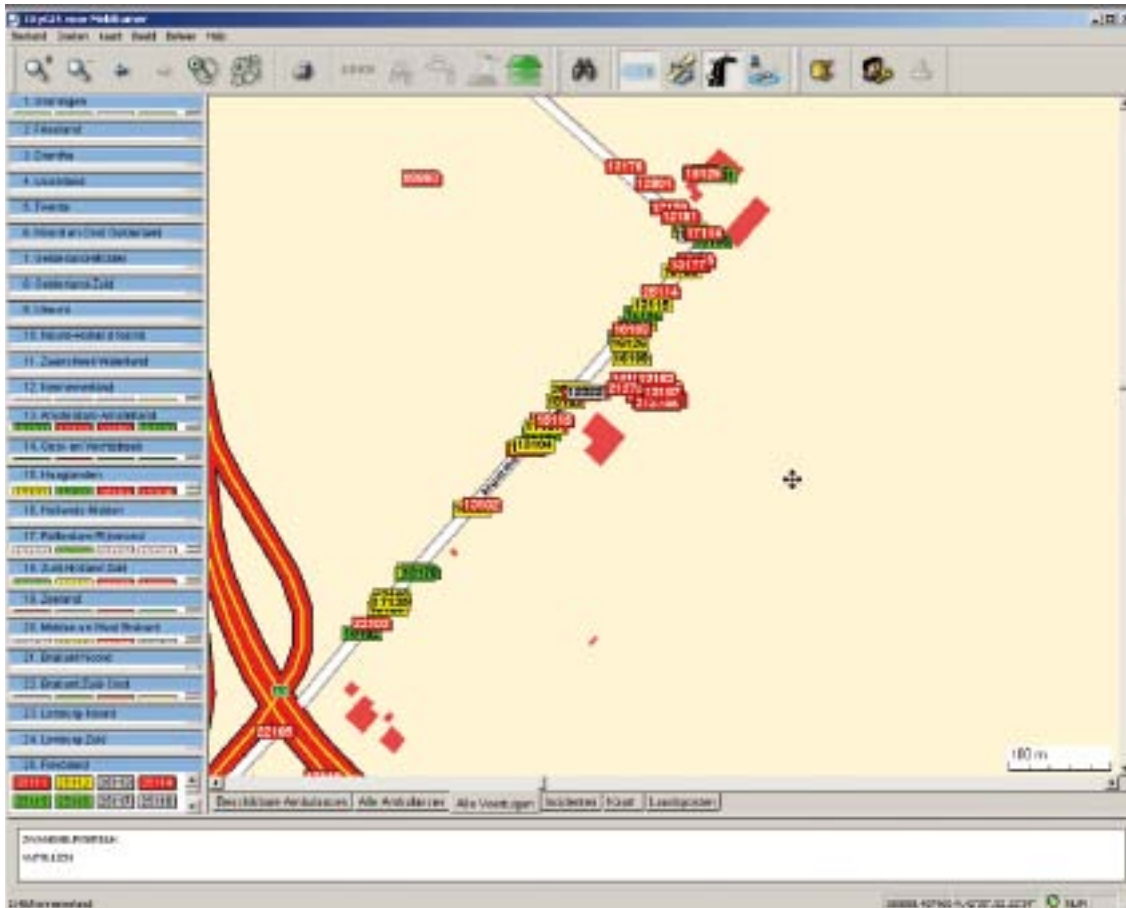
Figure 13: Screen view from the geographic information system (GIS) of 25 February 2009 (Source: LMAZ)

All ambulance dispatch centres in the Netherlands have been equipped with the geographic information system (GIS) since 2005. This has considerably improved the management of the ambulance transport capacity. The GIS and automatic vehicle location system (AVLS) systems contribute towards the efficient organisation of interregional ambulance transport. Ambulance dispatch centres can view the transport movement of vehicles from other regions in their own area using the link to the GIS system. See figure 13.

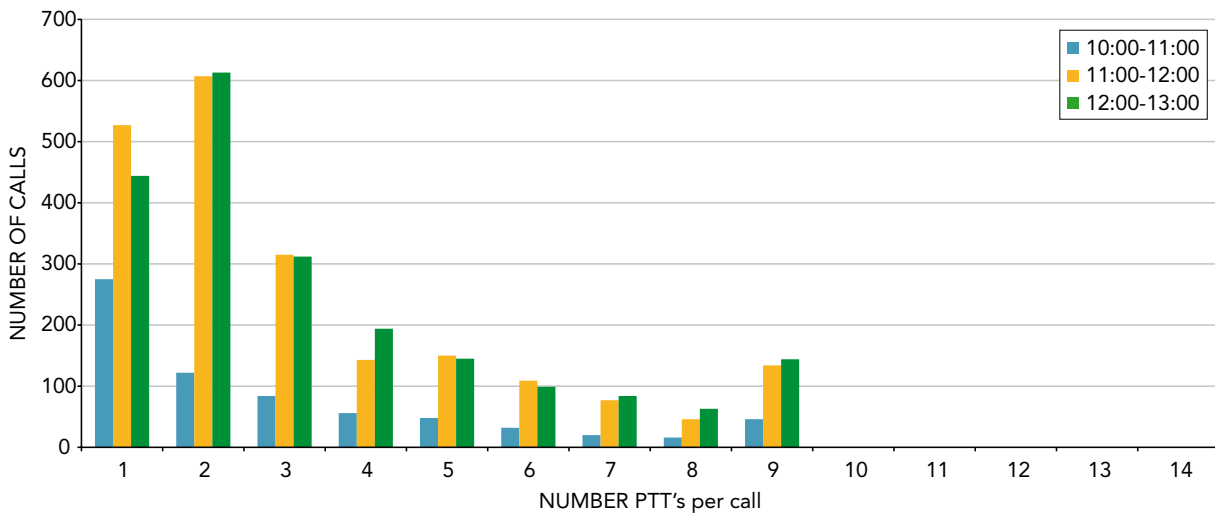
Figure 20: The number of times that the push-to-talk button was pressed per call held

The phenomenon of unanswered calls can also be determined through another route. When someone wishes to speak through the C2000 system, he or she can do this by pressing the push-to-talk (PTT) button. The person who answers must also press the push-to-talk button to respond to what has been said. At least two people must, therefore, press the push-to-talk button to exchange information or to confirm that the person who has spoken has been heard. One push for the first speaker and one push for the response to this. Figure 20 shows the number of times the push-to-talk button was pressed per call between 10:00 and 13:00 local time.

Figure 20 shows 280 times the push-to-talk button was pressed once, between 10:00 and 11:00 local time and, therefore, the call did not lead to a response.<sup>102</sup> A single response was given to 120 calls. The second and third considered hour show a different ratio with regard to the unanswered calls when compared to the calls that involved more than one push-to-talk instance; 525 and 440, respectively.

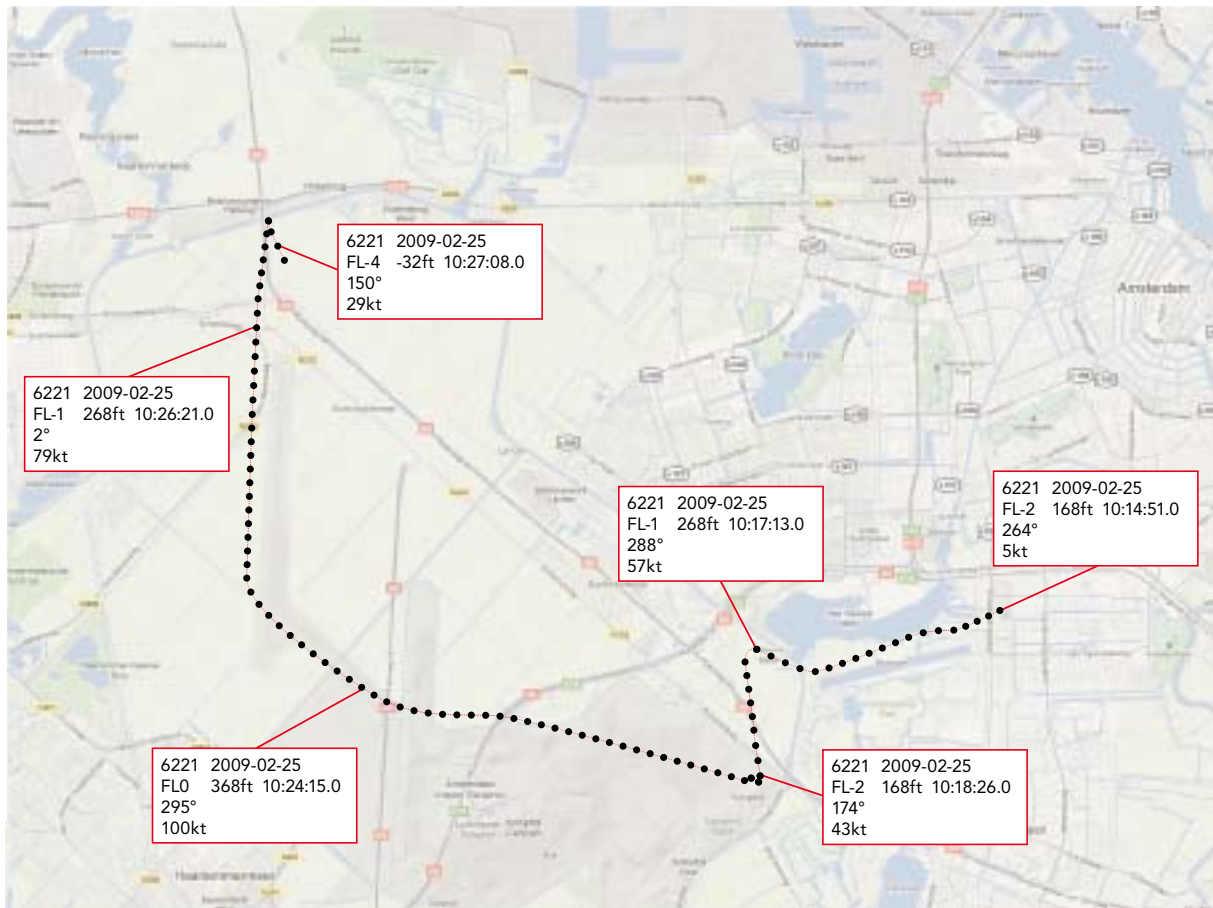
Figure 24: Flight course 1<sup>st</sup> flight of Lifeliner 1 VU Amsterdam → Kromme Spieringweg

By request of the Dutch Safety Board plots were made by Air traffic control the Netherlands of the flight movements of the three MMTs involved on 25 February to project the flight paths. Analysis has shown that less than 10 minutes is a feasible flight duration (including taking off and landing) for the Amsterdam MMT. After (direct) alerts to Lifeliner 1 by the National Ambulance Dispatch Centre, Lifeliner 1 reported to the Ambulance Dispatch Centre in Amsterdam. Although the fact that the Amsterdam dispatch centre was aware of the location of the aircraft accident, Lifeliner was instructed to contact the Kennemerland dispatch centre. The contact between Lifeliner 1 and the Kennemerland control room was difficult and various locations were dispatched to the team (Figure 24).

Action	Corrected time compared to UTC	Flight duration
Departure from VU/airborne	11:14.51	
Schiphol-East UGS B	11:18.26	
Schiphol-West UGS C	11:24.15	
Kromme Spieringweg	11:27.08	12 minutes 17 seconds

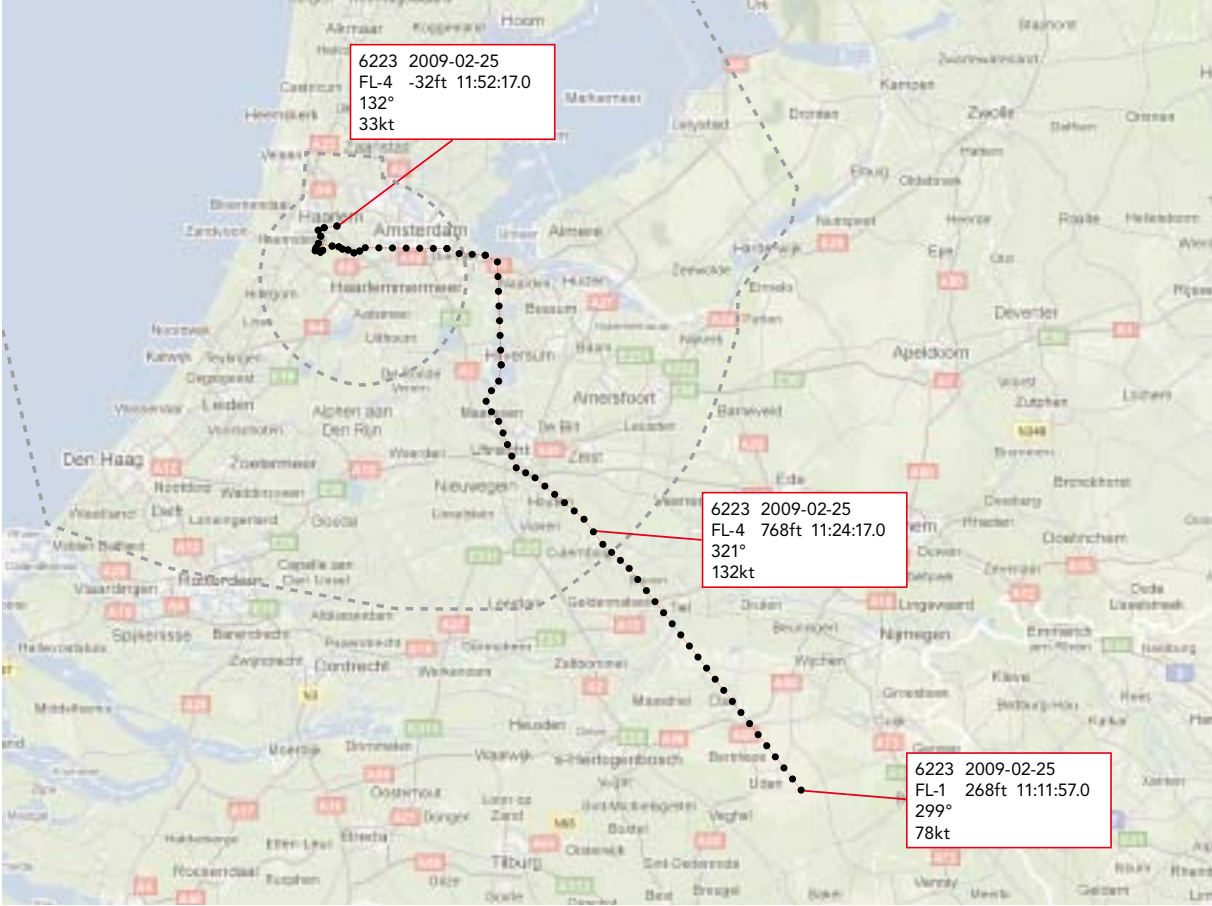
Figure 27: Flight course of Lifeliner 3 flight, Volkel air base → Kromme Spieringweg (part 1)

In addition to the analysis of the flight duration of the Amsterdam team, the flight path of the Gelderland MTT was also checked. Despite repeated requests directed to the various control rooms involved, this team was unable to obtain an exact accident location. After first having been directed by Air Traffic Control the Netherlands from Volkel in the direction of Pampus the helicopter had to fly to Vijfhuizen where the pilot could not find the accident location.

Action	Corrected time compared to UTC	Flight duration
Departure from Volkel/ airborne	11:11.57	
Kromme Spieringweg	11:52.17	40 minutes 20 seconds

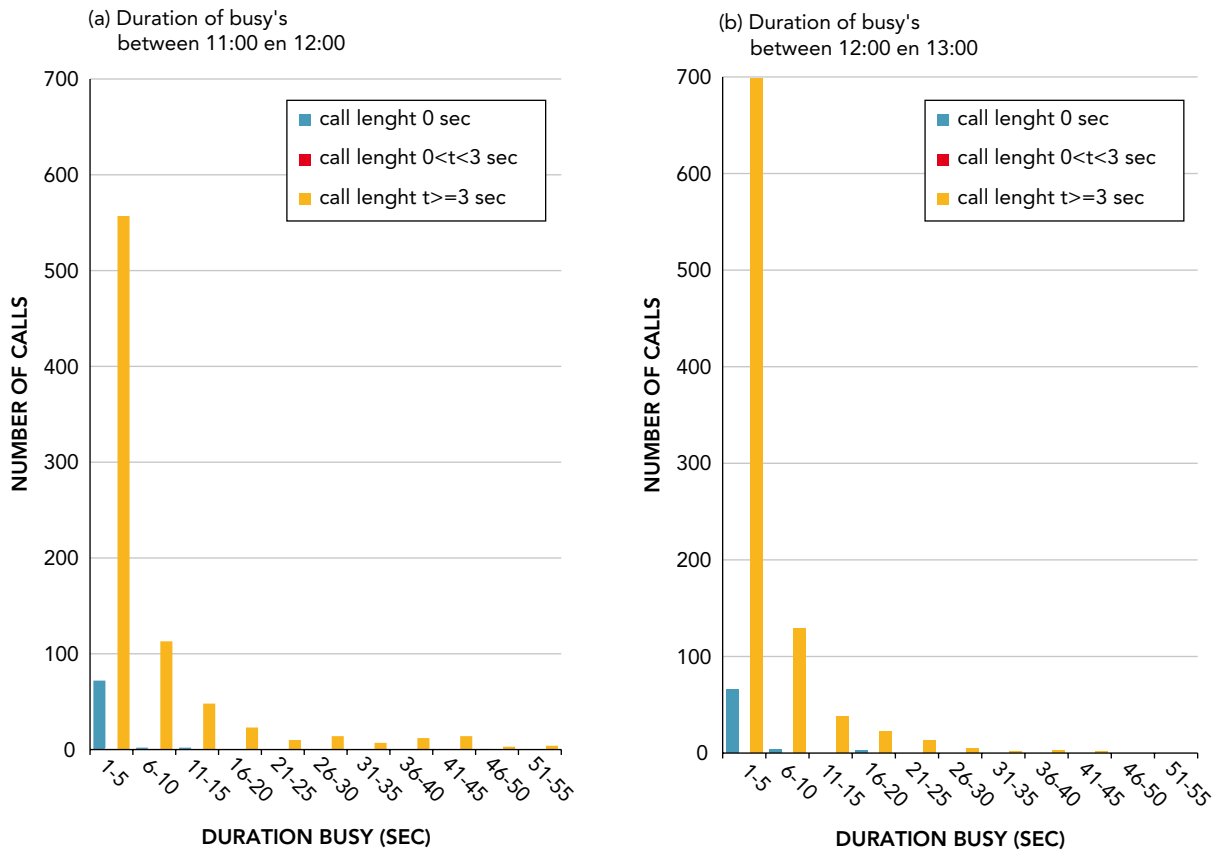
Figure 29: Distribution of 'busy' calls between 11:00 and 12:00 local time and between 12:00 and 13:00 local time (the category 0<t<3 seconds (red) has been left out due to the calibration of the Y-axis)

The results are also shown in figure 29 (remark: not all points from table 12 are visible due to the scale of the vertical axis). This shows all call requests vertically that were not immediately taken ('busy'). Not only has a subdivision been implemented horizontally based on the waiting times that took place in seconds but also based on the duration of the call time that followed after the call having been busy. The following subdivision was used:

The figures in section 5 already showed that the demand for call channels was regularly greater than the available call channels between 11:00 and 12:00 local time and between 12:00 and 13:00 local time. 2091 calls were requested in total between 11:00 and 12:00 local time. 1207 calls could be made immediately. There were 884 calls put in a queue of this number. Figure 29a shows that 630 (71% of the total number of 'busy' calls) took place after a waiting time of no more than 5 seconds. 116 calls (13%) took place after a waiting time between 5 and no more than 10 seconds with regard to these 884 calls. The waiting time was longer with regard to 40 calls. The maximum waiting time that occurred was 55 seconds.

A total of 78 calls were interrupted by the caller before a call was actually connected between 11:00 and 12:00 local time. Of this number, 73 requests (the ones furthest to the left in the blue column in figure 29a) were interrupted by the caller within five seconds. Four interrupted the call within ten seconds and one caller interrupted the call after 50 seconds. The C2000 system did not break off any calls due to the two and a half seconds in which the caller must speak were exceeded.

The total number of call requests that was placed in the queue was greater than in the preceding hour between 12:00 and 13:00 local time (see figure 29b). The overall picture, however, is the same:
