**Investigation into the cause of the
fast ferry Voskhod 605 accident
on 18 October 2003
in Amsterdam**

The Hague, May 2005

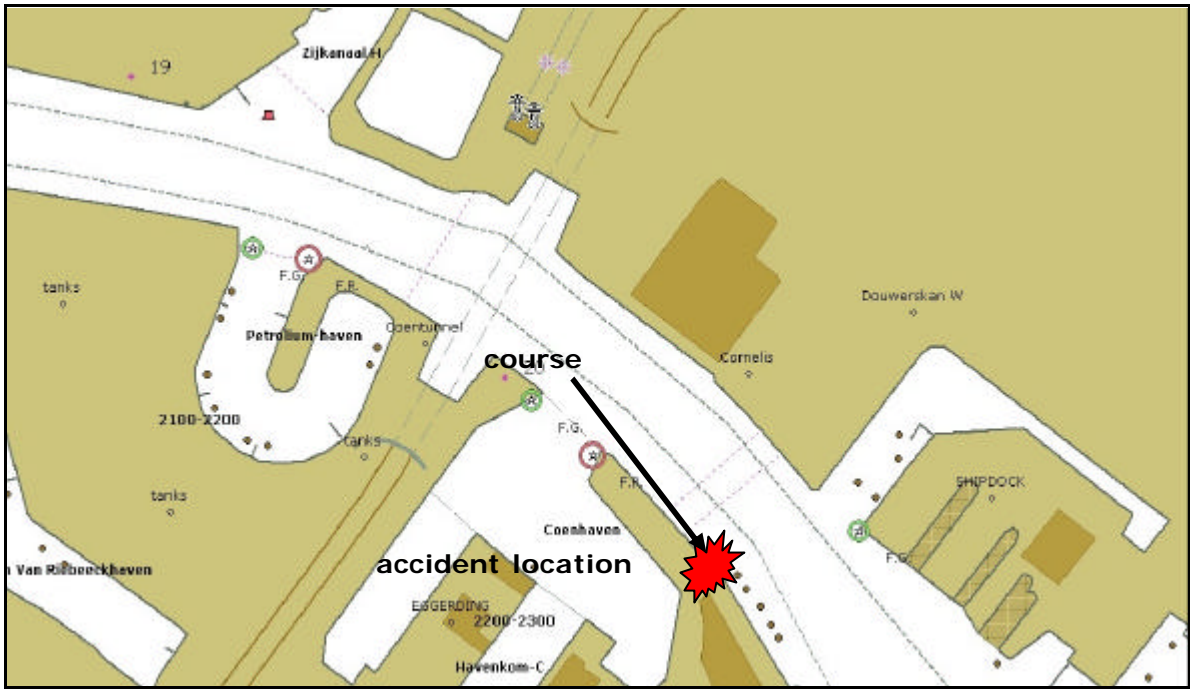
Figure 1a: Location of the collision on the Noordzeekanaal in Amsterdam

On 18 October 2003 at 1250 hours an accident occurred with the fast ferry Voskhod 605, which ran into the quay at approximately 60 km/h just beyond the Coenhaven in Amsterdam (see figure 1). 21 people were injured in the accident and the fast ferry was badly damaged. Looking back it must be concluded that the outcome has been relatively good, because in the collision the hull appeared to have been torn open right in the longitudinal direction of the corridor where no passengers were, and where the aluminium hull had absorbed the collision forces well by crumpling.
