# Train collision Amsterdam Westerpark

*The Hague, December 2012*

On 21 April 2012 a train collision occurred in Amsterdam, near Westerpark. A sprinter and an intercity train collided head-on. At least 190 out of at least 425 occupants<sup>1</sup> were injured, of whom 24 were found to have sustained serious injuries. A day after the accident one of the seriously injured passengers died as a result of the injuries suffered.

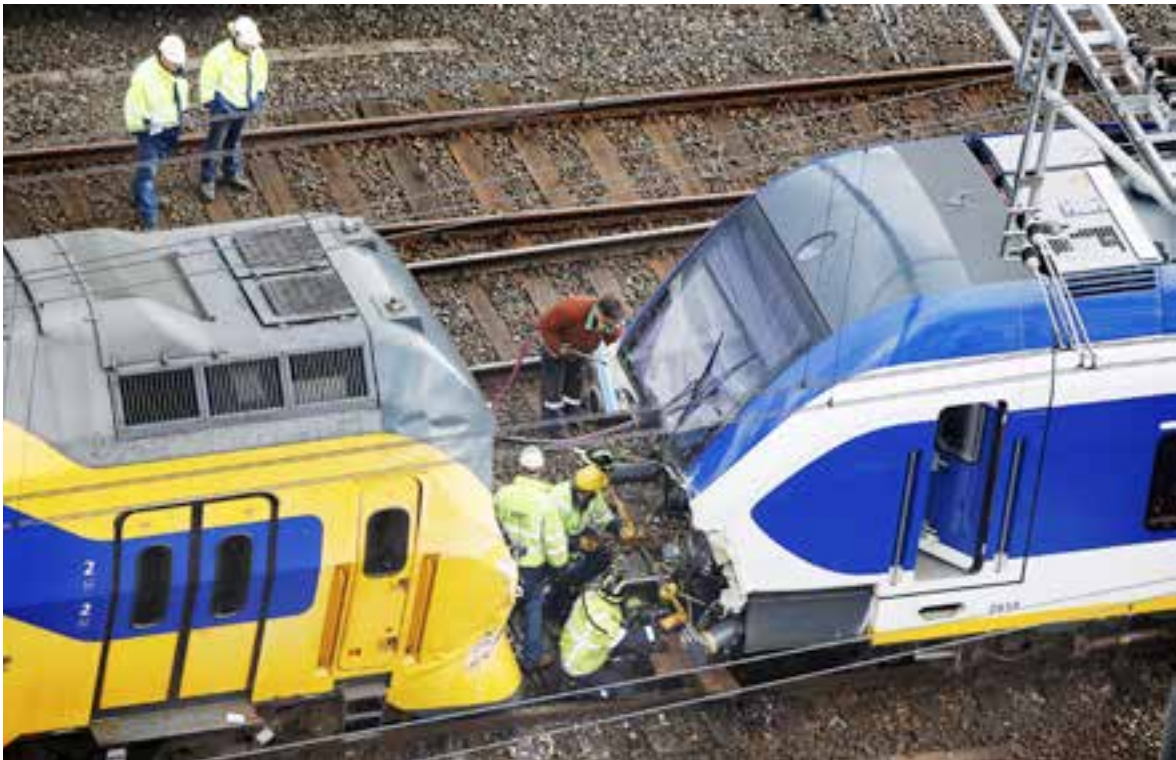
*The trains after the collision. Source: ANP-Jerry Lampen*

The collision occurred as a result of the sprinter driving past a red signal. The driver of the sprinter had made an error in observing the red signal and thought that the signal had displayed yellow. The train driver subsequently failed to notice that he was passing the red signal because he had been distracted.

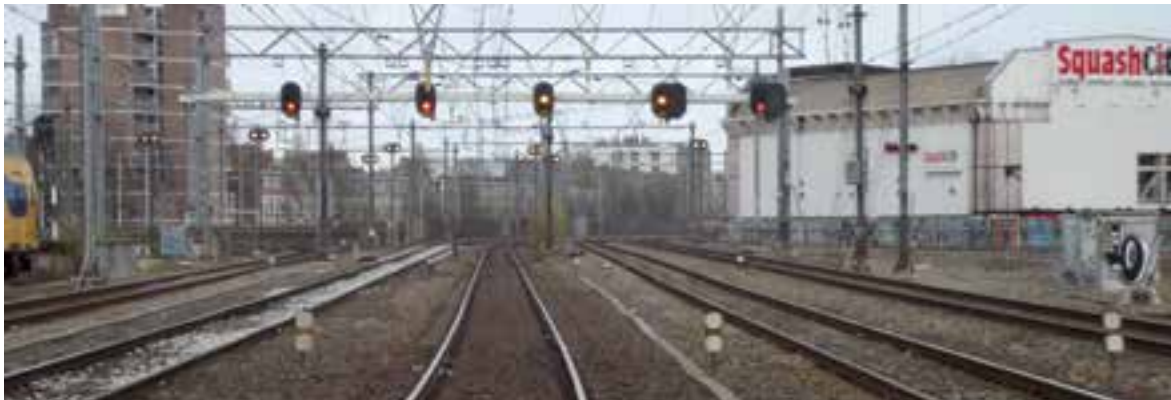
Figure 4: Signal 606 is the middle of five signals in a row and is positioned just after leaving Amsterdam Centraal station. The photograph was taken the day after the collision. Source: Dutch Safety Board

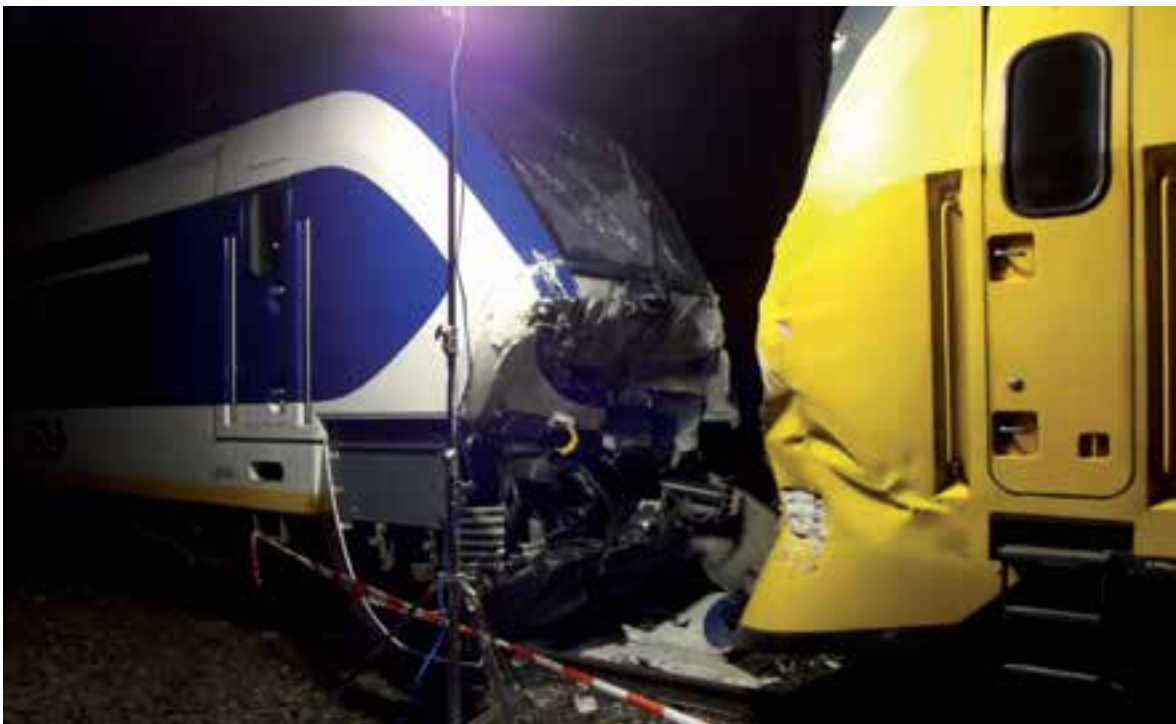
Figure 8: The trains after the collision. Source: Dutch Safety Board

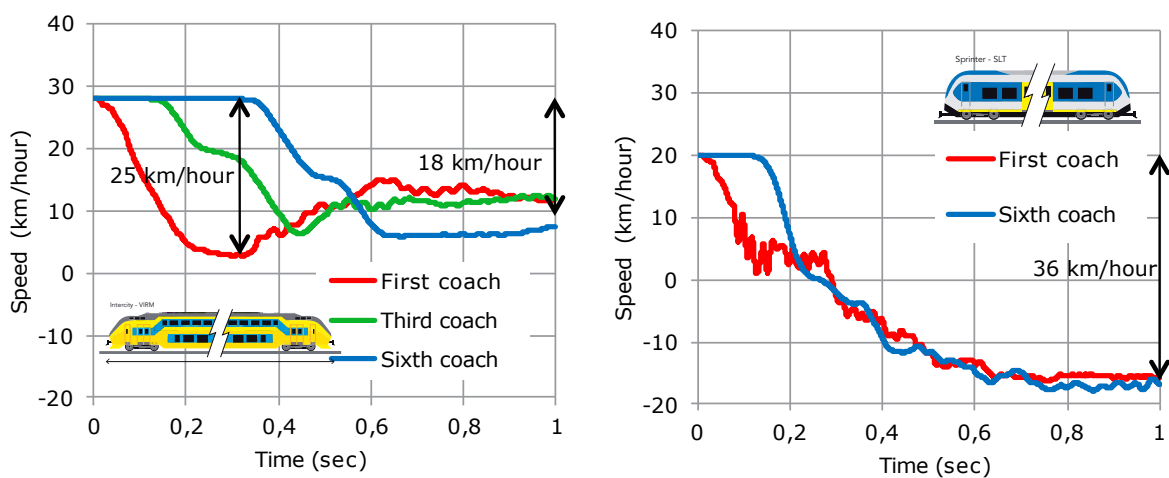
According to the indicative calculation, the intercity continued to travel forward at a speed of approximately 10 km/hour after the collision. The sprinter was no longer travelling forward at this time, and was moving backwards at a speed of approximately 16 km/hour. The collision therefore caused a change in the sprinter's speed that was approximately twice as great as that of the intercity: around 36 km/hour and 18 km/hour respectively. This difference is attributable to the fact that the intercity is approximately twice as heavy as the sprinter. Based on this change in speed, it would appear that the sprinter's passengers were at greater risk of injury than those travelling in the intercity.

Figure 13: The speed development of various coaches in the two trains during the collision.

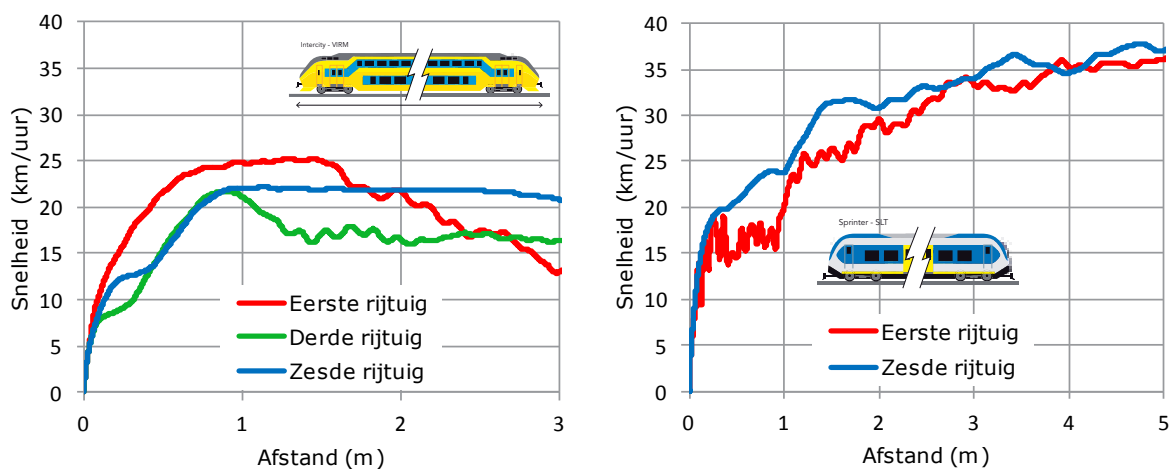
Figure 17: The speed of the secondary collision in relation to the distance between occupant and interior component.

According to the indicative calculation, it was possible for occupants of both trains to collide with an obstacle at even small distances with a considerable speed. Up to a certain distance the speed in the first intercity coach, could exceed the speed in the other coaches of this train. More injuries were reported in the first intercity coach than in other coaches. The injuries were also more serious. The individual who died a day after the incident as a result of her injuries was also sitting in the first coach. This distribution of injuries corresponds with the indication of the speed of the secondary collision shown in figure 17.

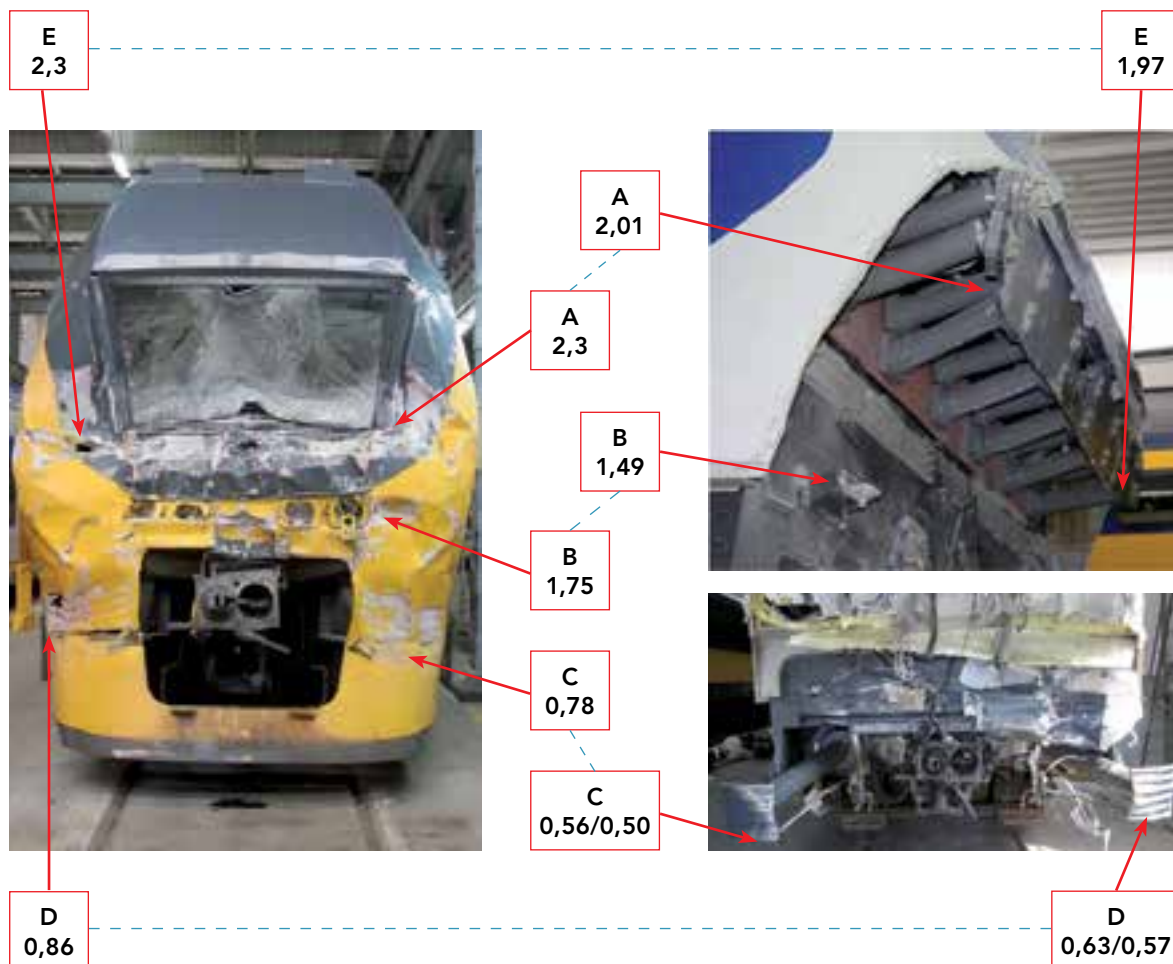
The front of the intercity train was damaged by various sprinter components. A comparison between the height of the damage sustained and the height of the relevant sprinter components showed that the front of the sprinter rode up over the front of the intercity train approximately 25 to 30 centimetres during the collision. Figure 2 specifies the most important height values.

Figure 2: Comparison between the respective heights of sprinter components and intercity train markings.  
Source: Dutch Safety Board

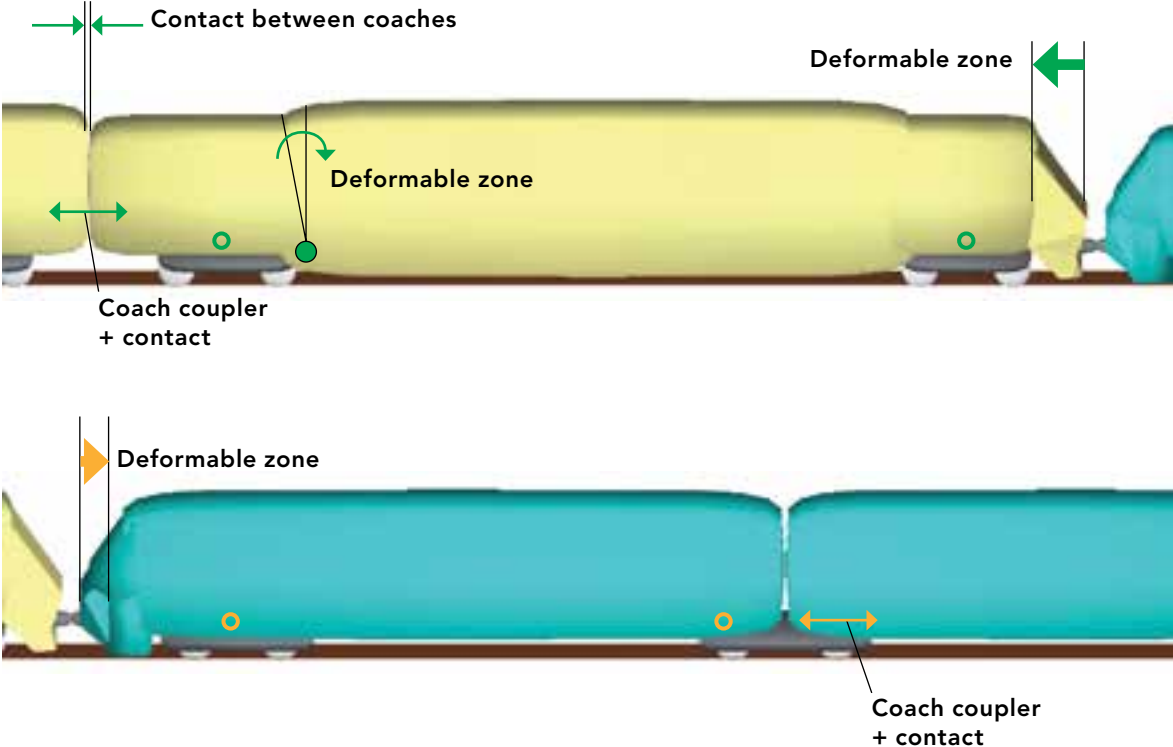
Figure 5: Coach models used in the simulation.

Figure 5 shows the coach models used in the simulation (the upper image represents the intercity train while the lower represents the sprinter).

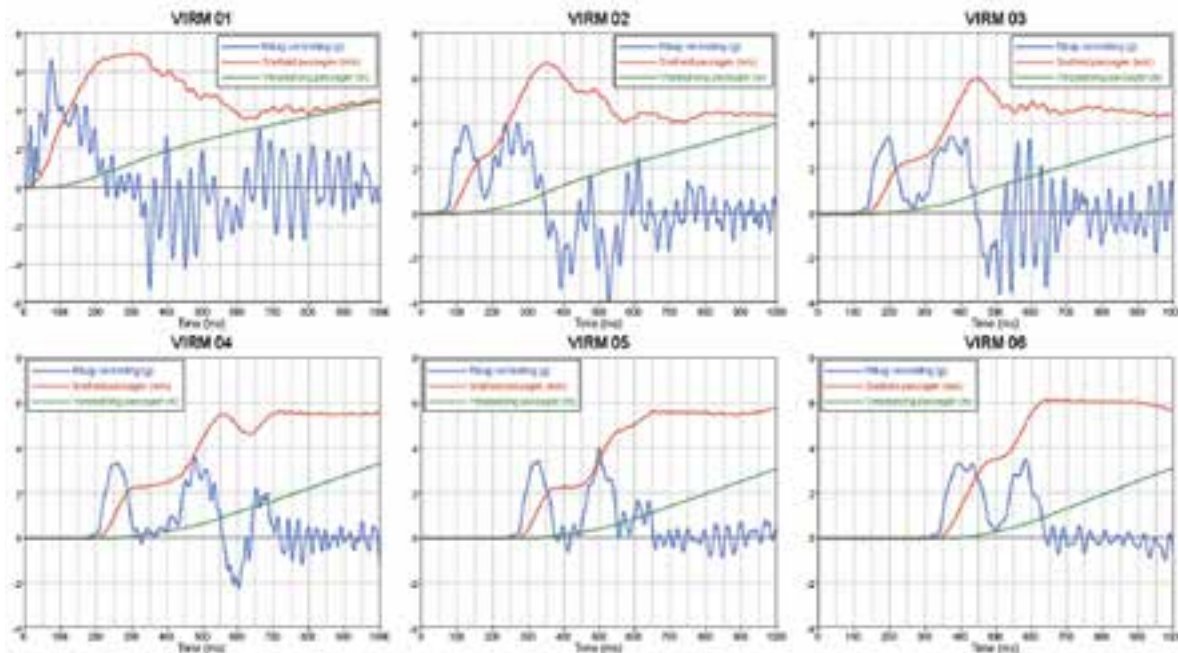
Figure 6: The movement trajectory of the six coaches of the intercity train.

The result of the simulation, described in further detail in the TNO-TASS report referred to above, has been summarised in the graphs below.

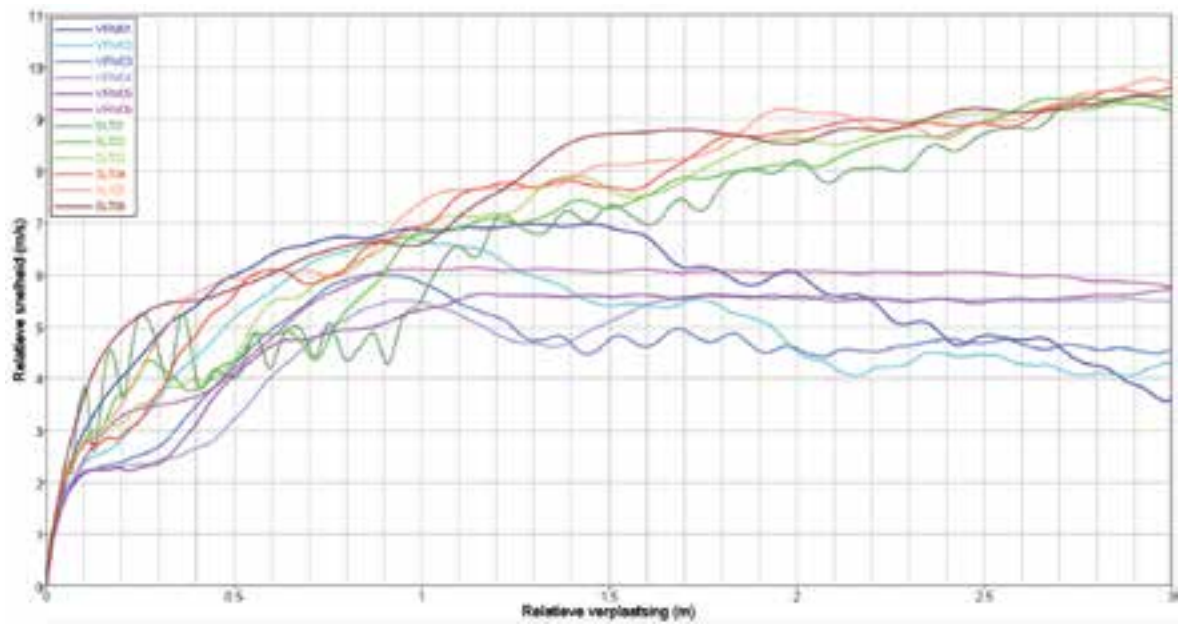
Figure 8: The movement trajectory by coach of a (non-fixated) virtual occupant for each coach.

Figure 8 provides an indication of the occupants' potential speeds in comparison with the train during the collision, depending on the distance over which they could move freely within the train.
