Bezwijken torenkraan

Rotterdam 10 juli 2008

Collapse of a tower crane

The Hague, 2009 (project number S2008BD0710-03)

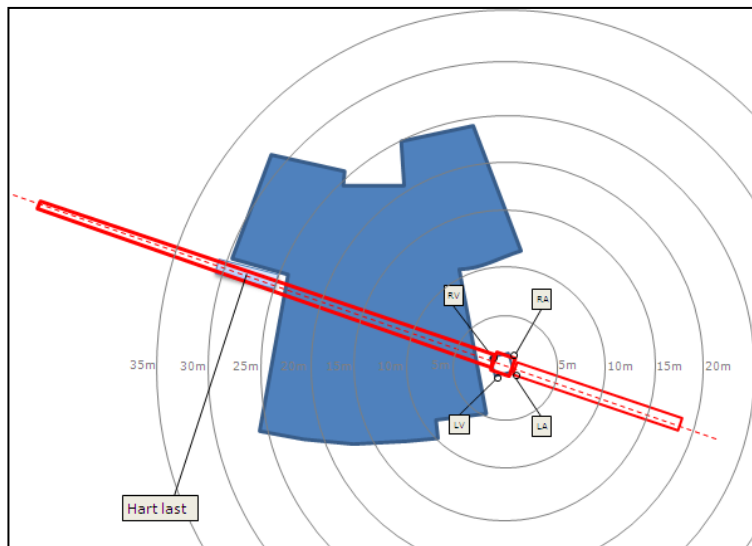
Figure 6 - Overview of radius of the tower crane at the construction site, showing the position of the tower legs; RV – front right, RA – rear right, LV – front left and LA – rear left (source: Aboma Keboma).

After the crane collapsed, all mast sections up to and including the transitional section were still upright, having suffered no visible damage. The first mast section above the transitional section was bent. The left rear tower leg (see Figure 6 for the designations of the tower legs) had broken loose at the mortise and tenon connection at the bottom (58.5 metres above the foundations). The upper part of the first mast section above the transitional section was bent completely out of shape, as were the next two sections. The tower legs, which normally form a square, were now positioned in the shape of a diamond shape in relation to one another, approximating a flat surface. The uppermost of those deformed parts, the third mast section, had torn loose at all four tower legs. The left front tower leg was visibly buckled.
