# Shifting cargo causes emergency

Lessons learned from the occurrence  
involving the Eemslift Hendrika,  
5 April 2021

*Den Haag, July 2022*

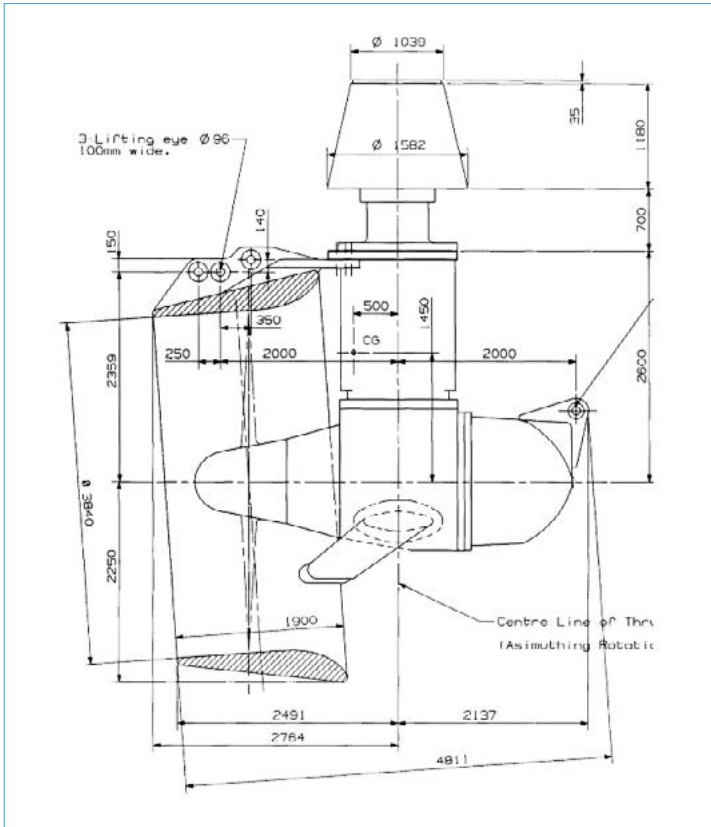
The information in relation to this request received by the captain and first officer from the chartering department consisted of voyage instructions and contained information on the ports of loading and unloading; details on the thrusters; a technical specification of the thrusters including a drawing indicating the dimensions and centre of gravity; and the weight of the thrusters - 60 tons each. The information included the remark that the thrusters contained oil. Figure 3 shows the dimensions of the thrusters in millimetres. The first officer made a stowage plan based on the voyage instructions, that was approved by the captain and sent to the chartering department to be checked. The captain had been working for the operator for several years but was now on his first voyage in his new role as captain. The approval of the stowage plan sent to the chartering department also acted as confirmation by the captain that, in his opinion, it should be possible to load and ship the thrusters.

Figure 3: Dimensions of the azimuth thrusters. (Source: Amasus)

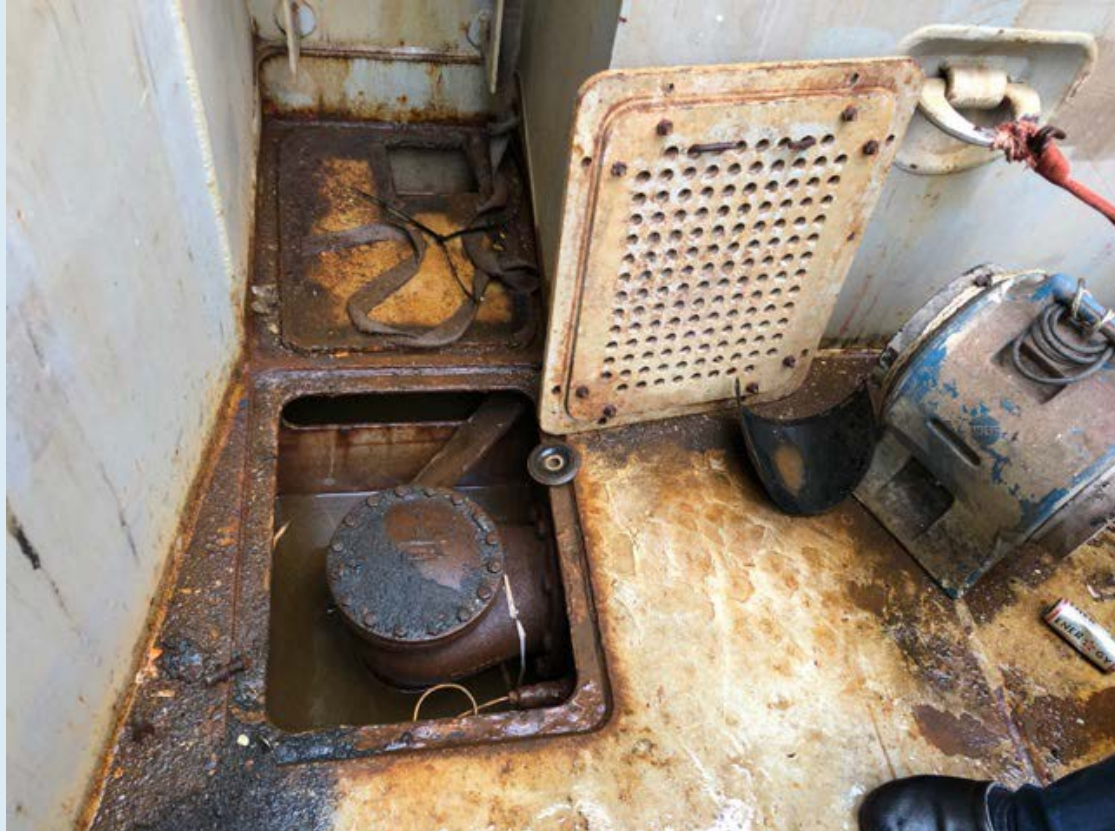
The bilge is the lowest area of a ship below the waterline where the two sides of a ship meet at the keel beam. At various locations in the vessel there are bilge pits where bilge water is collected. The bilge pits are fitted with a float that will activate the bilge HLA if the bilge water in the bilge pits reaches a certain level. The bilge pumps, with their suction line connected to the bilge pits, can be used to pump out the bilge pits. The HLA of this vessel is audible and visible on the bridge, in the engine room and in the chief engineer's hut.

Figure 5: Bilge well in the hold of the vessel.

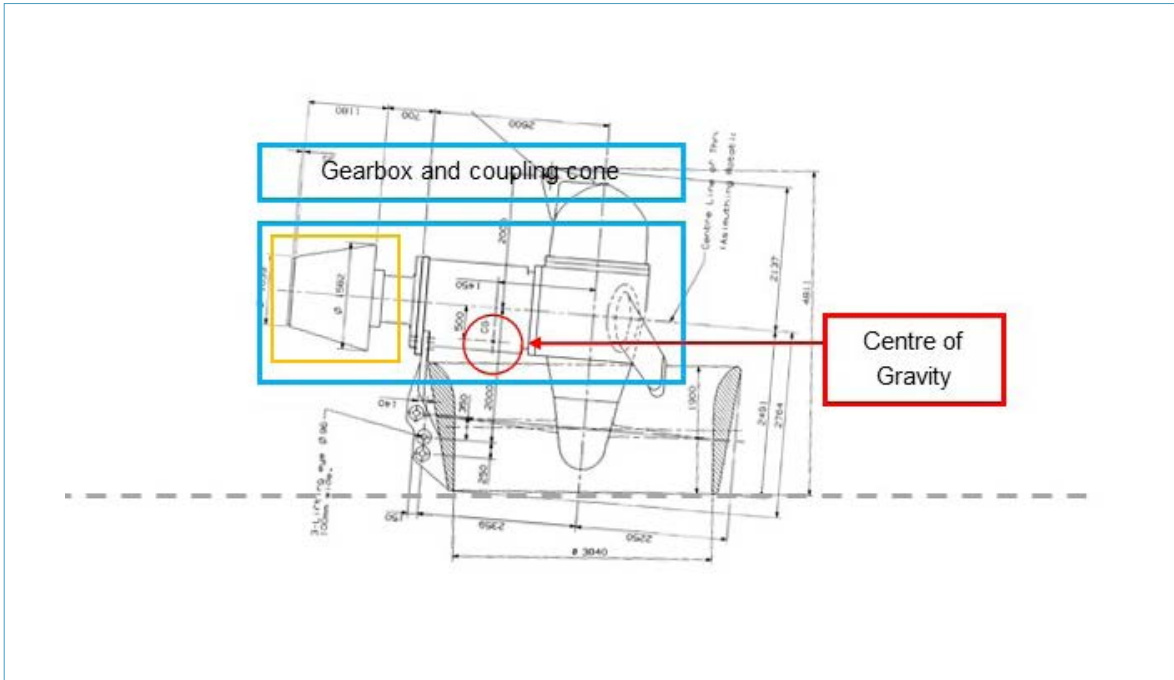
The CoG as indicated on the drawing of the azimuth thrusters is a theoretical CoG. In reality the CoG can differ because of, for example, shifting of oil in the gearbox. The crew usually determined the CoG when the cargo was being lifted. In the same way, the CoG of the thrusters was determined by the relief first officer and the captain. When the azimuth thruster was lifted from the single lifting point, the thruster's nozzle was about horizontal. From this observation, the relief first officer derived that the thrusters' CoG was in the centre of its horizontal plane.

Figure 14: Illustration of the components of the azimuth thruster and the theoretical position of the CoG

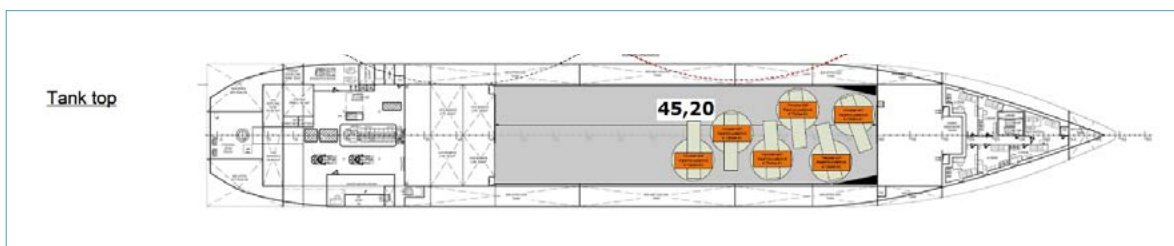
Annexes to the voyage instructions included the packing list for the thrusters, an example of the stowage plan<sup>12</sup> for the voyage Palermo – Ulsteinvik with only the thrusters plotted out, a photograph of a thruster and the technical specifications. The photograph of the thruster and the technical specifications were the same as provided by the freight broker to the chartering department.

Figure 15: The stowage plan as received by the captain and first officer from the operations department.

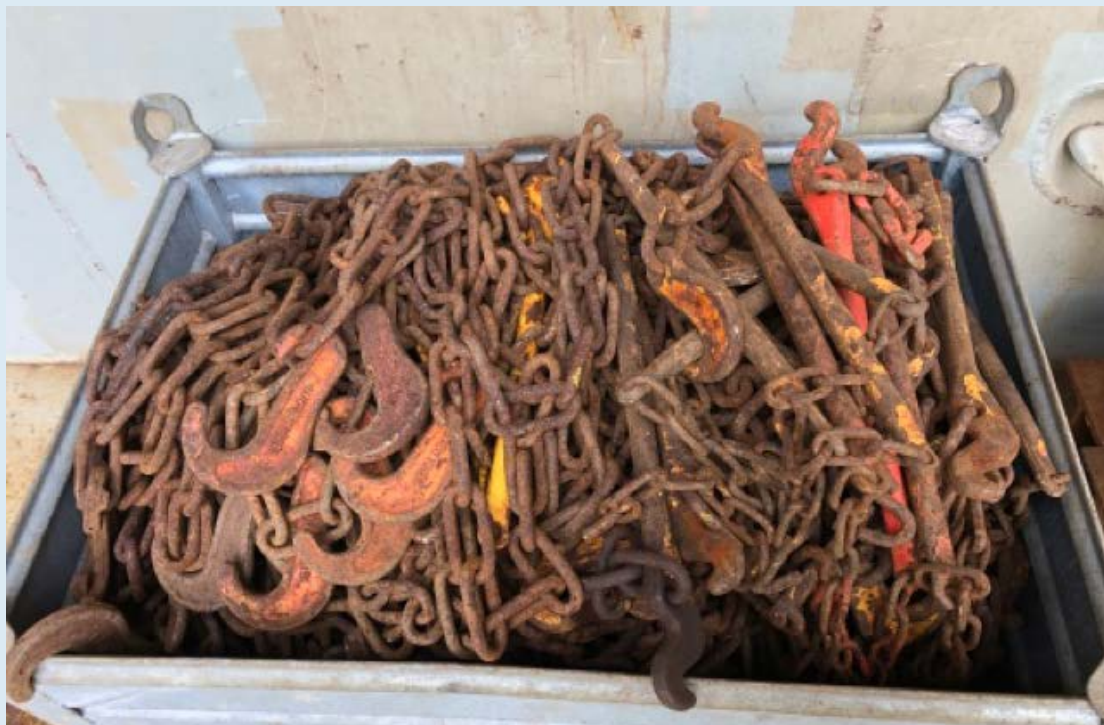
A visual inspection may identify visually broken or damaged lashing material which subsequently needs to be kept separate. Since a visual inspection is not conclusive with regard to the actual condition of the lashing material, the lashing material on board was generally used for a few years. As the material is used in a salty environment, it starts to look corroded relatively quickly. The lashing material was replaced every few years. Lashing chains in poor condition may have a reduced load capacity. In merchant shipping this is a common method for using and checking a ship's own lashing material.

Figure 19: A container with lashing chains and tensioners on board the vessel.
