DUTCH
SAFETY BOARD

Shipping Occurrences Report

January 2023 - July 2023

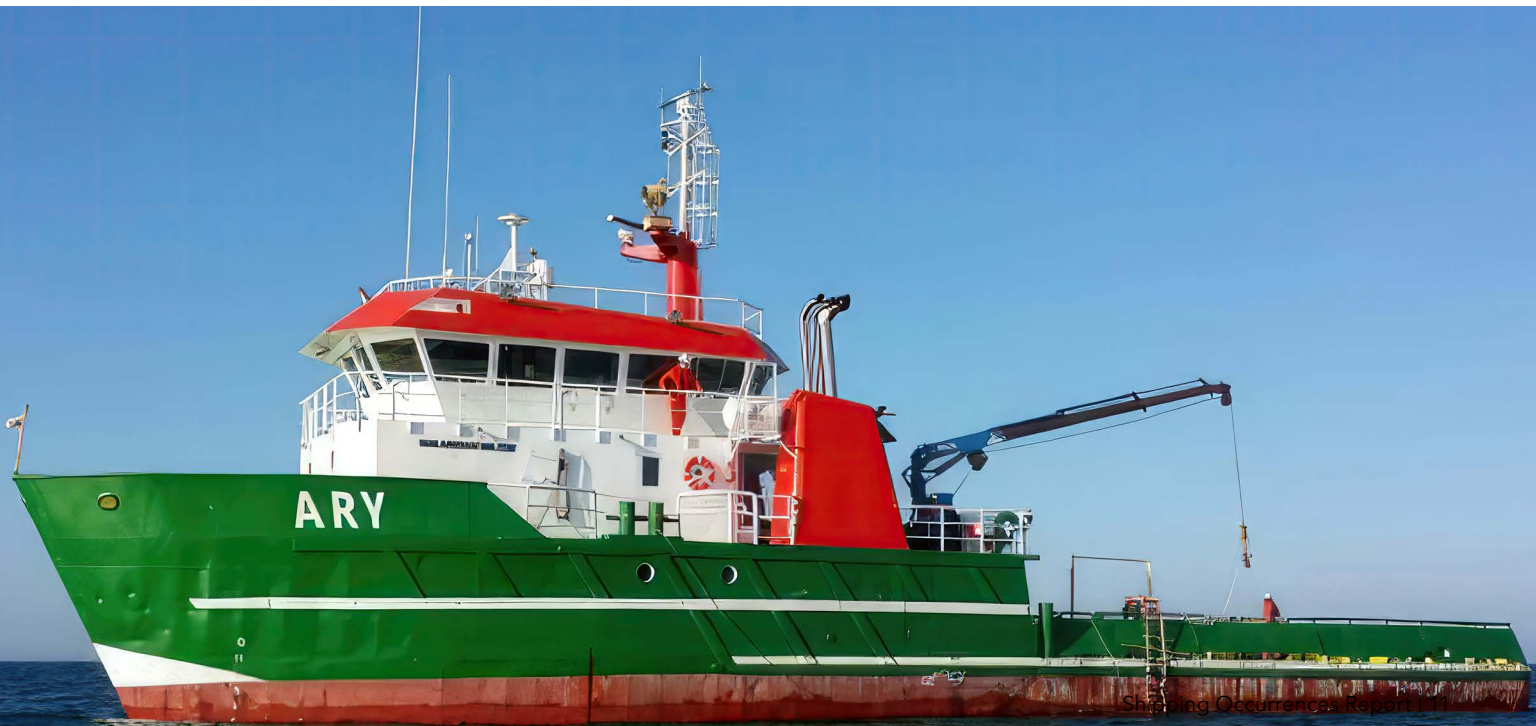
▼ Ary. (Source: Van Laar Maritime)

The Vanuatu Maritime Service concluded in the report that the ship's gangway was on board the Ary prior to the accident. The captain had deliberately made this decision due to the tide. On the morning of the accident, a number of crew members, including the casualty, were due to embark the Ary or another ship of the same shipping company lying alongside. On arriving in Lauwersoog after a car journey from Poland, they chose to board immediately without consulting anyone. They did this without first putting on the necessary personal protective equipment (PPE) on shore and requesting the captain of the Ary to put the gangway in place.

While climbing aboard the Ary without the required preparation, the casualty slipped and fell into the water. An alarm was immediately raised and the man overboard procedure (MOB procedure) was activated. However, despite this, they were unable to recover the casualty from the water within a few minutes. When, in due time, they were able to recover the casualty, he had already died.

The Vanuatu Maritime Service concluded that the captain of the Ary had been negligent in taking the new crew members on board by failing to inform them of the requirement to wear PPE and failing to put the gangway in place. Moreover, the MOB procedure was allegedly not carried out correctly.

The Dutch Safety Board did not fully recognize these conclusions. The lesson learned should primarily be that crew members who are joining a ship also need to have their own responsibility in wearing the prescribed PPE and should also ascertain for themselves whether they can board a ship safely.

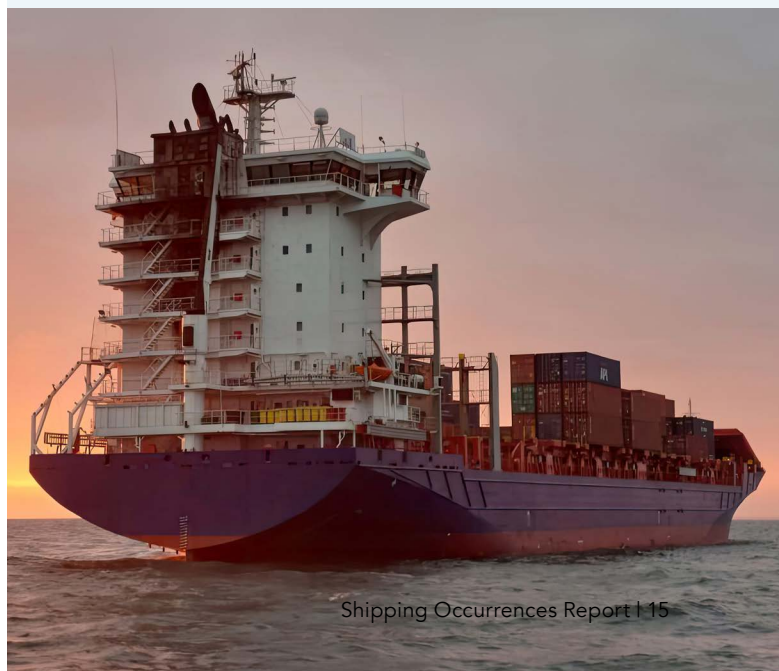
▼ The cargo vessel. (Source: Latvian Coastguard)

On 22 February 2023, a fire broke out on board a Dutch flagged container ship sailing in the Gulf of Riga. While the crew was fighting the fire, there was a power outage on board, after which the crew abandoned the ship. The fire was found to be raging in the ship's funnel and eventually extinguished by itself. The ship was towed to a port in Latvia.

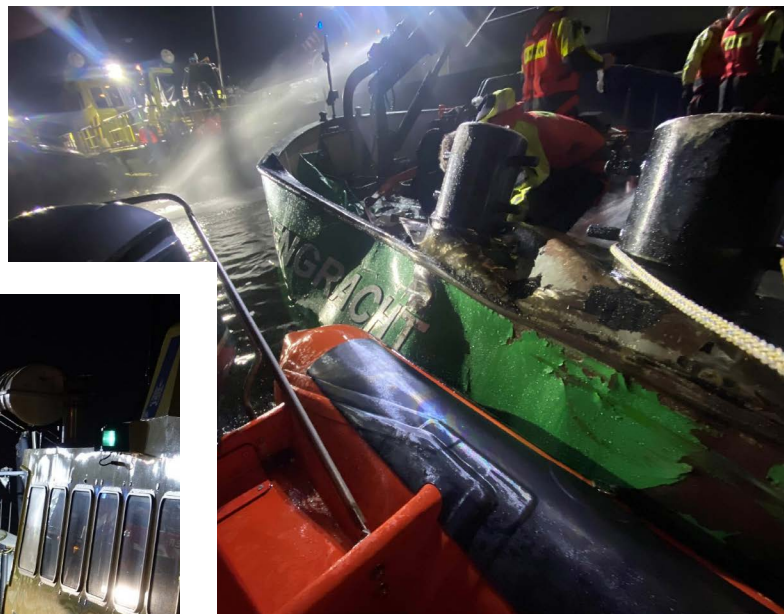
▲ Lindengracht. (Source: KNRM)

In the navigation channel at Flevokust, a collision took place between the cement tanker Lindengracht and the cargo vessel Zandlink I, both sailing under the Dutch flag. The tanker was carrying cement and the cargo vessel sand. As a result of the collision, the Lindengracht suffered an oil spill, which was subsequently cleaned up. One of the vessels suffered a tear to the hull, but was able to remain afloat with the assistance of the fire brigade, who pumped the incoming water out of the hold. Both vessels were able to reach port, under their own power.

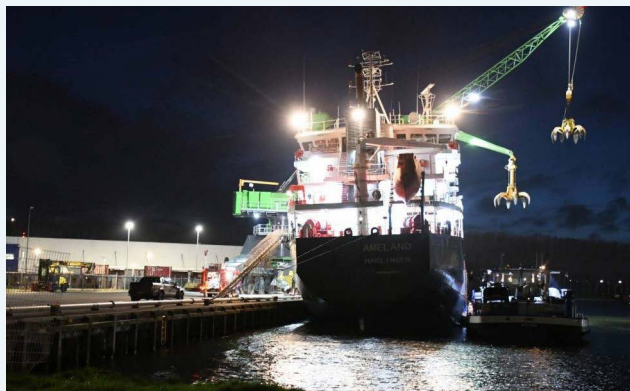
▲ *Esmee alongside the coaster. (Source: Provicom)*

At around 20.20 hours on Thursday 30 March 2023, a deckhand of the German inland vessel Esmee fell overboard, while checking the mooring lines. The vessel was moored alongside a coaster. After the emergency services were called, fire brigade divers searched for the deckhand, and the victim was found underwater at 20.55 hours. The victim eventually died.
