DUTCH
SAFETY BOARD

Shipping Occurrences Report

May - October 2020

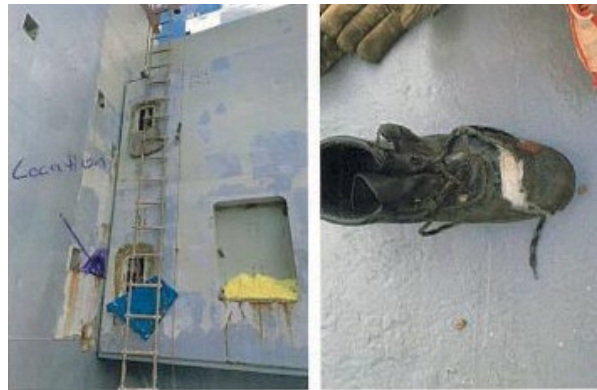
Leg between fishing cables, Shetland Islands, United Kingdom, 7 July 2020

In the afternoon of 7 July 2020, a deckhand on the fishing vessel SCH302 Willem van der Zwan trapped his leg between the fishing cables he was guiding. While hauling in the cables around the drums, the cables became entangled behind the victim, causing his leg to be trapped. As a result, he was pulled up against the guide frame, leading to a broken ankle and fibula. The victim required hospital treatment, and was evacuated by helicopter.

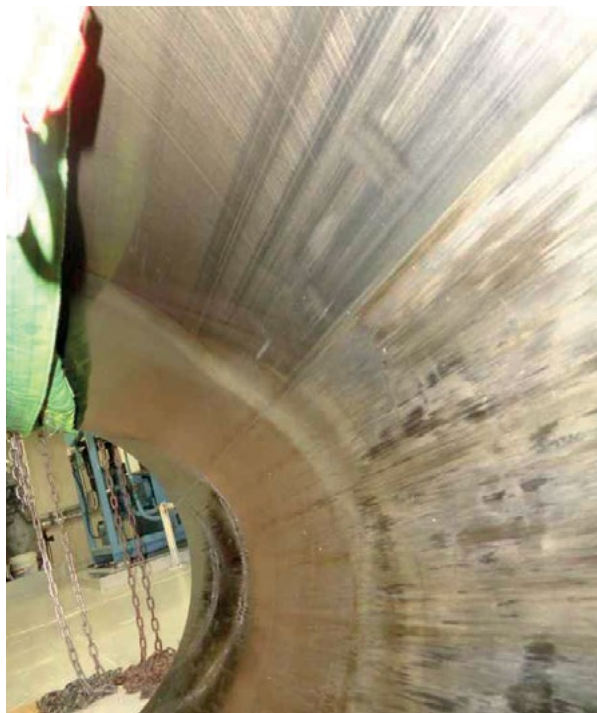
Engine failure, Karlshamn, Sweden, 24 October 2020

On 24 October 2020, the Dutch cargo vessel Lady Astrid was travelling from Karlshamn in Sweden to Chatham in the United Kingdom with a cargo of timber, when it suffered a main engine failure in international waters on the North Sea, off the coast of Noord-Holland. The main engine was shut down and investigation revealed that cooling water has flooded part of the main engine. This situation could not be corrected at sea. Tug assistance was required, and the Lady Astrid was towed into IJmuiden.

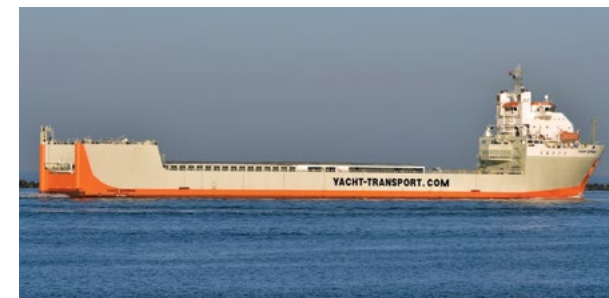
Water leak due to cracked GRP pipe, Atlantic Ocean, 5 October 2020

On 5 October 2020, the Dutch heavy cargo vessel Yacht Express took on a large quantity of seawater. This happened when the vessel was sailing on the Atlantic Ocean. The cause was failure of part of a Glassfiber Reinforced Plastic (GRP) pipe in a pump room. The crew decided to close the watertight doors, and switched on the bilge pump. The decision was also taken to set course for the nearest safe haven, Freeport on the Bahamas. En route to Freeport, it became clear that the capacity of the bilge pump was insufficient. Therefore it was decided to transport additional pump capacity to the vessel. Thanks to this additional pump capacity, the pump room was successfully pumped dry, allowing the crew to close the shut-off valves.

Classification: Serious
