GENERAL INFORMATION

Occurrence:	2008107
Classification :	Accident
Date, time of occurrence:	14 September 2008 at 12.47 ¹
Place of occurrence:	Markermeer, near Hoorn, the Netherlands
Aircraft registration:	PH-4B6
Aircraft model:	Zenair CH601 Zodiac
Type of aircraft:	Micro light aircraft (MLA)
Type of flight:	Recreational flight
Phase of operation:	En route
Damage to aircraft:	Destroyed
Number of crew:	One
Number of passengers:	One
Injuries:	Both occupants fatal
Other damage:	None
Lighting conditions:	Daylight

SYNOPSIS

During flight, at an altitude of 1100 feet, the right hand wing of the aircraft suddenly collapsed upwards. Subsequently the aircraft crashed into the Markermeer. Both occupants were fatally injured.

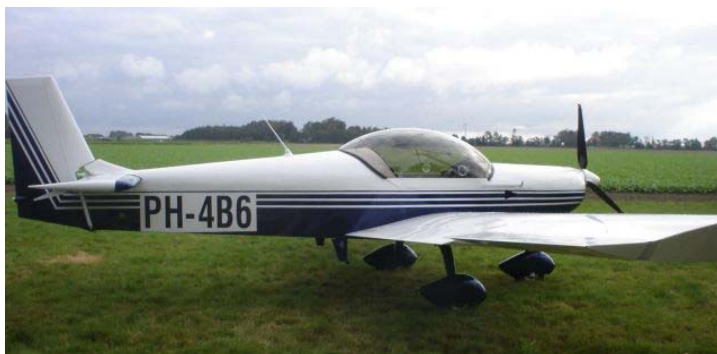
Figure 1: archive picture of PH-4B6

The accident PH-4B6 had been prefabricated in the Czech Republic. The owner had acquired the aircraft as a 'kit' and assembled it personally. Its maiden flight was performed on 8 September 2007. Until the accident it had logged a total of 92,6 flying hours. No anomalies occurred in that time.

The aircraft had a valid certificate of airworthiness. The periodical maintenance inspection to be performed every 50 hours, had been completed on 6 July 2008 by the owner.

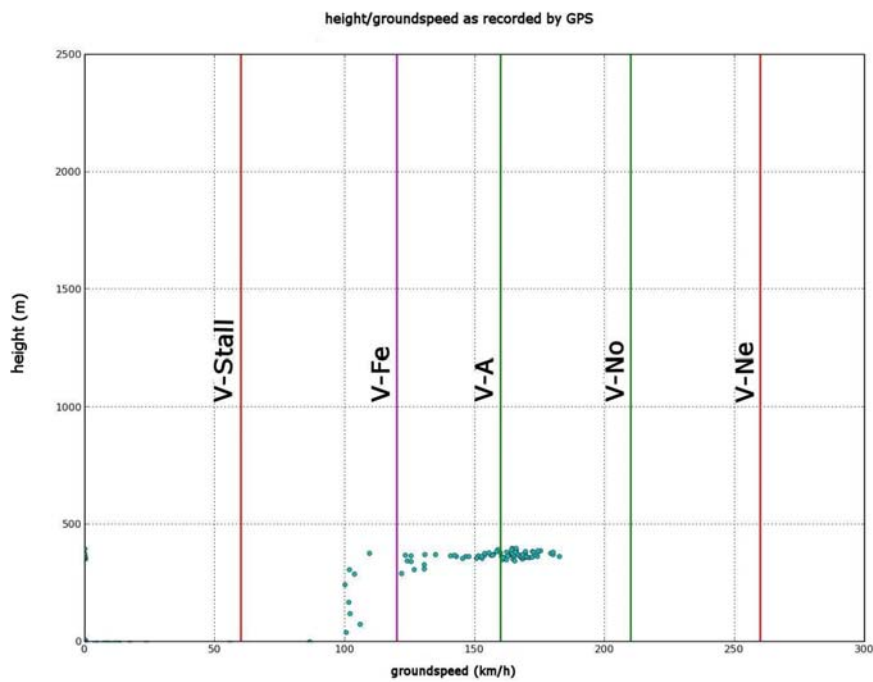
Figure 4: flying altitude and groundspeed as generated using GPS data

According to the flight manual of the Zodiac CH601XL, the maximum manoeuvring speed² (V_A) is 160 km/hr IAS (Indicated Air Speed) at the maximum allowed take off weight of 450 kg. The prescribed speed limit (V_{NE}) is 260 km/hr IAS.

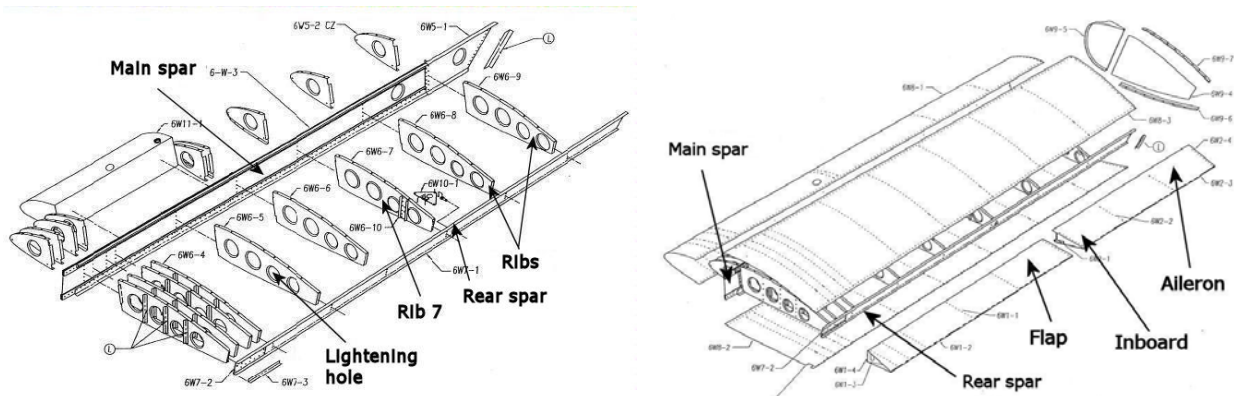
Figure 5: layout of wing construction of the Zodiac CH601XL

The wing of the Zodiac CH601XL consists of, amongst other things, a main spar and rear spar. The main spar is constructed by the manufacturer and delivered in one piece. These spars are interconnected by ribs. On the ribs the wing skin is fitted. The main spar is attached to the centre section, which extends through the fuselage, with six bolts. The rear spar is attached to an attachment bracket protruding out of the fuselage, with one bolt.

The upper- and lower girders (spar doublers and spar caps) of the right-hand wing main spar were buckled. A similar form of failure indicated exceeding of the permissible bending-moment in this part of the wing spar.

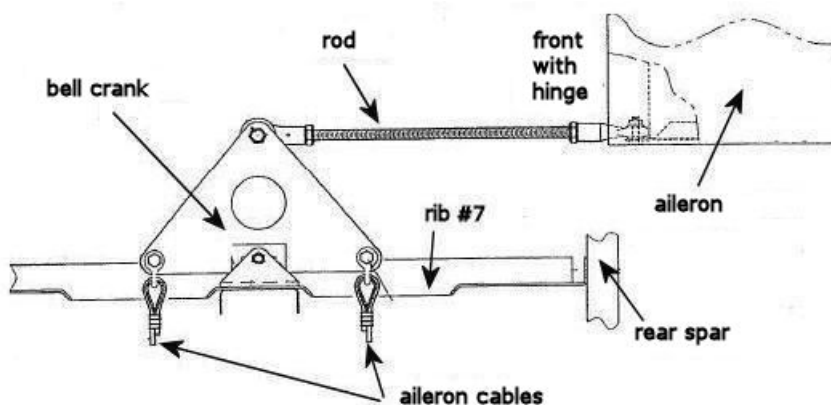
Figure 6: aileron drive of the Zodiac CH601XL

The aircraft is equipped with an aileron control system, utilizing steel control cables. The cables run from the control column, through lightening holes in the wing ribs, to a rib (#7) near the inboard area of the ailerons. Driving the aileron is accomplished by a push-pull rod which runs through a passage hole in the rear spar and is moved by the cable via a aluminium bell crank that is attached to this #7 wing rib. The rod is attached, with one bolt, to a bracket fitted to the aileron. The ailerons are, over their full length, connected to the upper side of the rear wing spar by a piano hinge. The ailerons are not mass-balanced.

- inspect all control cables on proper tension and adjust it to the correct value if required;
- inspect the ailerons on traces of damage;
- inspect the rear spar to fuselage attachment assembly.
