DUTCH
SAFETY BOARD

Quarterly Aviation Report

July - September 2023

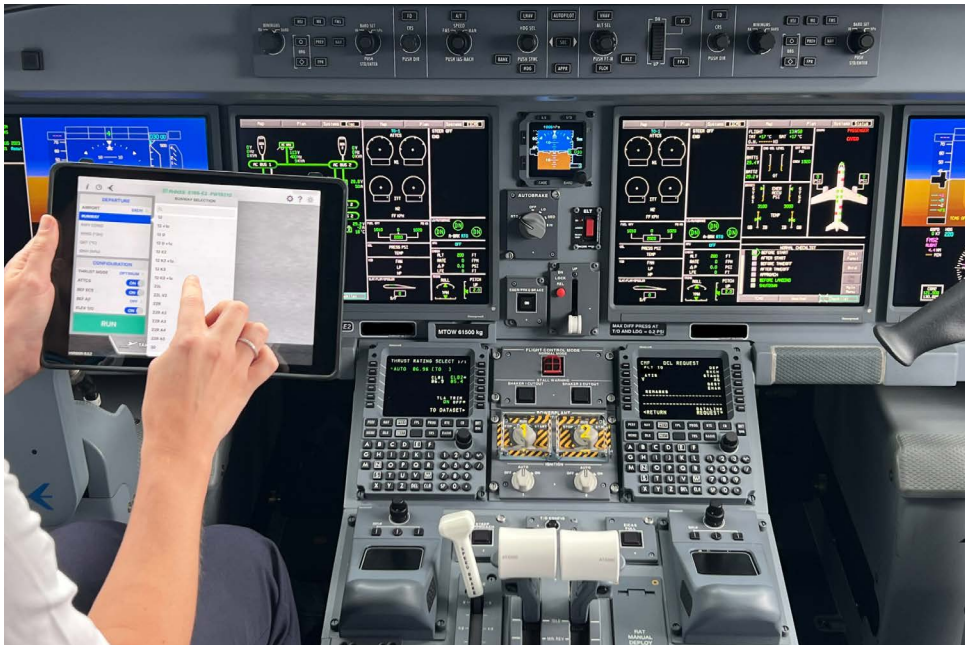
▲ Cockpit Embraer 195 and iPad. (Source: airline)

The Board formulates three lessons and a recommendation. The lessons aim to improve learning by operators. Operators may focus on improving data availability by increasing the amount of data and increasing the diversity of data sources, while they should also prioritise difficult to identify hazards or low-frequency occurrences with potentially catastrophic consequences for investigations and mitigating actions. The recommendation aims to stimulate the development of onboard technical solutions to reduce the risk of using erroneous takeoff data.
