DUTCH
SAFETY BOARD

Collision off the coast of Denmark

Lessons from the collision between
the Helge and the Wild Cosmos,
9 September 2022

The Hague, February 2024

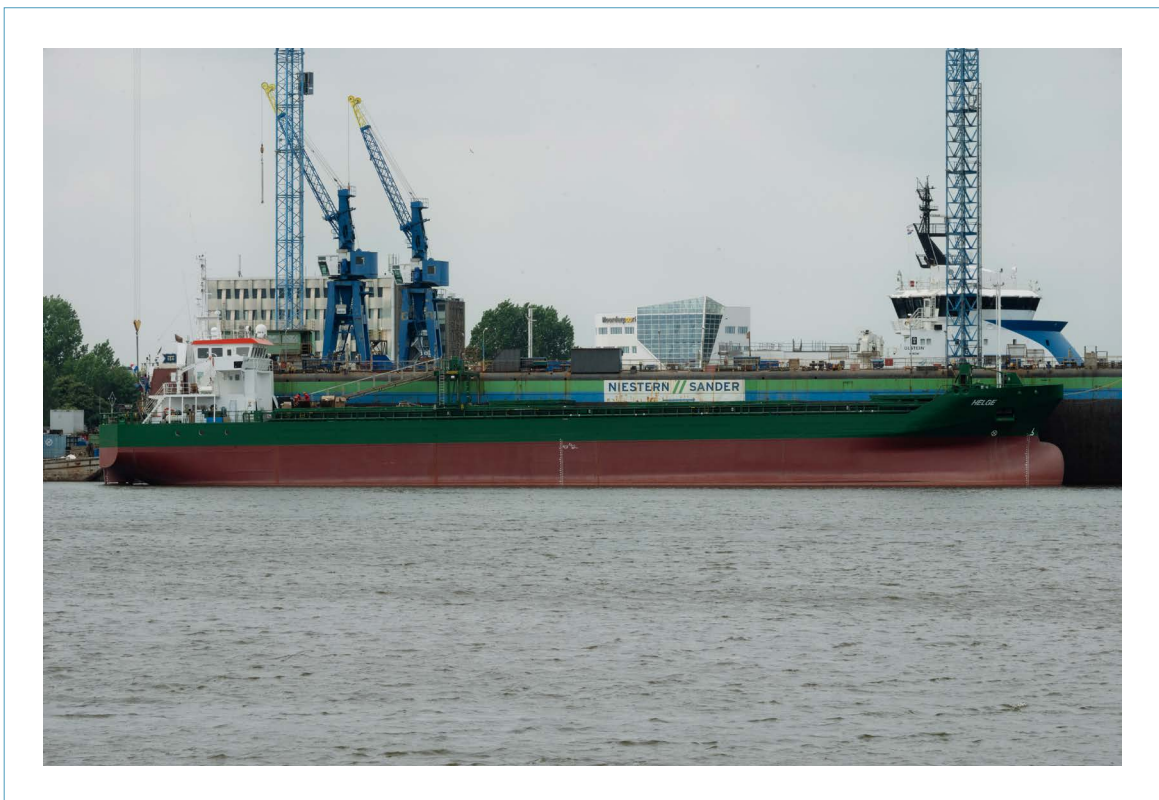
Figure 3: The Helge. (Source: Dutch Safety Board)

It also soon became clear that ballast tanks 3 and 4 of the Helge on the starboard side were leaking and filling up with water. As a result, the ship began to list to starboard. The chief engineer also reported a leak in the engine room. The ballast pump was started, to

pump out the water from the ballast tanks. A few minutes later, the list to starboard began to increase and there was also a total power failure. The chief engineer then started the emergency generator to restore power.

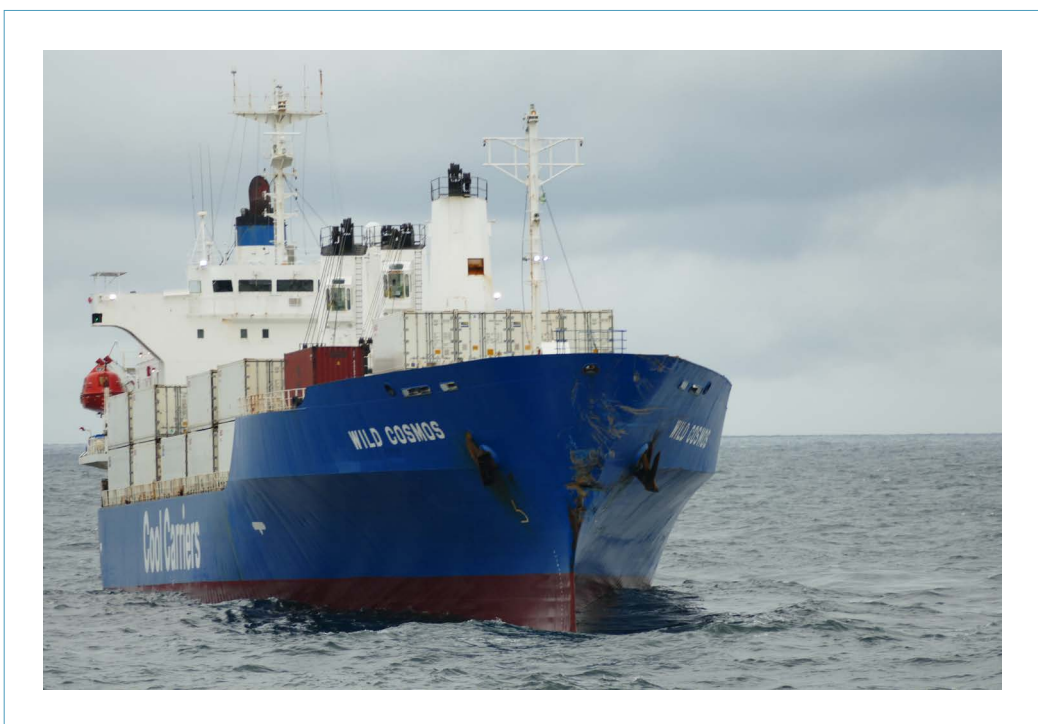
Figure 5: The Wild Cosmos. (Source: Danish Fishery Inspection)

On Friday morning 9 September 2022 at 05.14 hours local time¹, the Dutch freighter Helge was struck on its starboard stern by the freighter Wild Cosmos, sailing under the flag of the Bahamas. The collision occurred during the hours darkness in international waters off the west coast of Denmark. Due to the damage sustained from the collision, the Helge was in danger of sinking and the crew abandoned ship and boarded a liferaft. Salvage workers eventually managed to keep the vessel afloat and towed it to Esbjerg. The Wild Cosmos had damage to its bow above the waterline and continued its journey after an inspection.
