DUTCH
SAFETY BOARD

Risk management for the transport of dangerous goods by rail

Train collision Tilburg

6 March 2015

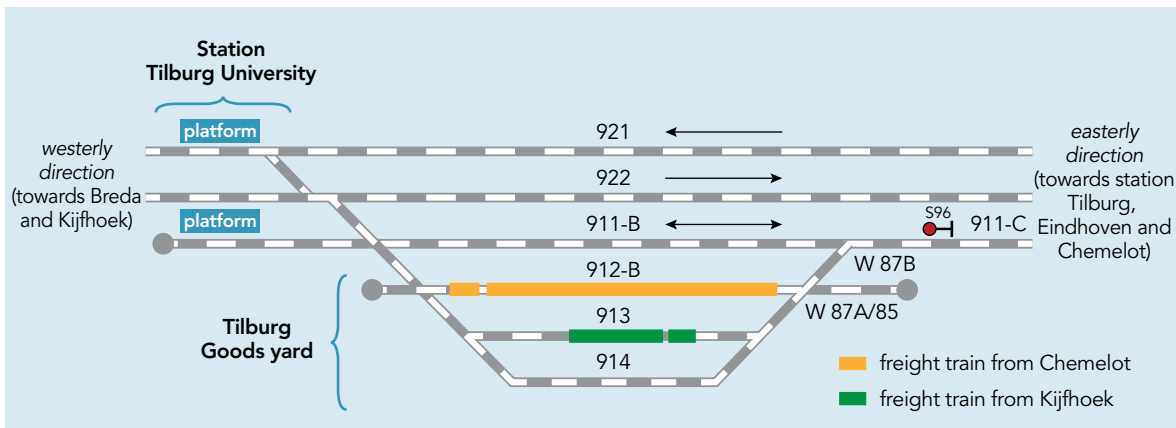
Figure 3: Because of the specially scheduled driver change, both freight trains were guided onto side tracks at the Tilburg-Goods yard. Because the train from Chemelot was too long for the side track, signal 96 remained at red.

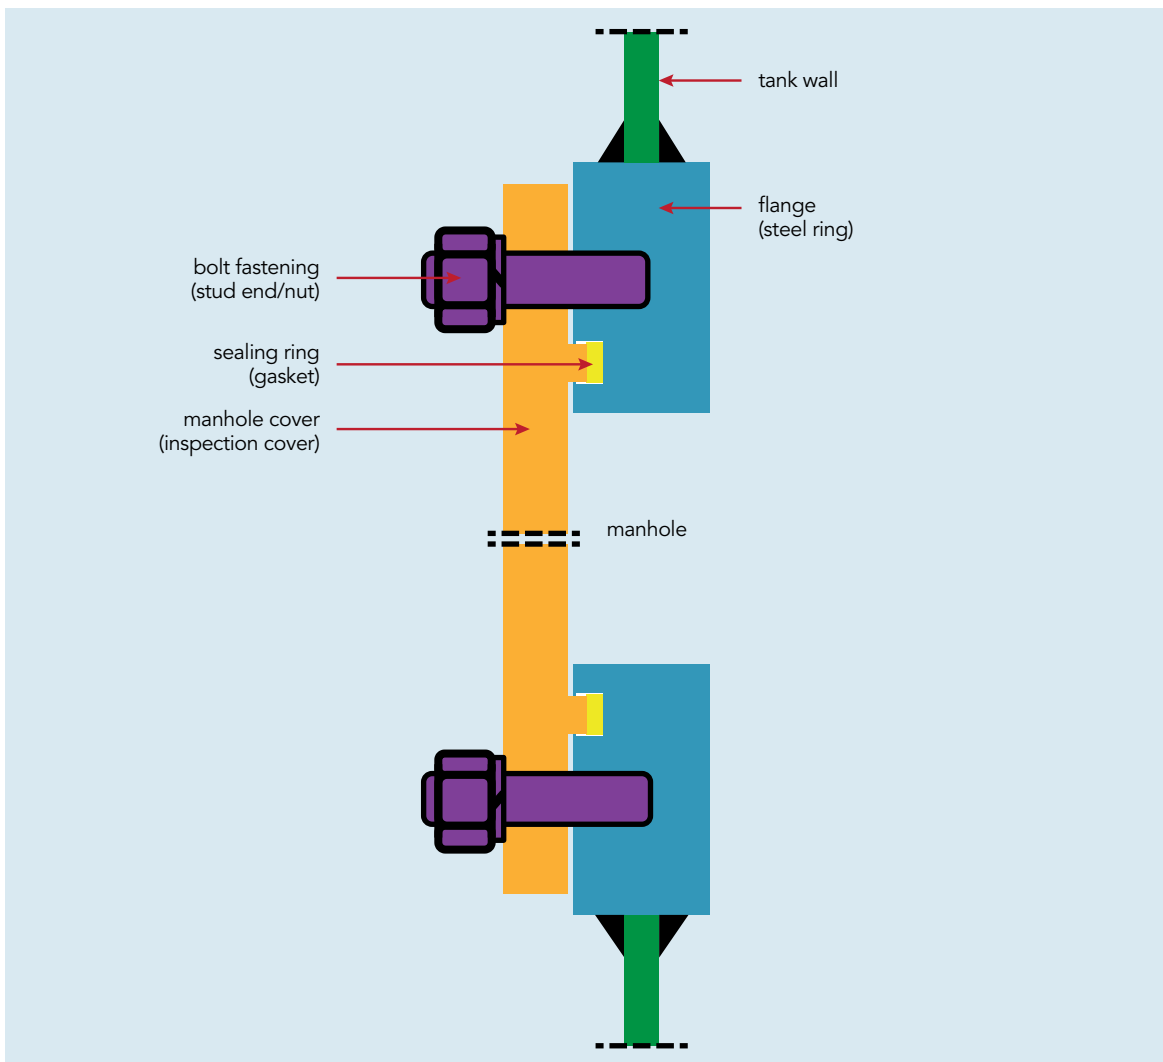
Figure 9: Cross-section of the manhole cover, diagrammatic representation.

The cover, the flange and the sealing ring complied with the regulations. The tightening torque²⁸ of the bolt fastenings, following the collision, proved to be less than the torque to which they should be tightened when the cover is applied (see appendix B2). That the bolt fastenings were insufficiently tight following the accident is probably explained by the fact that during the collision, considerable external forces were applied to the manhole cover. The underlying thought is that the sealing ring was probably somewhat crushed by the collision forces applied to the cover, and as a consequence it lost some of its elasticity.

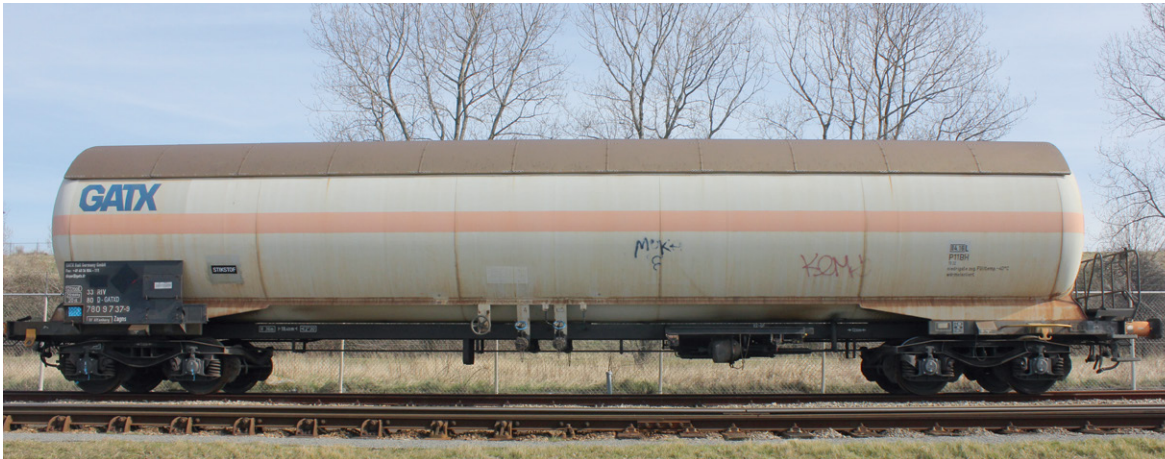
The rearmost wagon was a tank wagon suitable for the transport of (liquefied) gas. The wagon in question was a tank wagon of the type Zagns, built in 2004; the vehicle is the property of GATX and has been hired on a long-term charter by SABIC. The tank wagon was loaded with 52.5 tonnes of 1,3 - butadiene (HIN 239, UN-no. 1010).

Figure 19: The run-into tank wagon. (Photo: Dutch Safety Board)

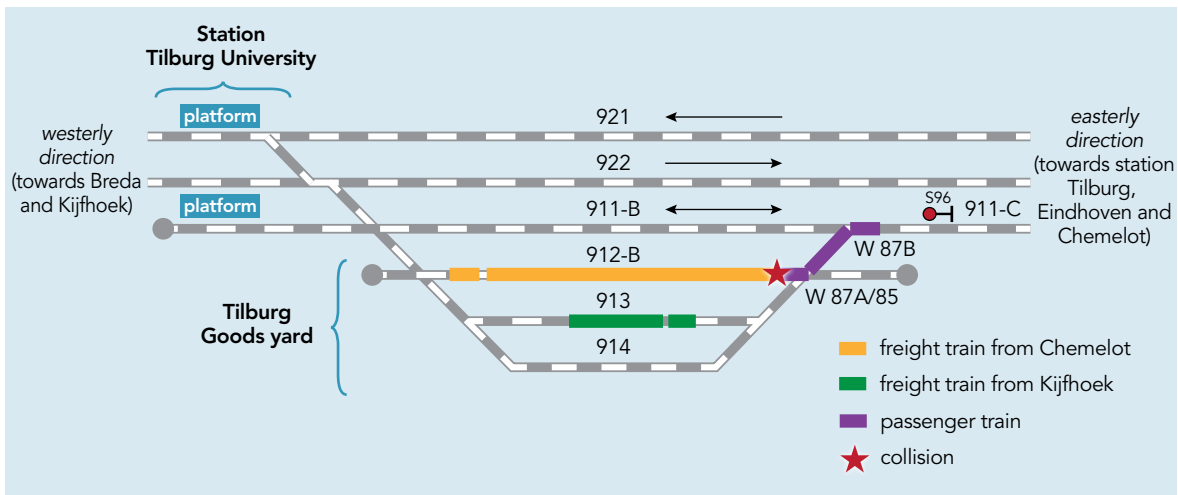
Because the signal was not equipped with the automatic train protection system ATB - Improved Version,⁷⁷ there was no automatic braking intervention. The eventual consequence was that the passenger train, via switch 87B that had not yet been switched to the correct position, and switch 87A/85, was guided onto side track 912-B (see figure 21). As previously explained, that track was occupied by the freight train. The driver of the passenger train activated his brake at the last moment, but because of the limited distance this was not sufficient to avoid a collision with the freight train.

Figure 21: This drawing is a diagrammatic representation of the position of both freight trains and the passenger train at the moment of the collision.

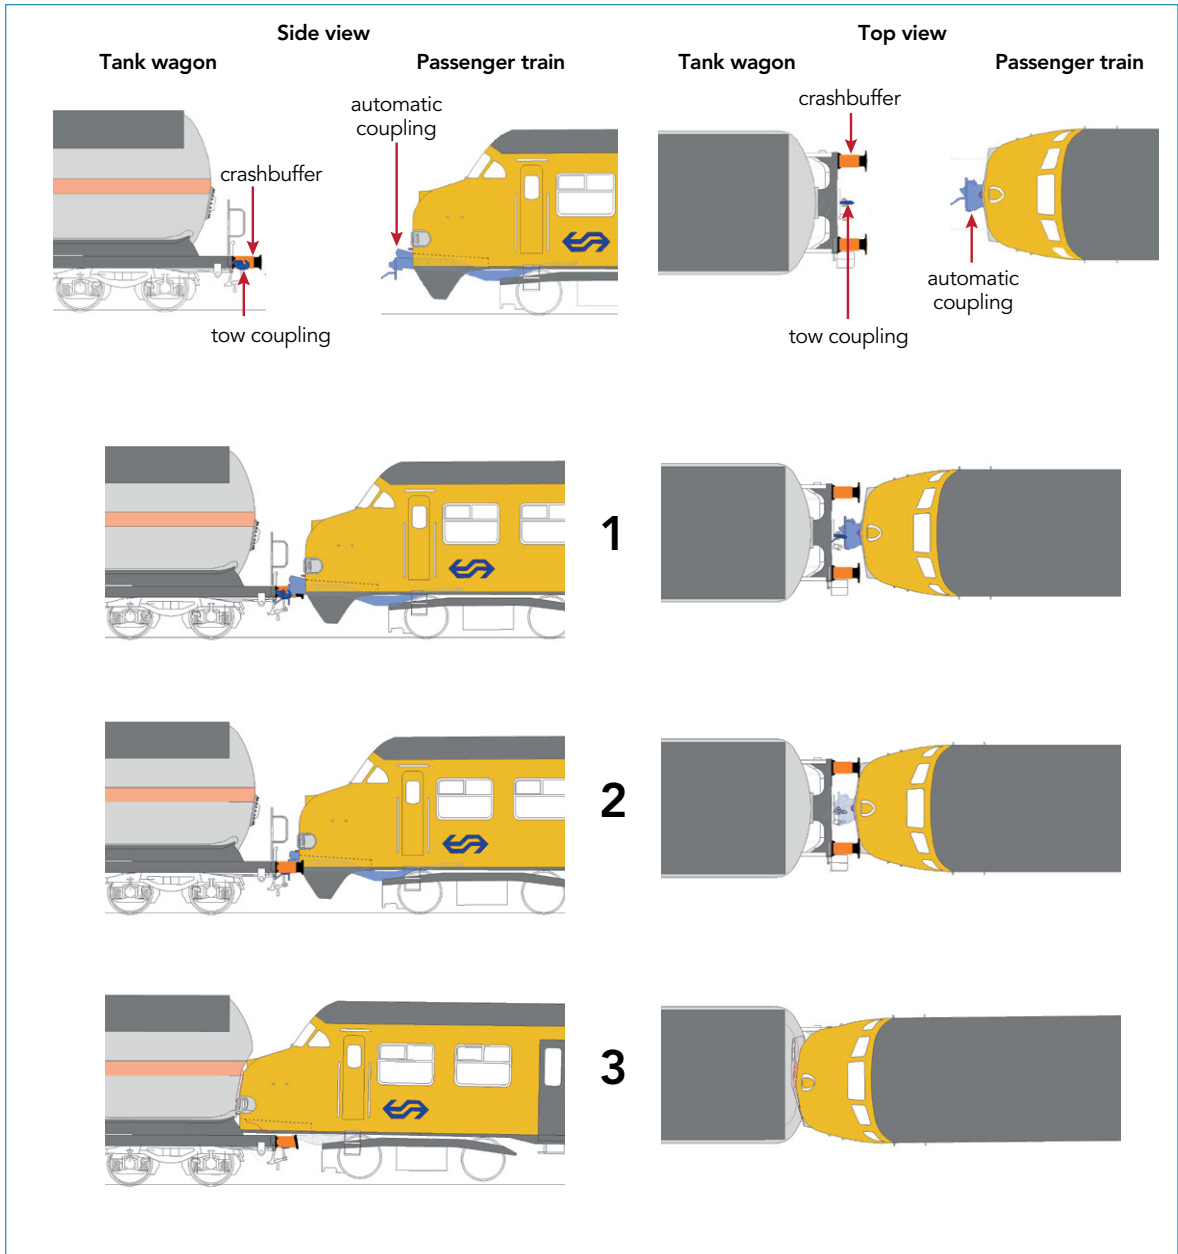
- The first contact took place between the automatic coupler on the front of the passenger train and the tow coupling at the back of the rearmost tank wagon of the freight train.
- As a result of the contact, the automatic coupler of the passenger train was compressed, at which point the front of the cab of the passenger train collided with the buffers of the tank wagon.
- Because only the top section of the buffers was struck, the front section of the passenger train 'climbed up' and over the buffers. The front of the passenger train then collided with the rear wall of the tank.

Figure 22: Broadly speaking, the collision consisted of three phases, whereby the front of the passenger train first collided with the tow coupling (1), then the buffers (2) and finally the tank of the rearmost tank wagon (3).

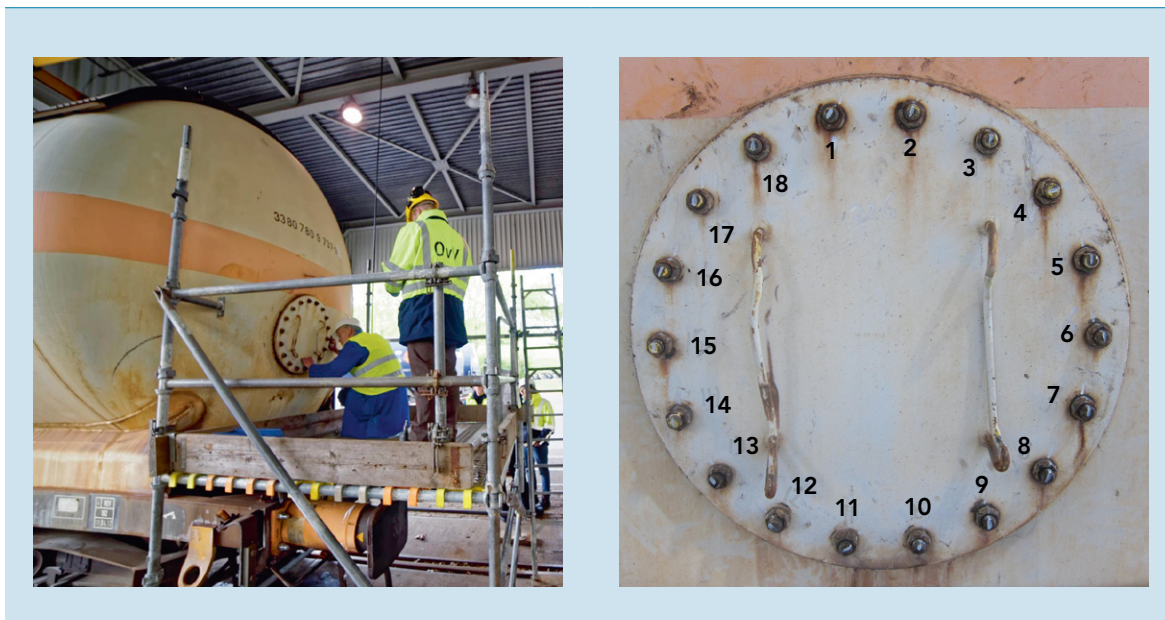
Figure 27: The left-hand photograph was taken during the inspection carried out on 06-05-2015 in Geleen. The right-hand photograph shows the numbering of the bolt connections on the manhole cover (1 to 18) for the purposes of reporting. (Photos: Dutch Safety Board)

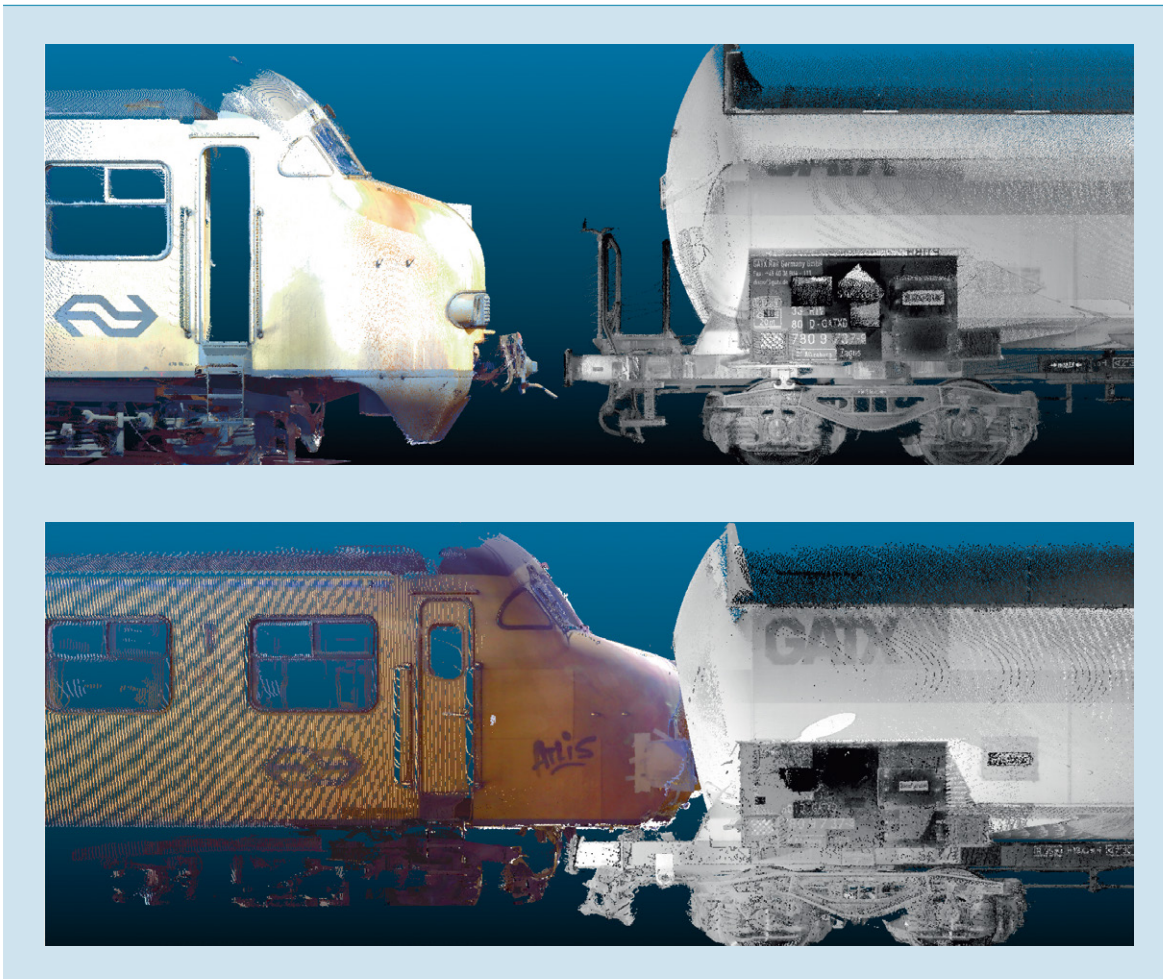
By comparing the 3D scans of the undamaged fronts (see the top picture in figure 35), it became clear that the first contact occurred between the automatic coupler of the passenger train and the tow coupling of the tank wagon, followed by the front of the passenger train making contact with (the top section of) the buffers. By comparing the 3D scans of the damaged fronts (see the bottom photograph in figure 35), it also emerged that in the second part of the collision, the front of the passenger train rose by approximately two decimetres, and subsequently collided against the rear wall of the tank.

Figure 35: These pictures show the side views of the 3D scans of the passenger train and the tank wagon, in respect of one another. The top picture shows the undamaged fronts and the bottom picture the damaged fronts. (Photos: Dutch Safety Board - KLPD)

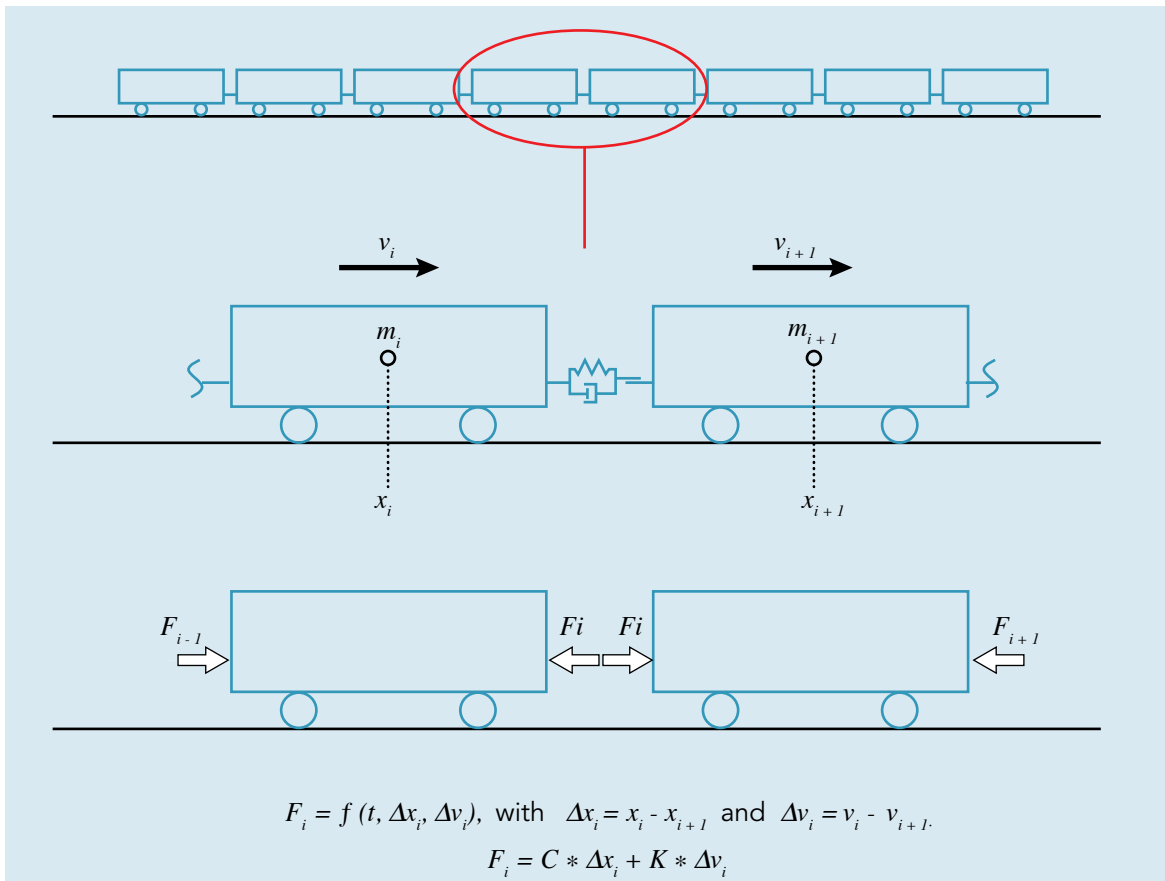
The calculation model used, as reproduced in diagram form in figure 37, consists of a series of coupling masses. The couplings between the masses take the form of elements of force, the force of which (over time) depends on the relative position (Δx) and relative speed (Δv); the elements of force consist of a spring linked in parallel (with the spring constant C) and an attenuator (with the attenuation constant K). The influence of the braking forces is accounted for by indicating for each mass whether or not a braking force was applied. The calculation model was implemented in the BODYSIM computer software (written in MATLAB version 2007b).

Figure 37: This figure is a diagrammatic representation of the calculation model.

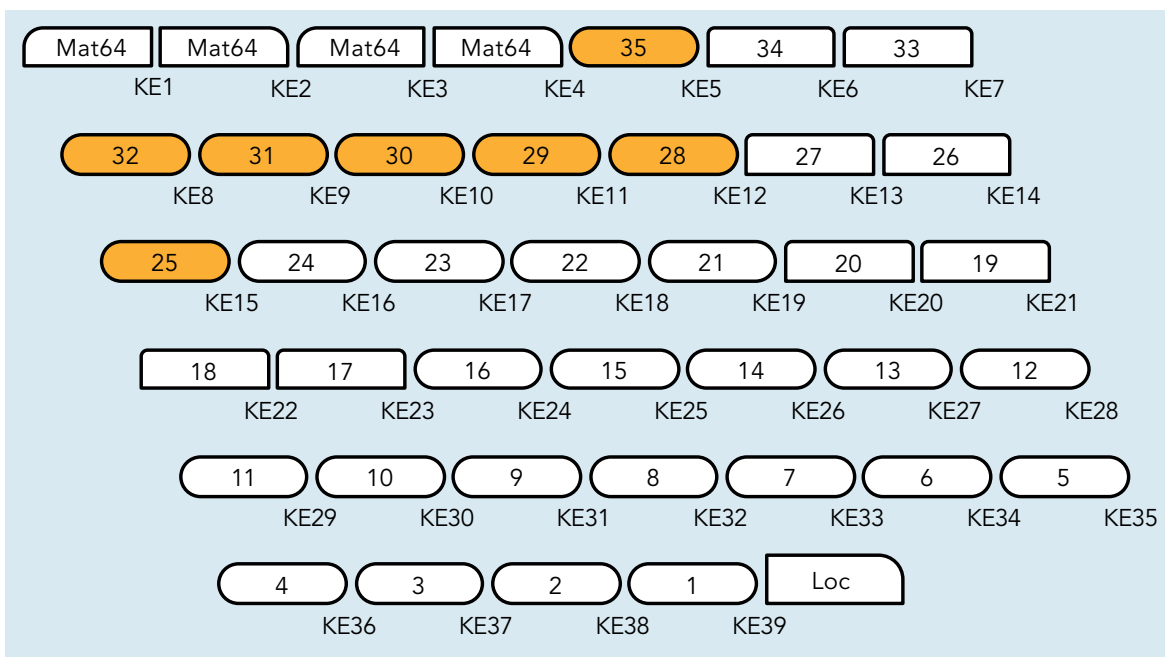
Figure 38: Diagrammatic overview of the calculation model in which the carriages/wagons are indicated, together with the numbering of the coupling elements (KE). The coloured wagons are loaded, the others are empty

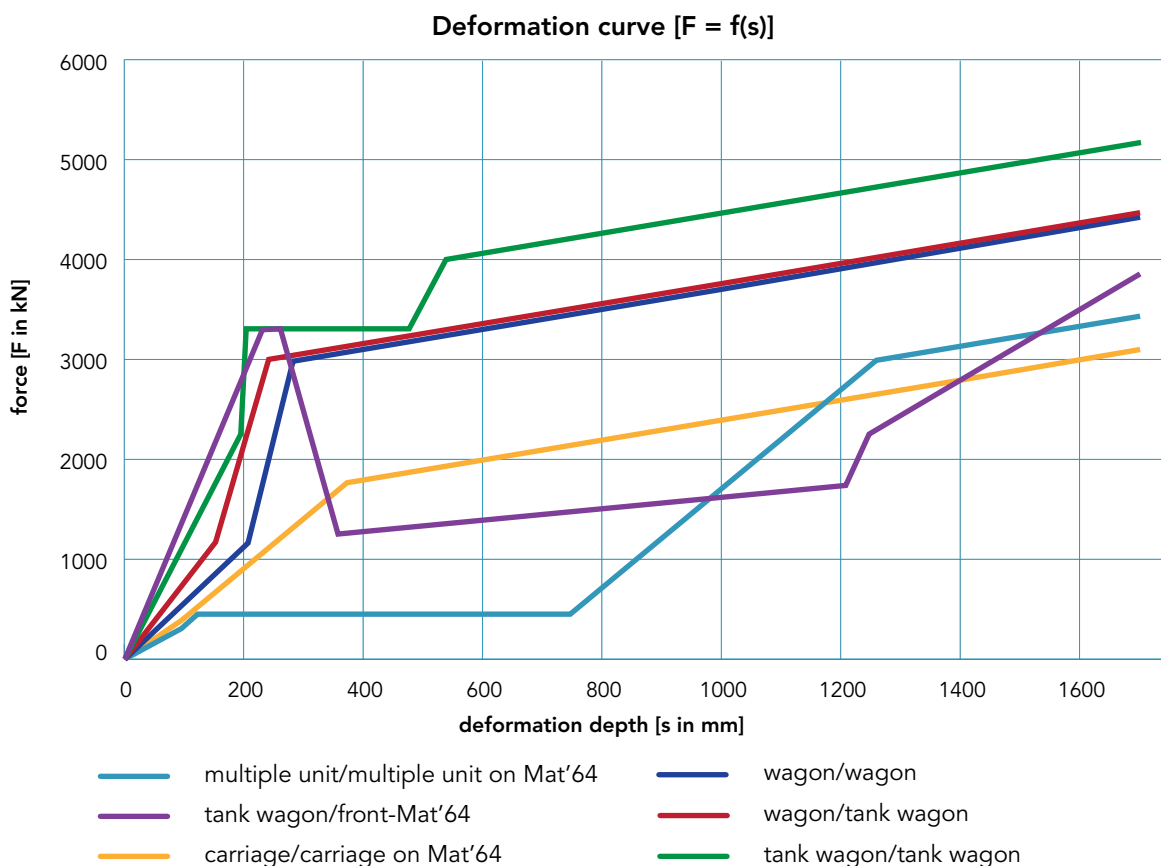
- Figure 39 shows the deformation curves employed for the various coupling elements. The course of the force/path diagrams is derived from the documentation concerning the (crash) buffers and couplings in question, and from deformations which were caused to the passenger train and tank wagon by the collision (as described in appendix B1). In respect of the deformation behaviour of the tank, a force/path development was assumed, such that the permanent deformation of the tank amounted to 0.35 m (in accordance with the measured value).

Figure 39: This graph shows the deformation curves (force/path diagrams) employed in the simulation of the calculation of the movements for the various coupling elements.

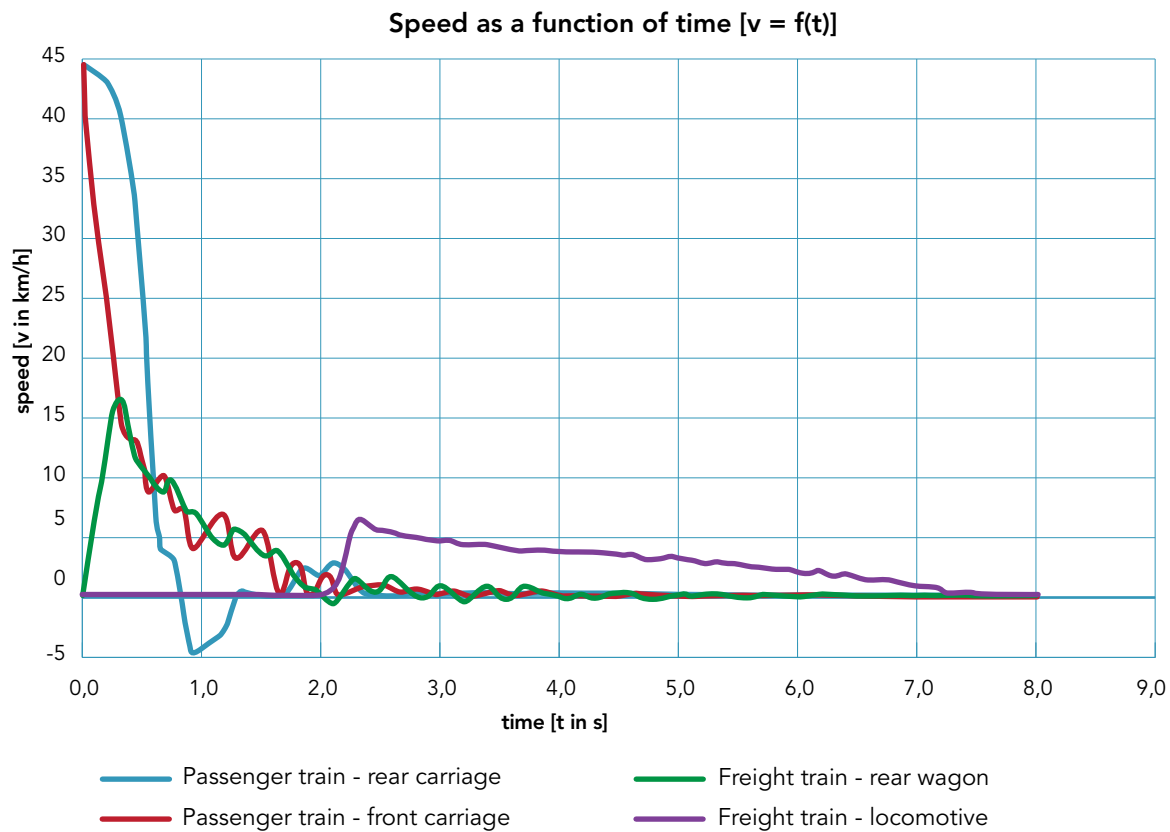
The reconstructed collision (see the graphs in figure 40) broadly speaking amounts to the following:

- The part of the collision period during which permanent deformation (damage) was done to the passenger train and tank wagon lasted approximately 0.4 seconds. In that period, the front of the passenger train was slowed down to approximately 15 km/hour, while the rear tank wagon was accelerated to approximately the same speed.
- It then lasts approximately 4 seconds before the passenger train and the rear tank wagon come to a standstill. The rear tank wagon is pushed forwards by the collision over a distance of approximately 4 metres.
- The displacement of the rear tank wagon is then transmitted through the freight train. Approximately 2 seconds after the start of the collision, the locomotive also starts to move. Approximately 5 seconds later, the locomotive once again comes to a standstill; in the intervening period, that vehicle is moved forwards by more than 4 metres.

Figure 40: These graphs show the reconstructed movement of the two trains during the collision.

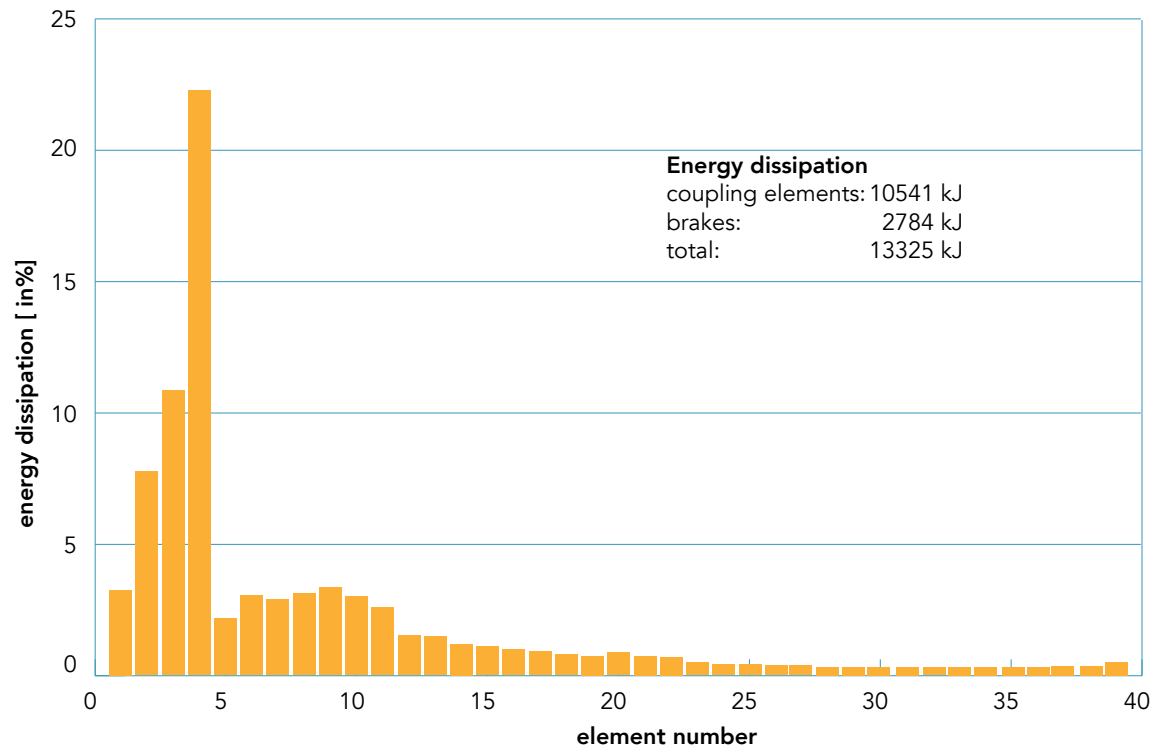
According to the reconstructed movements, the kinetic energy present in the passenger train at the start of the collision was converted as follows into other forms of energy (see figure 41):

- At the start of the collision, the kinetic energy of the passenger train amounted to approximately 13.3 MJ.
- Of that total, during the collision, approximately 5.9 MJ (almost 45%) was converted into permanent deformation (damage) of the passenger train and the rear tank wagon. Approximately half (3 MJ) of this amount related to damage to the front of the passenger train and the rear of the tank wagon; the remainder (also approximately half) related to damage to the connections/couplings between the carriages of the passenger train.

- The remainder of the kinetic energy (2.8 MJ or more than 21%) was converted into friction between the braked wheels (of the passenger train and the locomotive) and the rails.

Figure 41: This graph relates to the energy conversion in the reconstructed collision. The graph shows which percentage of the original kinetic energy of the passenger train is absorbed during the collision by the various coupling elements (for numbering see figure 37).

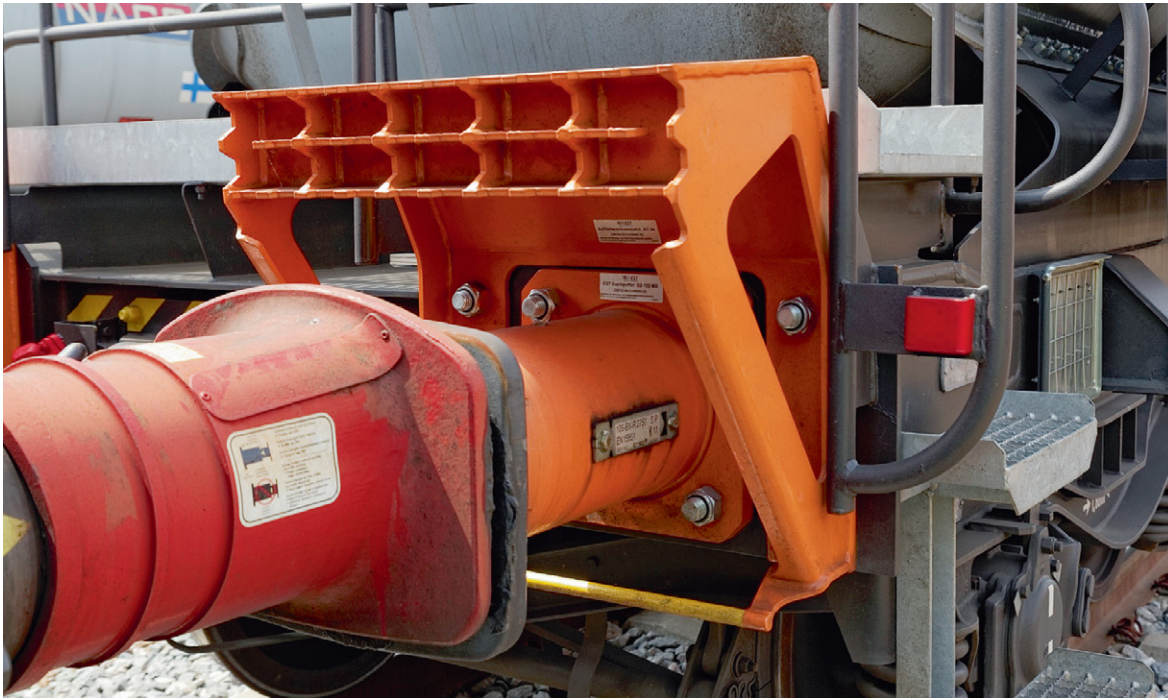
A number of different systems have now been developed. The common feature is that in essence they consist of a catch structure mounted above/below the buffers (see figure 45). The purpose of these catch structures is to halt buffer overriding as it starts.

The RID specifies that the catch structure must be resistant to vertical forces (upwards and downwards) of 150 kN. The structures must also be produced in such a way that they represent no hindrance to the normal use of the wagons (including tight bends), and that the risk of penetrating the base of the tank is not increased, as a result of an impact.

Figure 45: This photograph shows an anti climbing device. (Photo: SABIC)

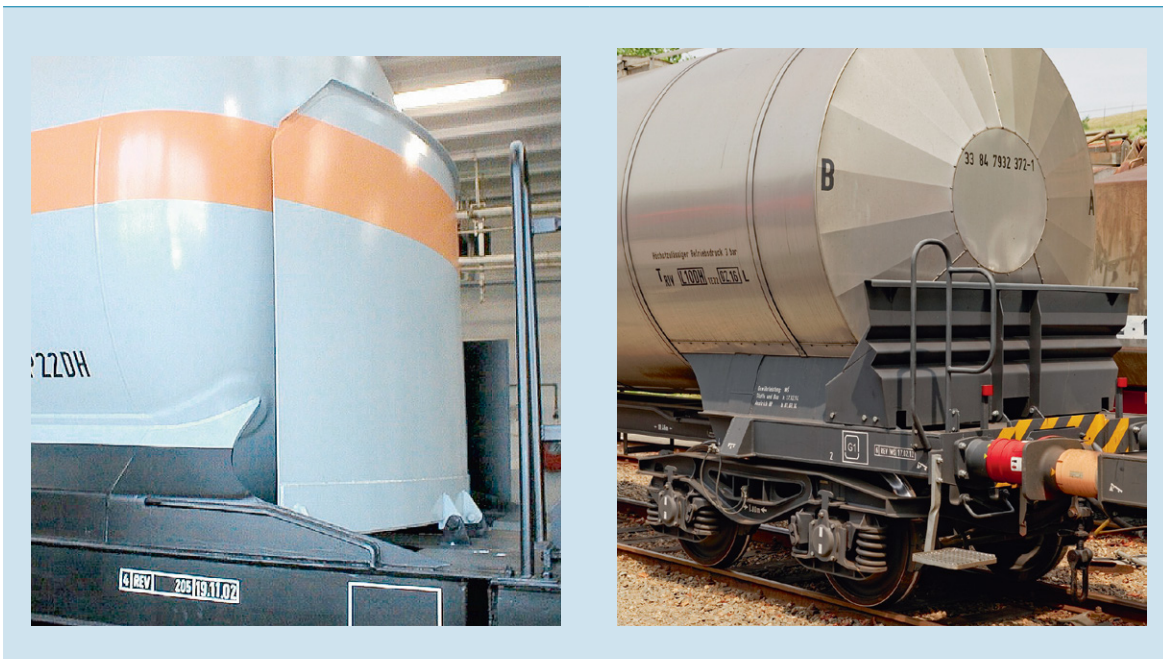
Protective shields/strengthened end walls are structures intended to prevent leaks in a tank as a consequence of a sharp part of the colliding vehicle (or its cargo) penetrating the wall of the tank. Structures of this kind effectively consist of a solid steel panel that is placed vertically in front of or against the end wall of the tank (see figure 46). The construction requirements in the RID relate to the width, height and thickness of the shield, and to its attachment.

Figure 46: These photographs show two examples of protective shields. (Photos: SABIC)

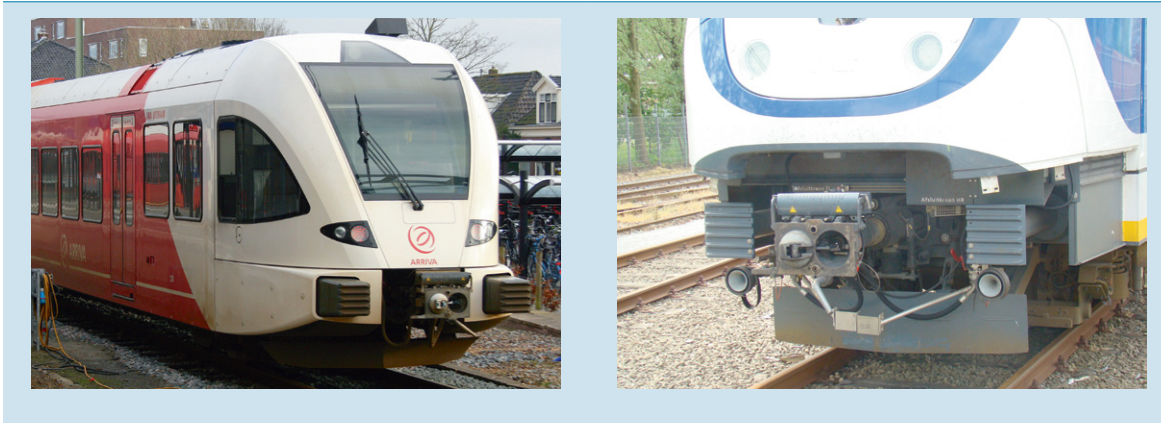
To meet these crash safety requirements, new passenger trains are, for example, equipped with crash buffers (see figure 48). Because these crash buffers are fitted in the same place as the (crash) buffers fitted on freight wagons, the assumption would appear justified⁹⁶ that the collision compatibility of modern passenger trains in respect of tank wagons is considerably better than is the case with the Mat'64 trains.

Figure 48: Both photographs show a modern passenger train equipped at the fronts with crash absorbers. On the train on the left-hand photo the crash absorbers are visible (on both sides of the automatic coupler). The right-hand photograph is a train of the type SLT operated by NS Reizigers: if the bottom section of the front panel is removed, the two crash absorbers and the obstacle deflector become visible. (Photos: left = Roel Hemkes, right = Dutch Safety Board)
