Quarterly Aviation Report

October - December 2023

Q4 2023

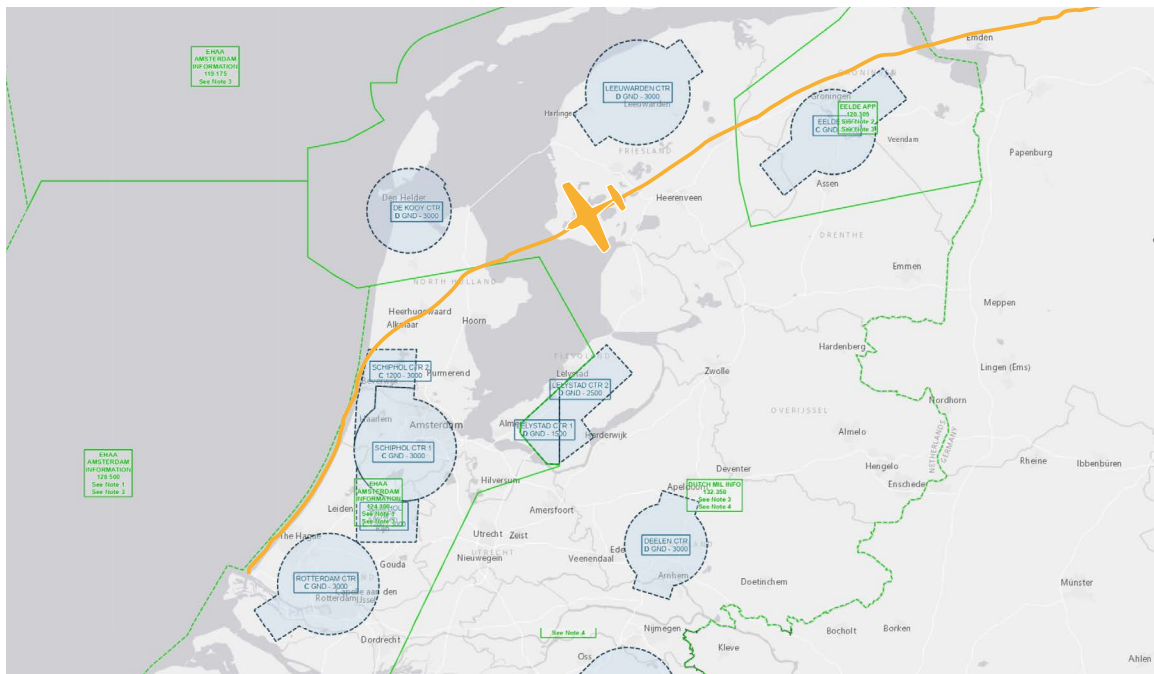
▼ Trajectory of the aircraft. (Source radar data: LVNL)

The cause of the accident could not be determined. Based on available radar data, the accident occurred at approximately 17.58:30 hours. Radar data confirm that altitude variations occurred during the last part of the flight before the aircraft descended from 800 feet above mean sea level (AMSL) and impacted the water.

An extensive analysis of the available weather information was performed to determine the actual weather conditions at the time of the accident. Along the route in Dutch airspace, weather conditions were initially quite good. In general, there was a visibility of more than 10 km, a light eastern wind and a cloud base between 3,000 and 5,000 feet. When the aircraft flew along the Dutch coastline in southern direction, the weather conditions were deteriorating: the cloud base was descending to 2,000 to 3,000 feet with a visibility of 3,000 to 5,000 metres. It seems plausible that the descent of the aircraft along the route to Hoek van Holland was necessary in order to remain in Visual Meteorological Conditions (VMC). During the last trajectory, flight visibility may have been further reduced with few/scattered clouds between 1,000 and 1,500 feet and a visibility of 1,500 to 2,000 metres in light, possibly moderate, rain. It cannot be established with certainty whether there was a discernible horizon, due to the possibility of reduced visibility as a result of light up to moderate rain in the vicinity of the accident site. With a cloud base between 1,000 and 1,500 feet, it is considered unlikely that the pilot lost visual contact with the surface during the last part of the flight.

Due to the limited wreckage parts recovered, a possible technical cause or contributing factor of a technical nature cannot be fully excluded. Examination of the available wreckage parts did not indicate pre-existing defects or anomalies.

Following the accident, LVNL has updated its Quick Reference Handbooks for air traffic controllers, adding to inform JRCC of situations where due to circumstances or flight path the controller assumes that the general aviation aircraft is in serious difficulty, even though the pilot did not (yet) report an emergency.

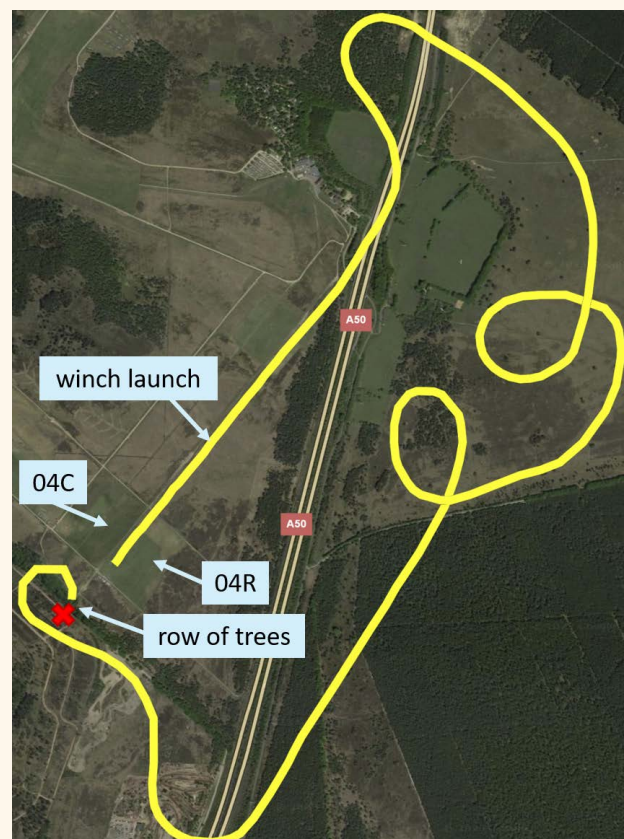
At 13.50 hours, the right wing made contact with the row of trees. The aircraft then crashed on the other side of the row of trees and landed upside down. The pilot died from her injuries. The glider was badly damaged.

▼ The flight path travelled. (Source: FLARM data, Open Glider Network and Google Maps)

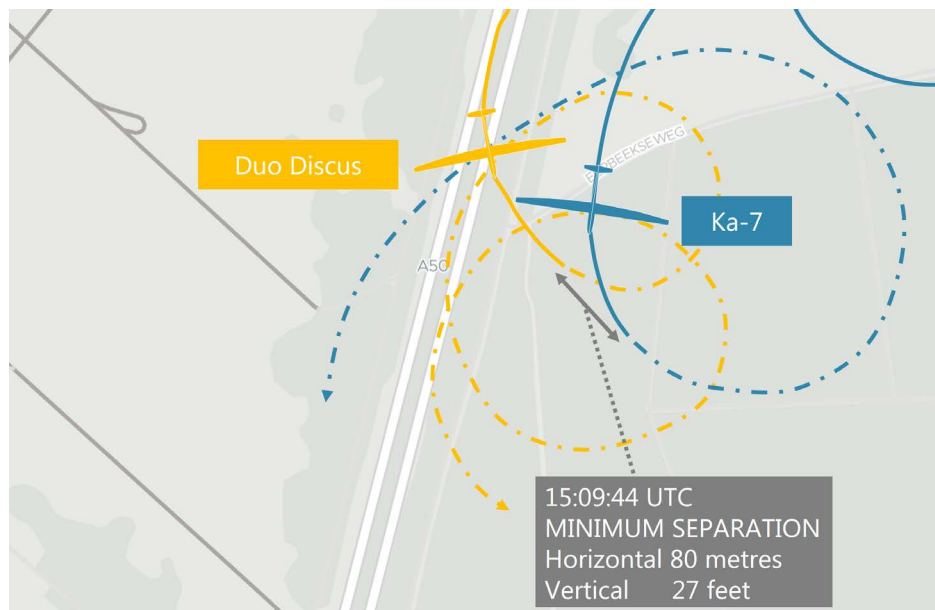
▲ The flight paths of the Ka-7 and Duo Discus at the moment of the airprox. (Source data: FLARM data, source map: OpenStreetMap)

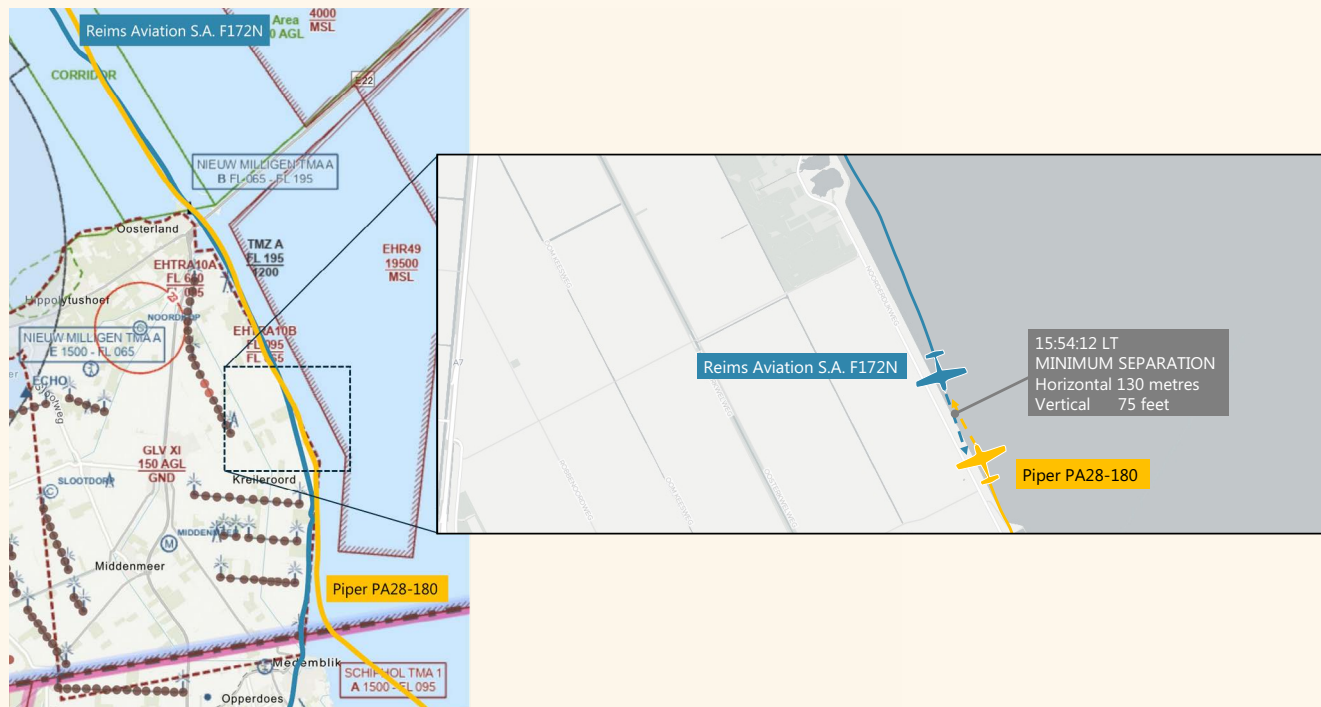
result, they both flew in opposite direction along the dike of the IJsselmeer. Both pilots were monitoring the frequency of Dutch MIL (132,350 MHz) and the pilot of the Reims had also registered there. Near Wieringerwerf, the aircraft came into close proximity at 15.54 hrs at an altitude of approximately 1,400 ft. This occurred in class G airspace. The pilots stated that Dutch MIL had not provided any traffic information.²³ Radar data shows that the aircraft passed one another at distances of 130 metres horizontally and 75 feet vertically. The pilots of both aircraft stated that the visibility conditions were good. The KNMI has confirmed this. Visibility was over 10 km and the cloud base was at 2,000-2,500 feet. The pilots

▲ The flight paths of the Reims F172N and the Piper PA28-180 and the moment of the airprox. (Source data: LVNL, source maps: AIP Netherlands and OpenStreetMap)

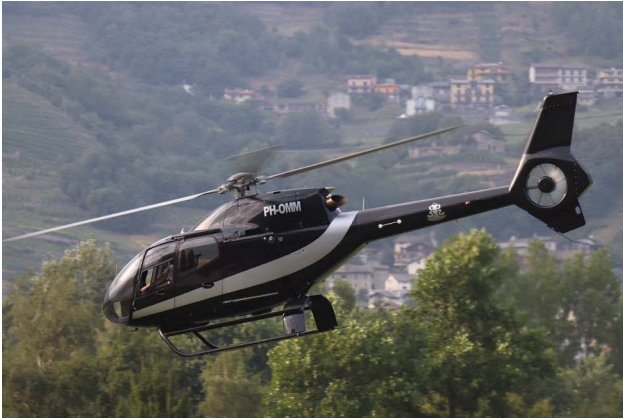
The Dutch-registered helicopter with two occupants crashed on a slip road of the motorway at Fino Mornasco. The Italian pilot was seriously injured and the passenger suffered minor injuries. The helicopter was damaged beyond repair.

The Italian ANSV investigated the occurrence and concluded that the pilot lost control of the helicopter at low height and the helicopter then made an uncontrolled rotation and crashed. This happened near the destination just before landing. The cause was not determined with certainty. However, it cannot be ruled out that the pilot's limited experience with the EC120B was instrumental in the occurrence taking place. This is because the EC120B has different flying characteristics than the helicopter (NH500) on which the pilot had gained most of his experience.
