DUTCH
SAFETY BOARD

Shipping Occurrences Report

July - December 2023

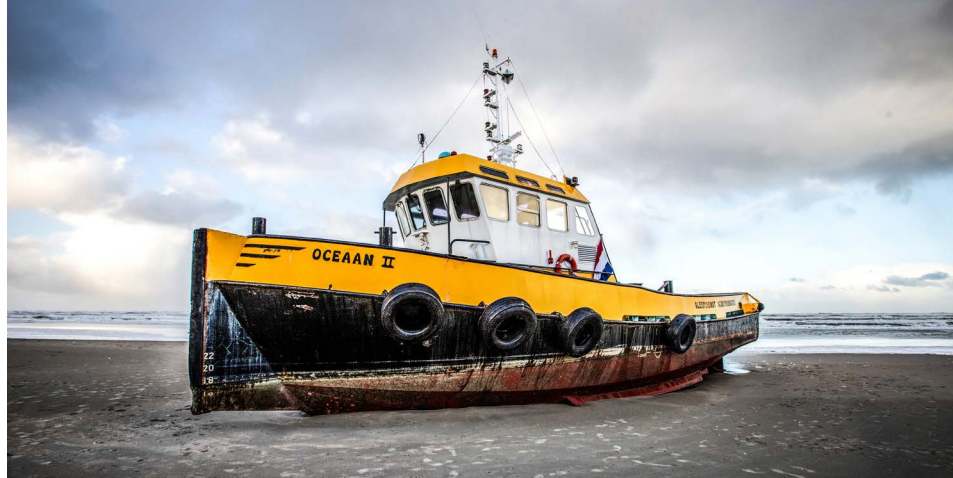
▲ *Ocean II on the beach. (Source: ANP)*

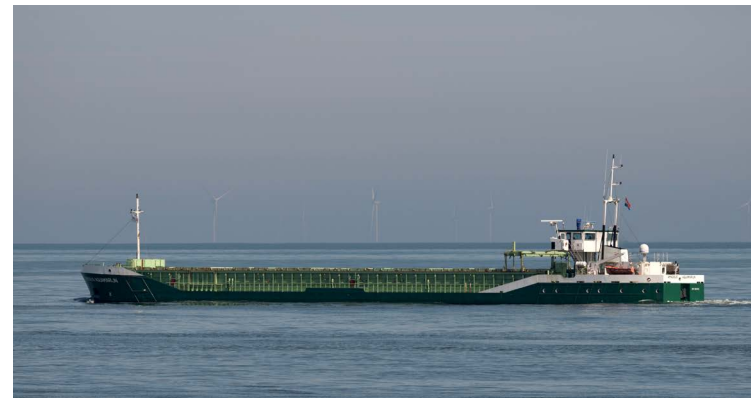
▼ *Figure 8a Amadeus Aquamarijn.*

The cause of the collision between the Belgian trawler Z60 Blue Angel and the Dutch cargo ship Amadeus Aquamarijn in the traffic separation scheme above the Wadden Sea on 23 December 2021 was that the mate of the Z60 Blue Angel failed to see the Amadeus Aquamarijn and therefore did not divert.

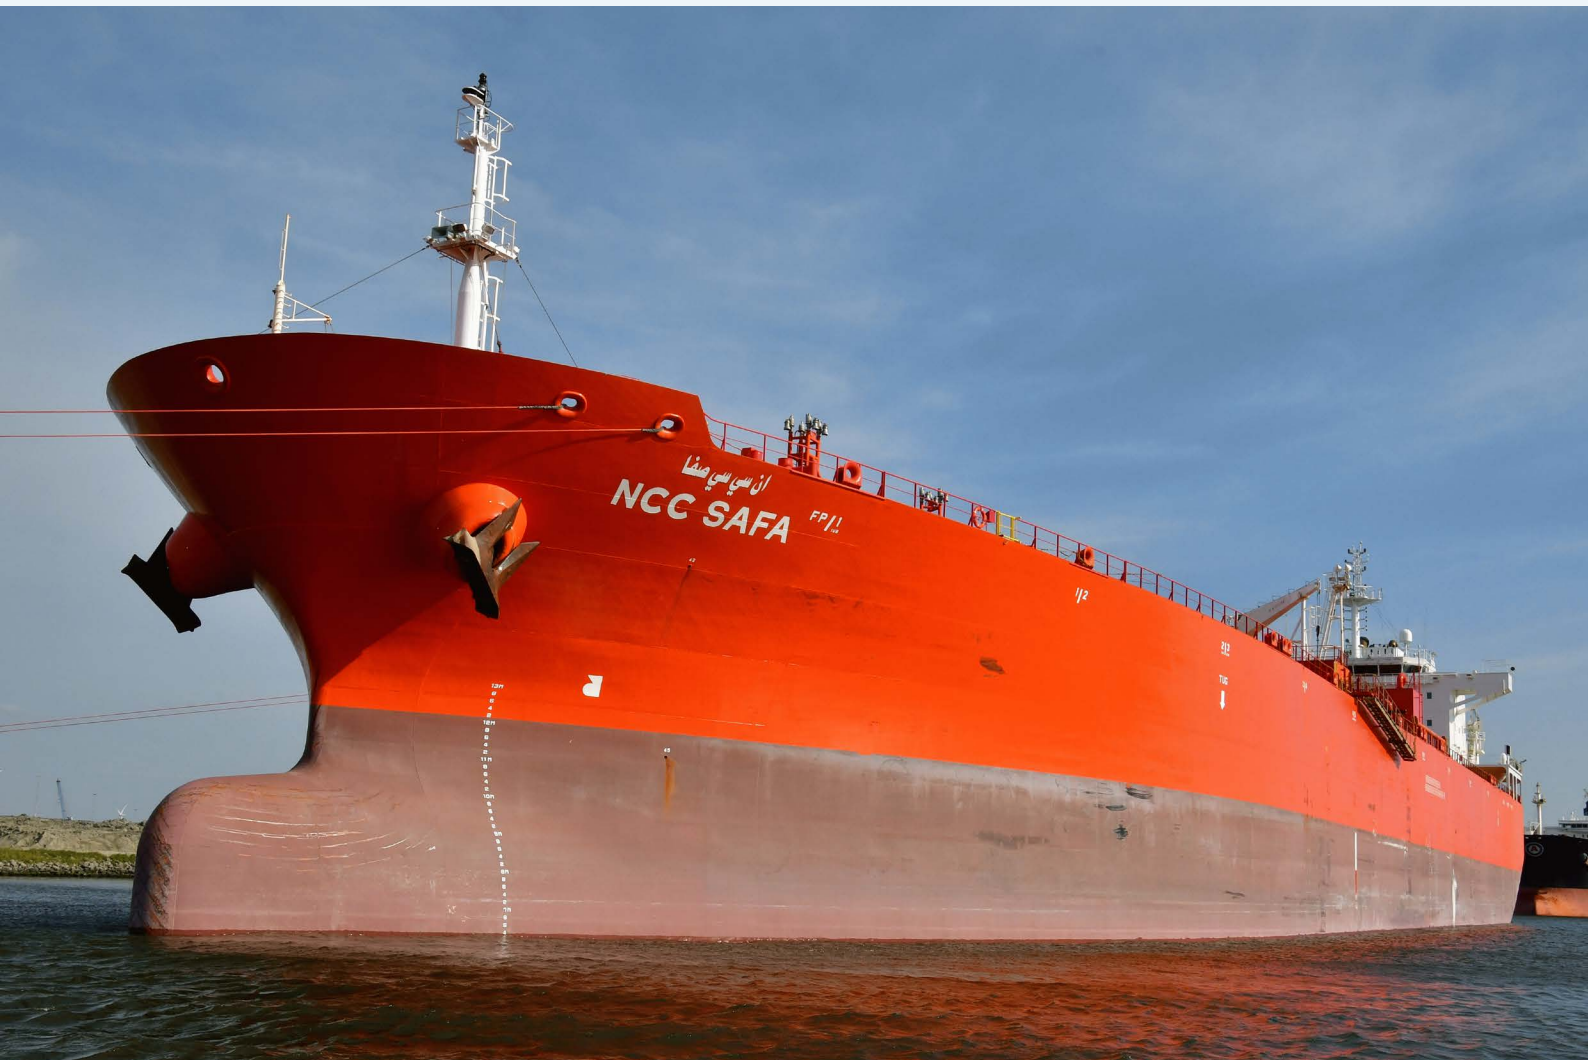
▼ Figure 9 NCC SAFA.

The occurrence involved an inert gas system in which just one single valve formed the hard safety barrier, a situation that is in principle unsafe and inadequate. This, in combination with the sense of time pressure that prevailed and incorrect assumptions based on a previously issued Entry Permit, which meant that procedures were not followed, made it possible for this occurrence involving both the deckhand and the first mate to take place.

The investigation revealed that a leaking valve allowed nitrogen to enter tank 1SB while the bow cargo tanks on board were being inerted. This inadvertently lowered the oxygen level in the tank. Despite being aware of the safety rules and the safety information available on board, the procedures were not adhered to. Prior to the inspection of tank 1SB by the deckhand, the risk analysis and accompanying gas measurements were not carried out and a new Entry Permit was not issued. Moreover, although both the deckhand and the first mate were wearing their helmet, overalls and safety shoes, neither was carrying a personal gas meter when they entered the tank.

Based on the investigation into the occurrence on the NCC SAFA, the Dutch Safety Board issued a recommendation to the ship manager and a number of lessons for the industry.

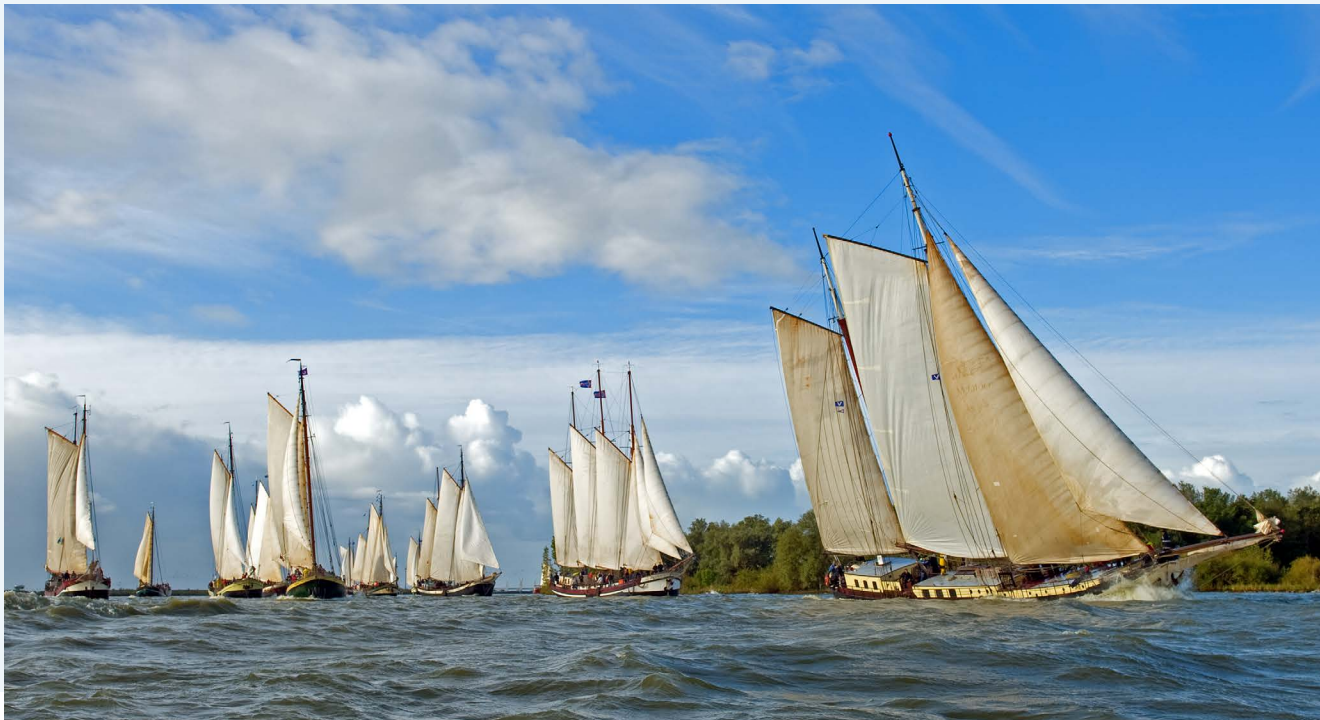
▼ *Figure 10 Historic Sailing Fleet. (Source: Hajo Olij)*

In 2022, there were two serious occurrences on board historic sailing ships, which cost the lives of two passengers. On 27 May 2022, two passengers on the historic sailing ship *Wilhelmina* were trapped by the boom after the topping lift came loose and the boom fell on deck. One person was killed and the other was taken to hospital with serious injuries. On 31 August 2022, a very serious accident took place on board the historic sailing ship *Risico* on the Wadden Sea, off Terschelling. There were two crew members and 14 passengers on the ship. The passengers consisted of 2 pupils and their two teachers who were on a school field trip. During a sailing manoeuvre, the wooden boom of the sailing ship broke, landing on a pupil. The young passenger died.

This investigation shows that the system still has gaps, despite several occurrences in recent years and the *Mastbreuk Harlingen* report. The recommendations from the *Mastbreuk Harlingen* report therefore continue to apply in full. The focus on safety is noncommittal, which leaves room

The Dutch Safety Board made four recommendations to the Minister of Infrastructure and Water Management to improve the supervision of the historic sailing fleet together with the ILT. The Board expects other parties such as skippers, owners, BBZ association, the inspection agencies and the Dutch Accreditation Council not to wait for the Minister and the ILT to take the initiative. They must also get to work to improve the safety of historic sailing ships.

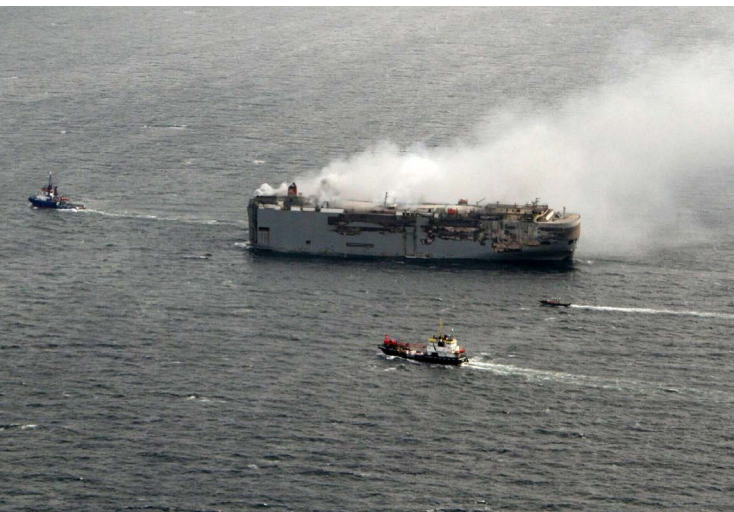
▼ *Figure 12 Fremantle Highway. (Source: ANP)*

Classification: Very Serious

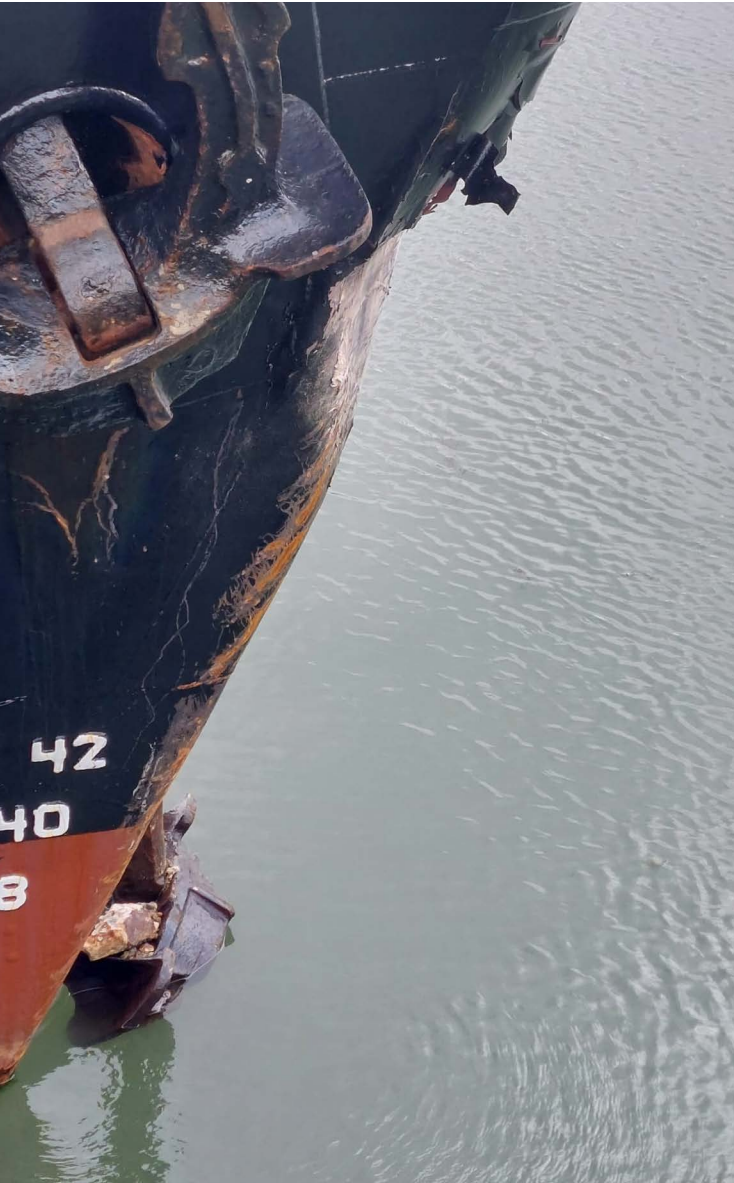
While mooring in West-Terschelling harbour on the short side of a jetty, the Dutch sea tugboat Holland collided with the quayside. The Holland is equipped with a reversible engine and a bow thruster and was using a tugboat while mooring. As the ship was headed toward the quayside, it was sucked towards already moored ships on its port side. In an attempt to avoid these, it hit the quayside. The ship was sailing with a group of passengers, one of whom suffered minor injuries as she fell off her chair and broke her wrist. The ship sustained damage to the prow above the waterline. There was no outflow or inflow of water. The classification society gave the Holland permission to sail back to Harlingen for repairs.

◀ *Figure 14 Damage to the prow Holland. (Source: ILT)*
