DUTCH  
SAFETY BOARD

# Oven overheat in aft galley

*The Hague, June 2024*

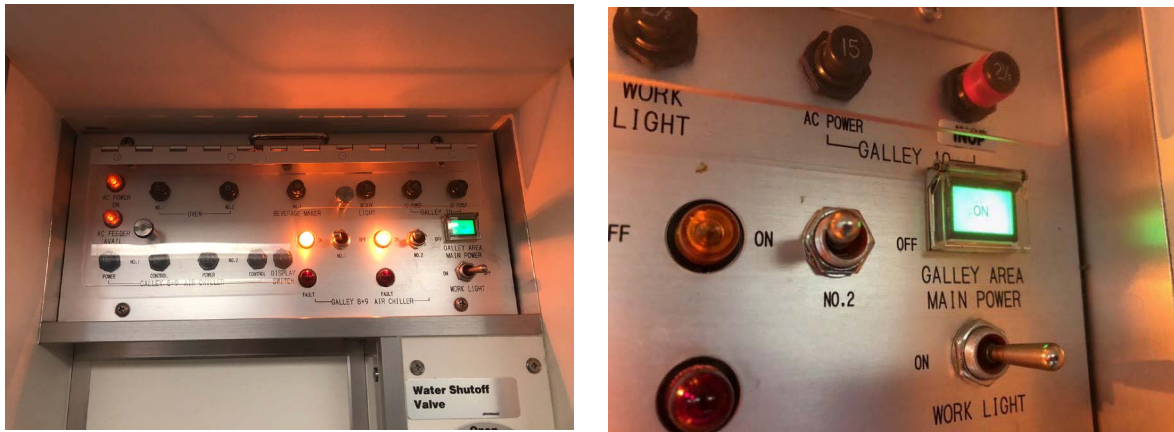
▲ Figure 1: On the right in both pictures, the green lit galley area main power button.

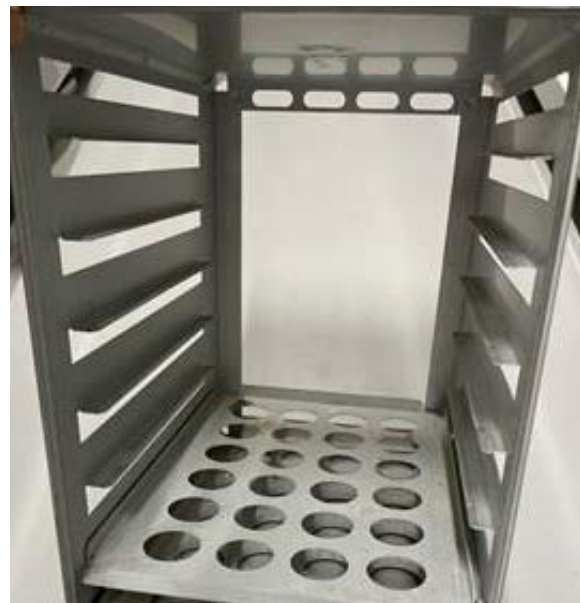
The meal tray carrier mostly had a closed perforated backside (see Figure 3, left). As a result, the heating time of the oven was significantly extended because of the disturbed airflow of the fan and heating elements. Confirmed by previous investigations of the manufacturer, this increased the temperature of the area behind the baffle plate as the closed backside reduced the heat distribution to the meals inside the carrier.

▲ Right, meal tray carrier with an open back.  
(Source: B/E Aerospace)

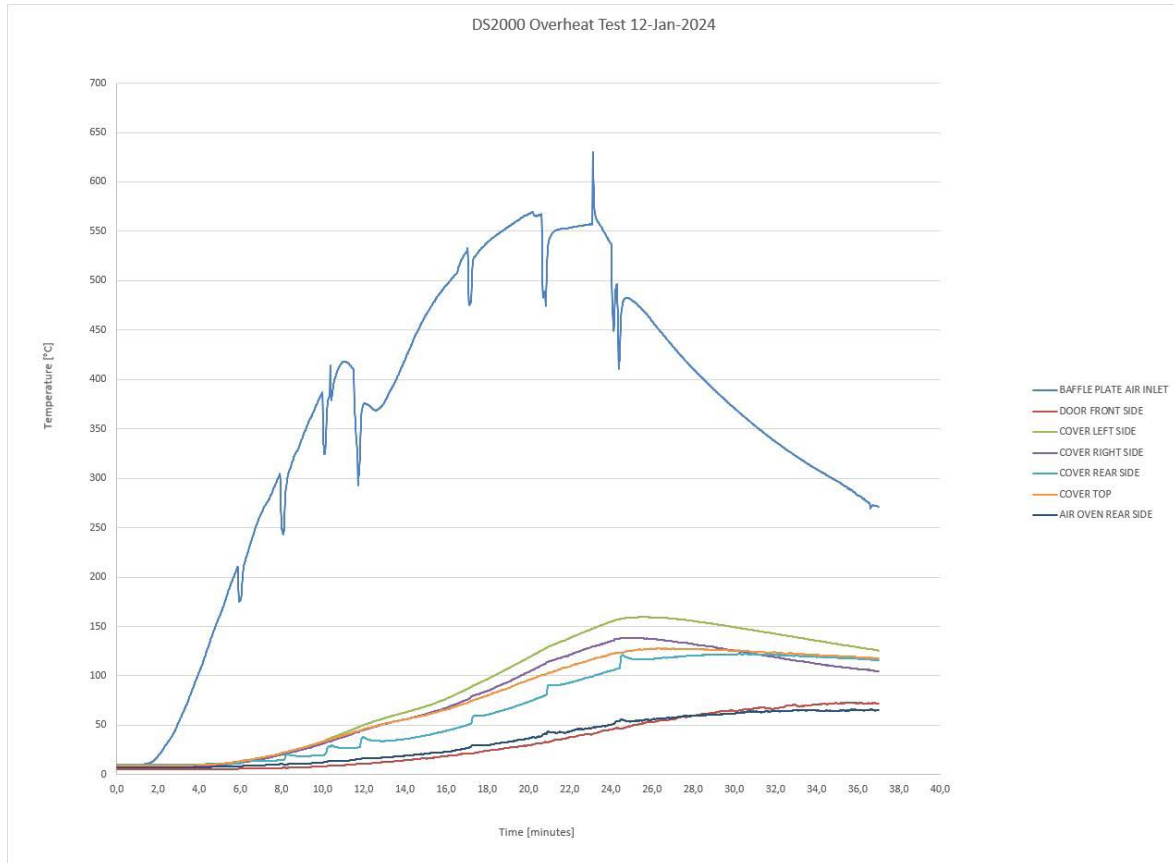
▲ Figure 5: The values measured by the various temperature meters on the test oven while duplicating an overheat condition. (Source: B/E Aerospace)
