DUTCH  
SAFETY BOARD

# Failure of aileron flight control cable Boeing 737-804

*The Hague, July 2024*

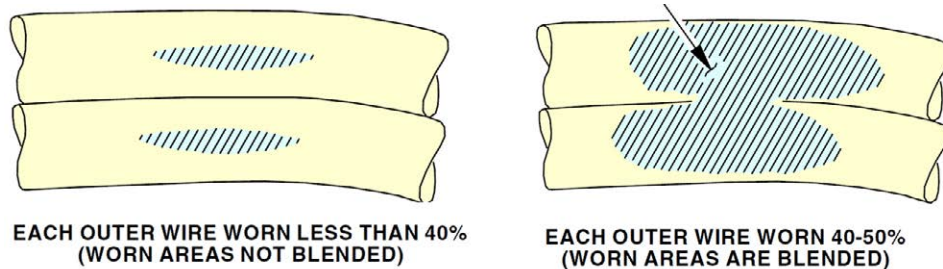
2 WEAR CONDITION RESULTING IN BLENDED SURFACES BETWEEN WIRES.

▲ Figure 4: Wear patterns. (Source: Boeing. Image Copyright © Boeing. Reproduced with permission.)

The pictures depicted in the AMM (see 2.6 figure 4) show a magnified cable to make clear how to check the percentages of external wear. In practise, however, the cable and its strands are small (thin). Blended spots on the cable are not always easy to detect. During an 'on condition' DVI it is nearly impossible for ground engineers to reasonably estimate the percentage of external wear. Furthermore, it is imaginable that during the last DVI of the PH-CDF an engineer accidentally overlooked that the allowed number of broken wires was exceeded.

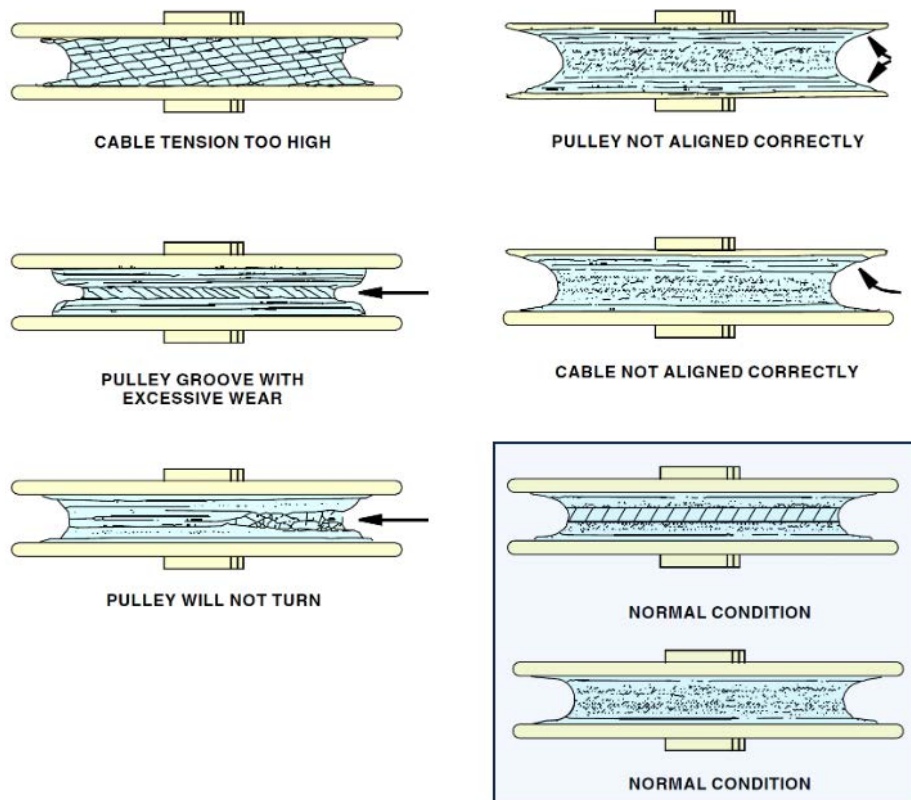
The Dutch Safety Board assessed the pulley in accordance with the Boeing 737 Aircraft Maintenance Manual (AMM)<sup>14</sup>. The AMM describes different wear patterns for the pulley, see Figure 11. Detailed visual examination of the pulley at the office of the Dutch Safety Board showed that the pulley rotated freely with normal wear patterns, as indicated in the framed figure below. It is noted that the functioning of the pulley ‘as installed’ – when it rotated under the load of the aileron cable being under tension - is unknown.<sup>15</sup>

▲ Figure 11: Damage patterns for various conditions. (Source: Aircraft Maintenance Manual) (Source: Boeing. Image Copyright © Boeing. Reproduced with permission.)
