# Quarterly Aviation Report

April - June 2024

# Investigations

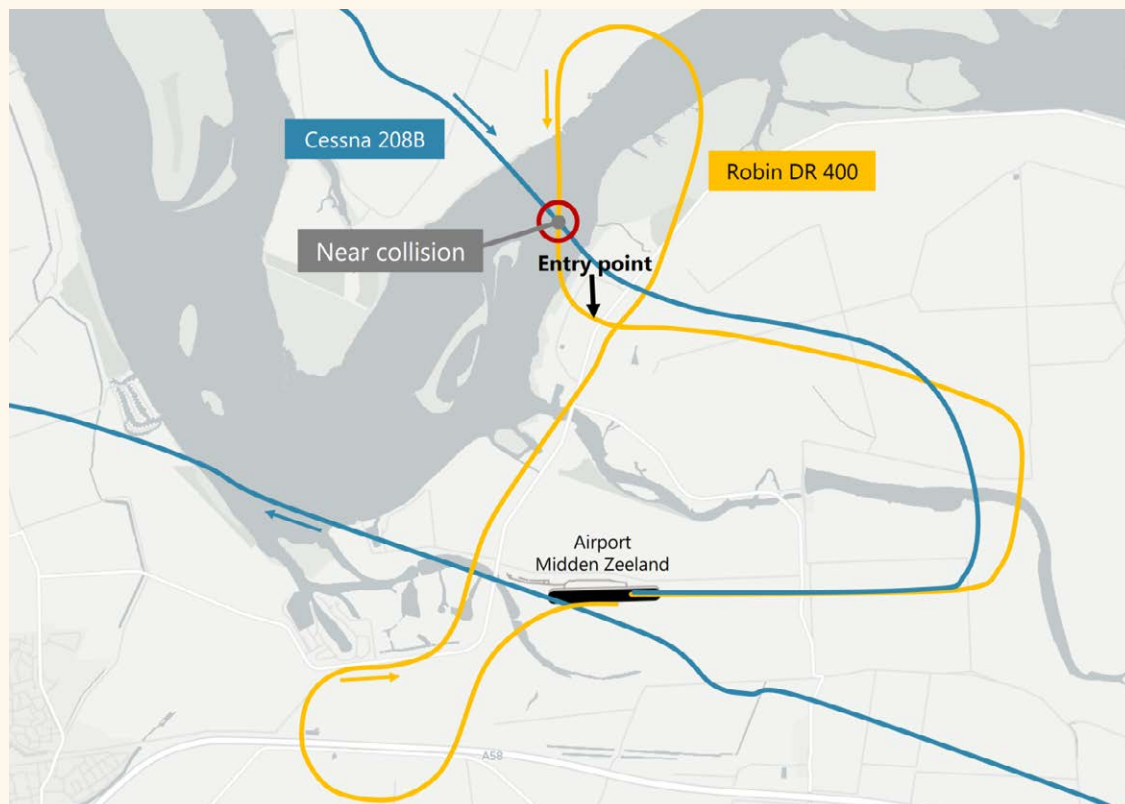
On October 8, 2023, a near collision occurred near Midden-Zeeland Airport (EHMZ) between a tug plane, a Robin DR 400, and an aircraft used for parachuting, a Cessna 208B. The planes flew in such proximity to each other that the Robin suffered damage to the canopy and rear-view mirrors.

▼ Cessna 208B and Robin DR 400 flight data. (Data source: EasyVFR (Robin DR 400) and SkyDemon (Cessna 208B), map source: OpenStreetMap)

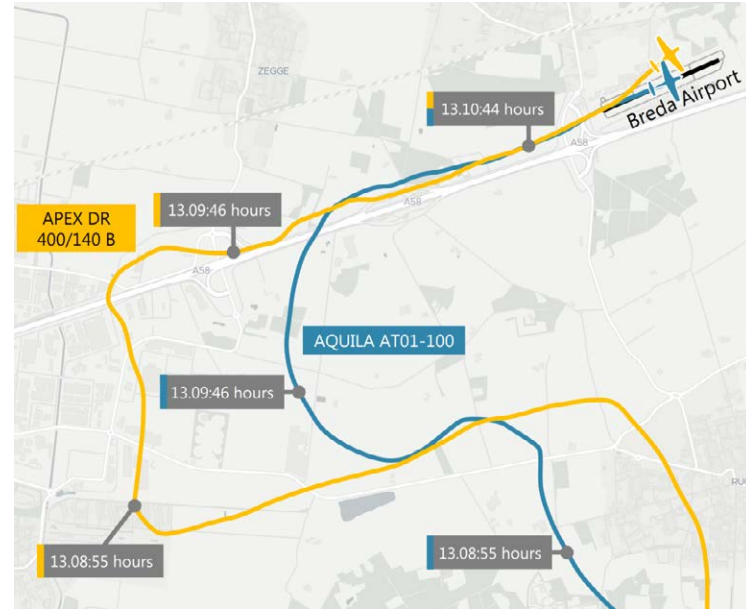
The DR 400 left the circuit area on the downwind leg and flew back into it on final. As described in the AIP, the air traffic circuit must be flown within the lateral boundaries of the circuit area. This is particularly important if there are several aircraft in the circuit area. The risk of an airprox in the circuit area can be reduced in this way.

▼ *Three-dimensional view of the flight paths of the two aircraft during the final approach to Runway 06. (Source: radar data LVNL, map: Google Earth)*

▲ *Two-dimensional view of the flight paths of the two aircraft in the circuit for Runway 06. (Source: radar data LVNL, map: OpenStreetMap)*

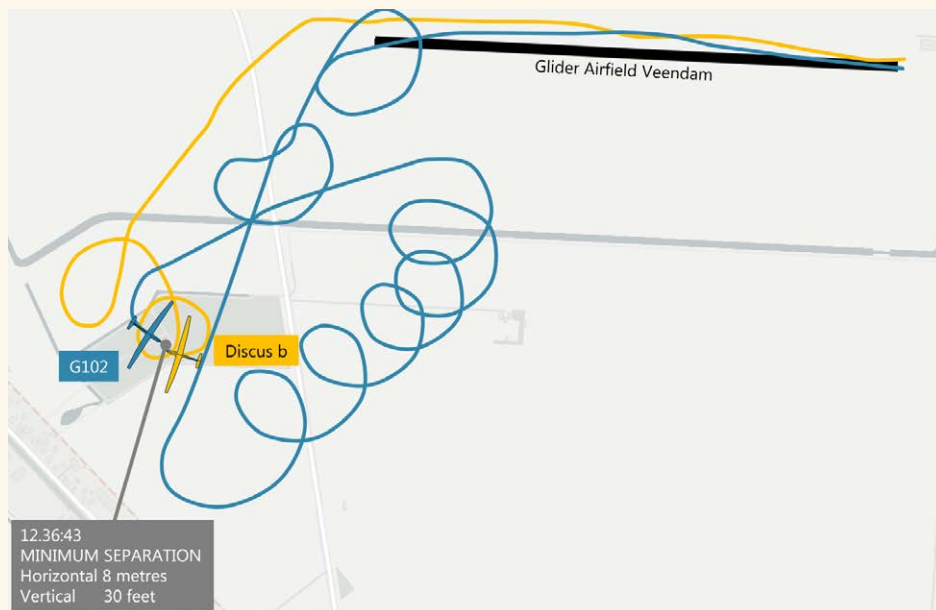
another attempt. When the G102 commenced the turn, the pilot had lost sight of the Discus. Therefore, he assumed he had not yet turned sufficiently and continued the turn. Shortly after, the G102 and the Discus found themselves heading straight towards one another. The pilot of the G102 then attempted to increase the distance by steering downwards and further in so as to make the turn shorter. His doing so could, however, not prevent the G102 from passing over the Discus in the opposite direction at close range. At that point, the minimum vertical separation was about 30 feet and the minimum horizontal separation was 8 metres. Both aircraft continued their flight.

▼ *The flightpaths of the two gliders. (Source of data: gliders' data loggers, source of map: OpenStreetMaps)*

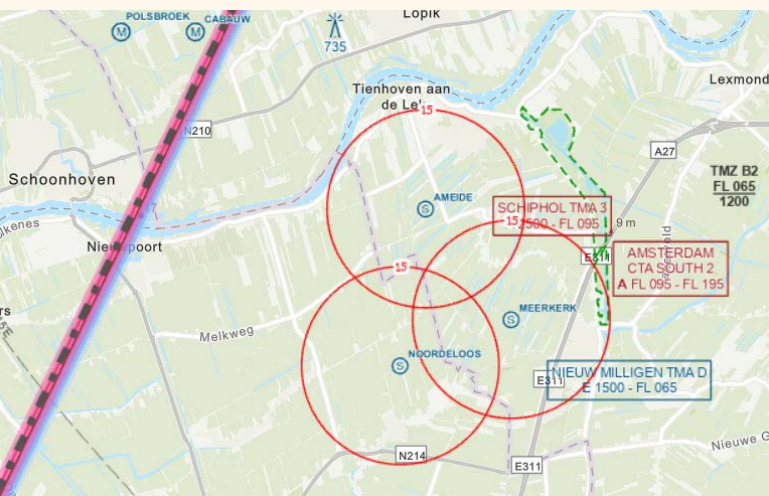
TMA 3, which has a lower limit of 2,500 feet. The <https://www.maurikparagliding.nl> website states – under ‘Actuele vliegverwachting’ [Current flying forecast] – whether the flying school is operational. The flying school also flies from a winch field at Noordeloos, the southernmost winch field in the figure below.<sup>6</sup>

▲ The three winch fields between Gorinchem and Lopik; the northernmost is located close to Ameide. (Source: VFR chart The Netherlands, LVNL)
