DUTCH
SAFETY BOARD

Flare launched with fatal consequences

The Hague, 25 September 2024

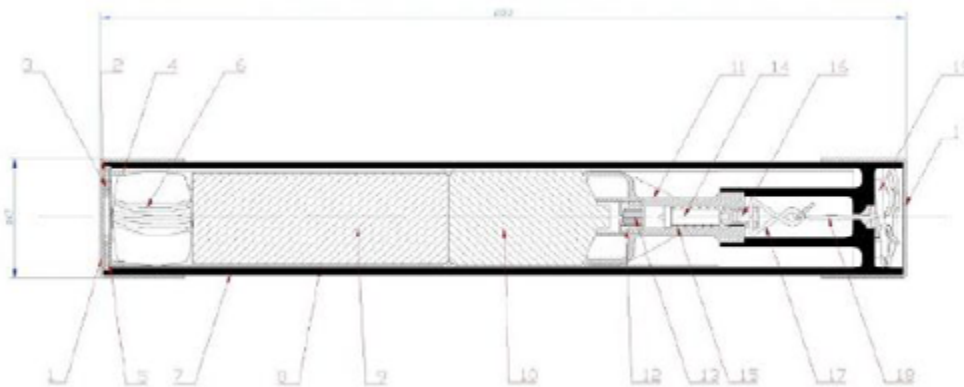
▲ Figure 1:2: Aluminium inner tube within which the motor unit is wedged.

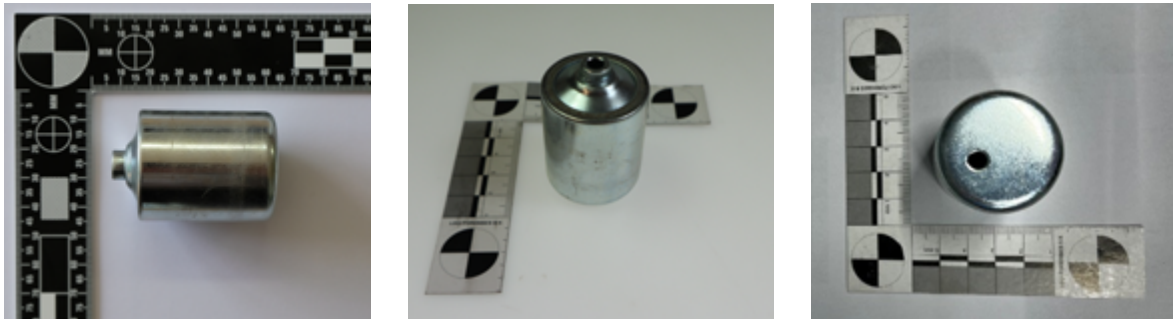
The motor (see Figure 6) consists of a filled and pressed holder on top of which is a lid which has been hemmed onto it (at a later stage). The closed motor unit is capable of withstanding the normal design pressure in the motor. The thrust of the flare is produced by the compressed combustion gases of the solid propellant leaving the motor via the venturi constriction. The venturi constriction consists of a short narrowed discharge opening, the 'throat'. This opening deliberately creates a lower pressure at the discharge opening (externally) compared to the pressure at the intake (in the motor), resulting in an increase in the discharge velocity.

The lid that seals off the motor consists of two parts. The parts that make up the motor, the casing, the lid with the venturi constriction stamped into it, and the cardboard inlay (see also 11) are procured externally. The placement of the venturi constriction in the lid is such that it cannot be forced out of the lid by excessive pressure build-up.

▲ Figure 7:1 (left): The motor, side view after sealing (hemming) lid.

▲ Figure 7:2 (mid): View of the underside of the venturi with the \varnothing 5.5 mm.

▲ Figure 7:3 (right): Top of motor unit with opening for the transmission of ignition to the actual candle unit.

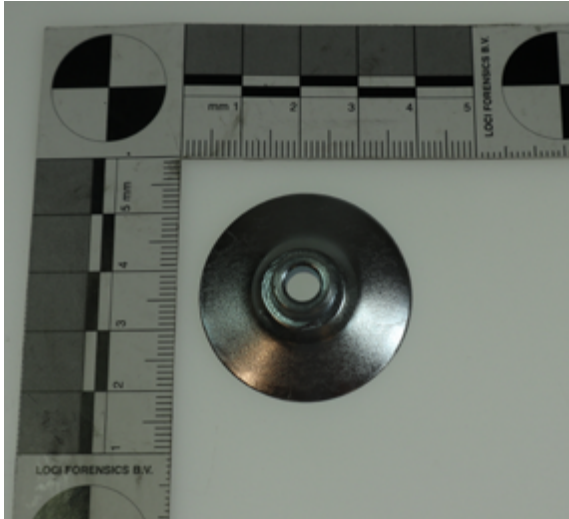
The lid (see Figure 8) is hemmed¹⁸ onto the motor holder by machine. It is unlikely that inadequate sealing of the motor unit led to uncontrolled combustion of the solid propellant outside the casing of the motor unit. If the lid were not properly hemmed, the pressure that would develop in the motor would remain too low, making an explosion unlikely.

▲ Figure 8:1: Lid assembly, left photo: top view.

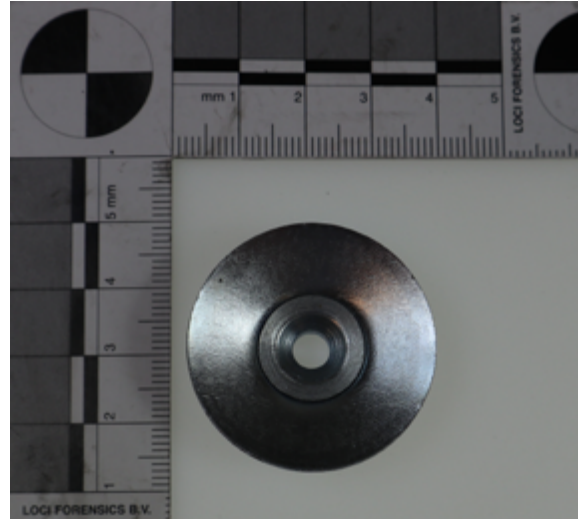
▲ Figure 8:2: photo bottom view with the pressed-in venturi constriction.

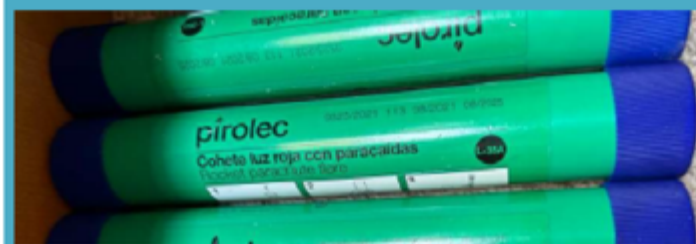
Pirolec Red Rocket Parachute flare L-35A
Ongevalsbatch 0525/2021 113 08/2021 – 08/2025
