DUTCH  
SAFETY BOARD

# Near mid-air collision in the Rotterdam Control Zone

15 June 2022

*The Hague, November 2024*

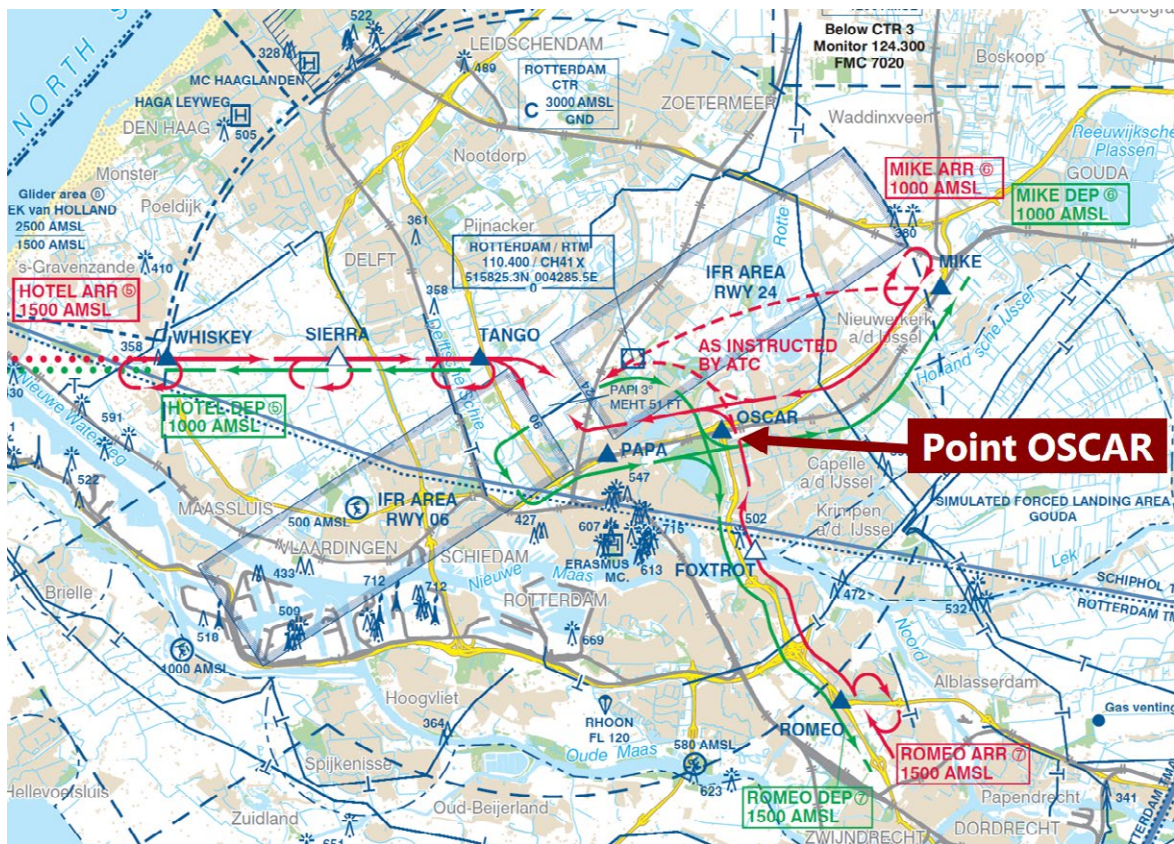
The different VFR routes are depicted in the AIP on the visual approach chart (see figure 5). The AIP specifically states that pilots shall adhere to the approach or departure route as indicated on the charts, unless otherwise instructed by ATC.

▲ Figure 5: Visual approach chart with VFR routes. Reference to point OSCAR added. (Source chart: AIP The Netherlands)
