DUTCH  
SAFETY BOARD

# Fatal Allision with Drilling Rig in Botlek Harbour

*The Hague, 26 February 2025*

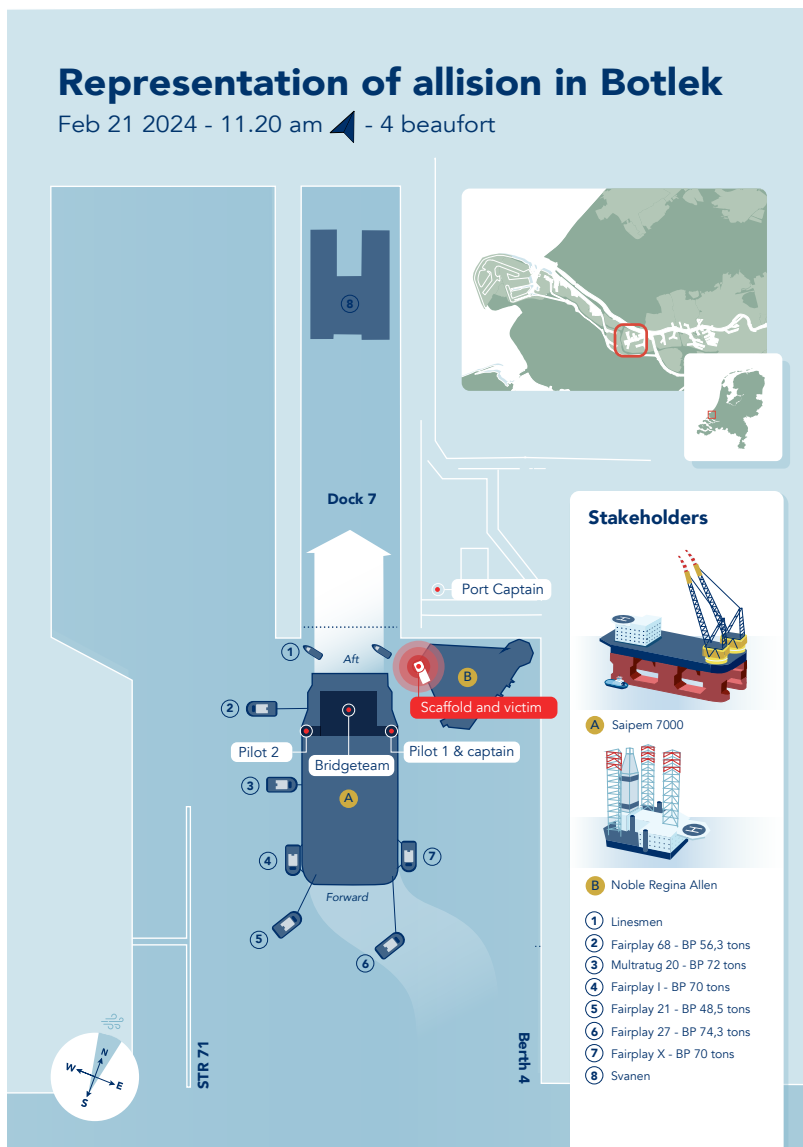
▲ Figure 3: Overview of the 2nd Werkhaven. The bollard pull of the tugs in this figure is indicated by BP.

The presence of the drilling rig meant that in practice, the distribution of the tugs – and thus the bollard pull per position – deviated from the step-by-step plan. The tug that was initially planned for the port aft of the crane vessel was relocated by the pilot to amidships on the starboard side (No. 3 in Figure 3) due to the presence of the drilling rig. The main task that the tug had in its original position was to, together with the tug at the other side of the aft (No. 3 in Figure 3), wedge the aft of the vessel and align it in front of the dock entrance by pushing against each other. At its position amidships on the starboard side, the tug was indeed able to counter a lateral movement, but wedging the aft of the crane vessel was no longer possible. Also, the influence of the tug on the turning direction of the crane vessel was limited in this position. The tug that remained at the stern (No. 2 in Figure 3) and that could influence the turning direction of the stern of the vessel had a bollard pull of 56.3 tonnes. Given that this was the only tug that could still influence the turning direction of the stern, it would have been favourable to attach a tug at that position that had greater pulling power. This also emerged from an interview with a towmaster.

To get the crane vessel back straight ahead of the dock, the pilot ordered the tug on the port forward side (No. 6 in Figure 3) to guide the bow of the vessel to starboard. That was a certain time<sup>23</sup> after the turning momentum (caused by the wind load) had commenced. The first pilot then asked the captain to use the vessel's bow thrusters so as to stop the movement of the bow and to correct the vessel's course. At 11.25 hours, the captain relayed the order to the Chief DPO to start the bow thrusters. In a short time, the power of the thrusters was increased from 10 per cent to 50 per cent and then to 100 per cent.

The stern and amidships tugs on the starboard side (No 2 and No 3 in Figure 3) pulled, but they were not powerful enough to compensate for the movement of the stern. See Table 4 for an overview of the distribution of the tugs and their pulling power. The stern thrusters were started shortly before the allision, but the time that was needed to move the crane vessel was too long to prevent the crane vessel from alliding with the drilling rig at 11.26:10 hours.
