DUTCH  
SAFETY BOARD

# Quarterly Aviation Report

October - December 2024

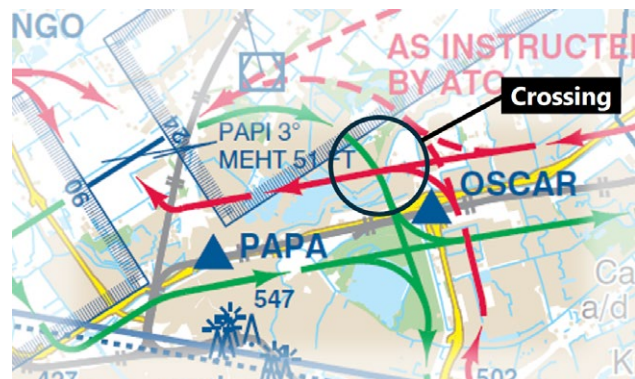
When Runway 06 is in use, the ROMEO arrival route crosses the ROMEO departure route at 1,500 feet near the reporting point OSCAR. Both aircraft neared the crossing point at the same prescribed altitude and at the same moment. Although Air Traffic Control (ATC) had informed both pilots earlier that they had opposite traffic, both pilots did not have the other aircraft (conflicting traffic) in sight when nearing the crossing point. When D-EBTO was about to cross the ROMEO departure route, the pilot observed N98825 at a late stage on his right and initiated an evasive action (a dive) to increase the vertical distance. The Dutch Safety Board classified the event as a serious incident.

Two comparable events had previously occurred at or near the same crossing point when Runway 06 was in use. In 2014, one aircraft flew a standard Mike departure procedure at 1,000 feet and another aircraft flew a standard Mike arrival procedure at 1,000 feet. In 2020, one aircraft flew a Mike

▲ Near mid-air collision near point OSCAR.  
(Source: AIP the Netherlands)

departure procedure at 1,000 feet and an arriving aircraft cleared for a 'direct course' in opposite direction flew at or approximately at 1,000 feet. In both of these near mid-air collision events arriving and departing traffic had crossing routes at the same or almost at the same altitude. Similar to the event on 15 June 2022, these two events and studies addressing the limitations of 'see and avoid' show that 'see and avoid' is sensitive to failure and therefore an unreliable safety barrier. As demonstrated by the events, in particular when Runway 06 is in use, adherence to prescribed VFR procedures and instructions may perpetuate the risk for conflict instead of mitigating it.

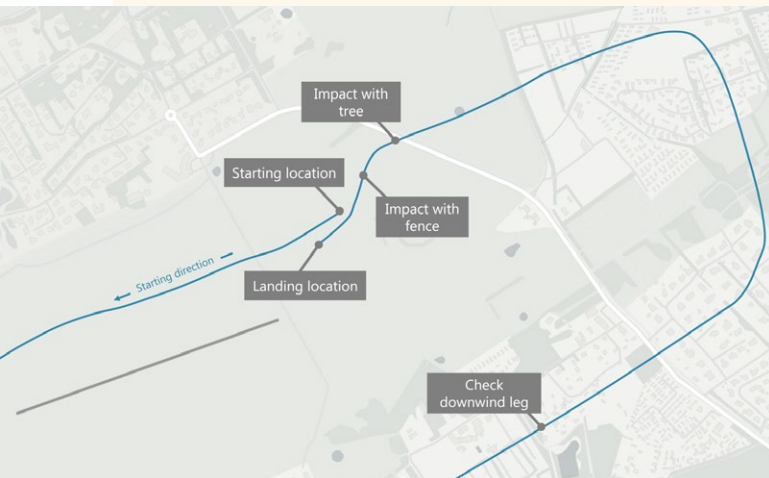
▼ *Flight path (Source: igc-data)*

On short final, the glider's left wing was badly damaged after striking a tree and a fence. The student pilot then landed the glider safely.

After a short flight of about 5 minutes, the pilot flew a left-hand circuit. On final, he closed the airbrakes as far as the locking mechanism. The pilot felt he was continuing to descend fast and that the aircraft was starting to stall. At low altitude, he reduced the pitch attitude of the aircraft, after which the left wing struck the top of a tree. As a result, the glider yawed to the left and its left wing struck a wooden post that formed part of the glider airfield's barbed wire fence. The glider flew towards the take-off point and the gliders that were parked there. The pilot made a turn and landed the aircraft to the southwest of the take-off point. The left wing was badly damaged. The pilot was unharmed.

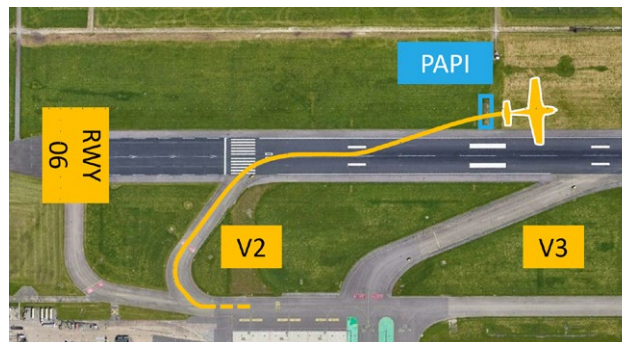
The pilot wanted to make a flight in the DR 400 from Rotterdam The Hague Airport (EHRD) to Breda International Airport (EHSE) to practice landings. During the take-off roll from Runway 06 on EHRD, the aircraft veered off the left side of the runway. This caused the aircraft to hit a Precision Approach Path Indicator (PAPI), resulting in damage to the left wing and the PAPI. The pilot was uninjured.

▲ Situation sketch. (Source: Google Earth edited by Dutch Safety Board)

The pilot repeated to himself 'Runway 06 identified, possible crosswind from the left, stick into the wind' and selected full power. The pilot stated that he expected to have to give a lot of right rudder, but it was not that bad. The airspeed increased and suddenly the pilot noticed that the aircraft was moving to the left side of the runway. The pilot did not remember any (roll) movement of the aircraft. He tried to correct the direction of the aircraft. The aircraft hit the PAPI and the aircraft stopped in the grass on the north side of the runway across the Taxiway V3.
