DUTCH
SAFETY BOARD

Engine failure followed by emergency landing

Diamond DA 50 RG, Kempen Airport

The Hague, April 2025

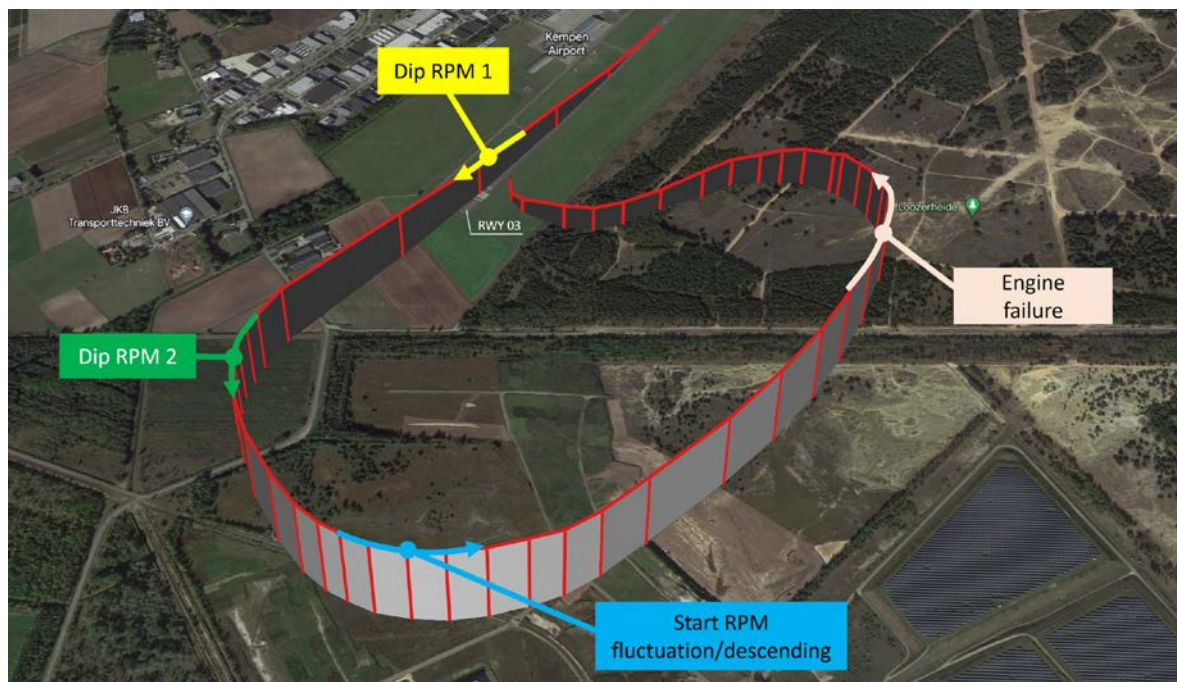
The pilot stated he chose to remain within the airport's traffic circuit for safety and adjusted the flight path to fly a short downwind leg for Runway 21. During this phase, while the pilot was communicating the engine issues on the frequency of the airport authority (Budel Radio) and declaring the intention to return to the airport, the engine's RPM started to fluctuate again, prompting the pilot to declare a 'MAYDAY'. The aircraft was at an altitude of about 475 feet on the crosswind leg, turning to downwind, when these fluctuations occurred. Budel Radio then confirmed that Runway 03 was available.

▲ Figure 1: ADS-B flight track including markers of the behaviour of the engine. (Source: ADS-B Exchange and FADEC of OO-HAN)

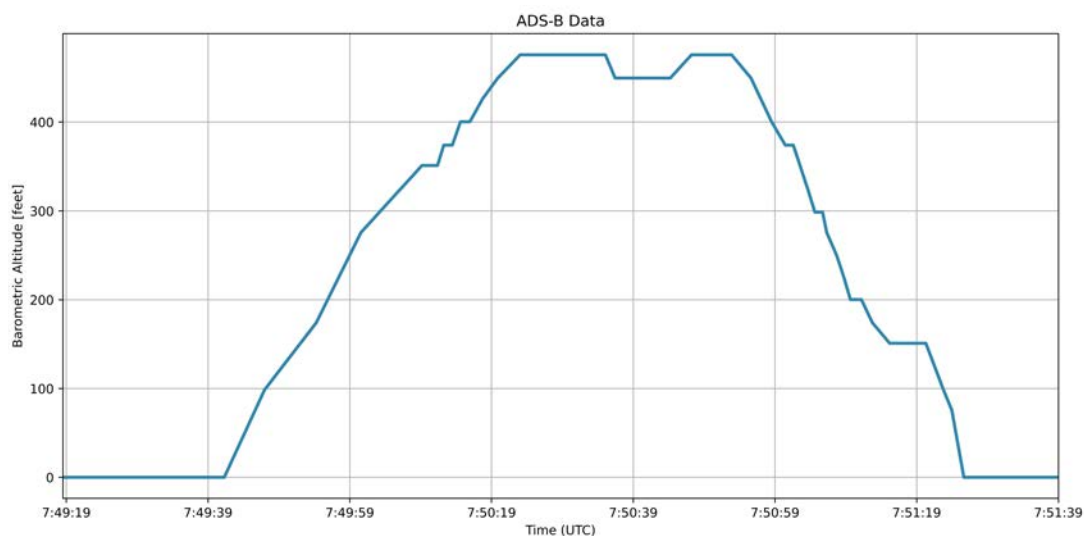
Additionally, ADS-B flight data has been obtained from ADS-B Exchange, giving the barometric altitude for the duration of the flight. The barometric altitude of the flight is presented in Figure 4.

▲ Figure 4: ADS-B altitude data. (Source: ADS-B Exchange)

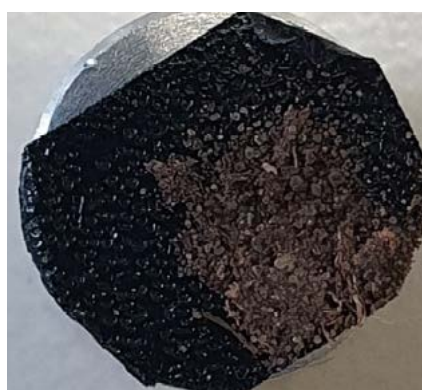
▲ Figure 17: Visual representation by optical microscope of the prepared sample for SEM analysis. (Source: SGS)

Further analysis included a simulated distillation according ASTM D 2887¹¹, procedure B, which helps in understanding the boiling rang and the compositional characteristics of the fuel. A representative portion of the sample was prepared for analysis using a Scanning Electron Microscope (SEM) coupled with an X-ray detector (EDX). The SEM analysis provided information about the fuel's morphology, revealing the micro-structural composition. The EDX component provided a qualitative element analysis, identifying specific elements present in the fuel sample.
