DUTCH
SAFETY BOARD

Shipping Occurrences Report

July 2024 – December 2024

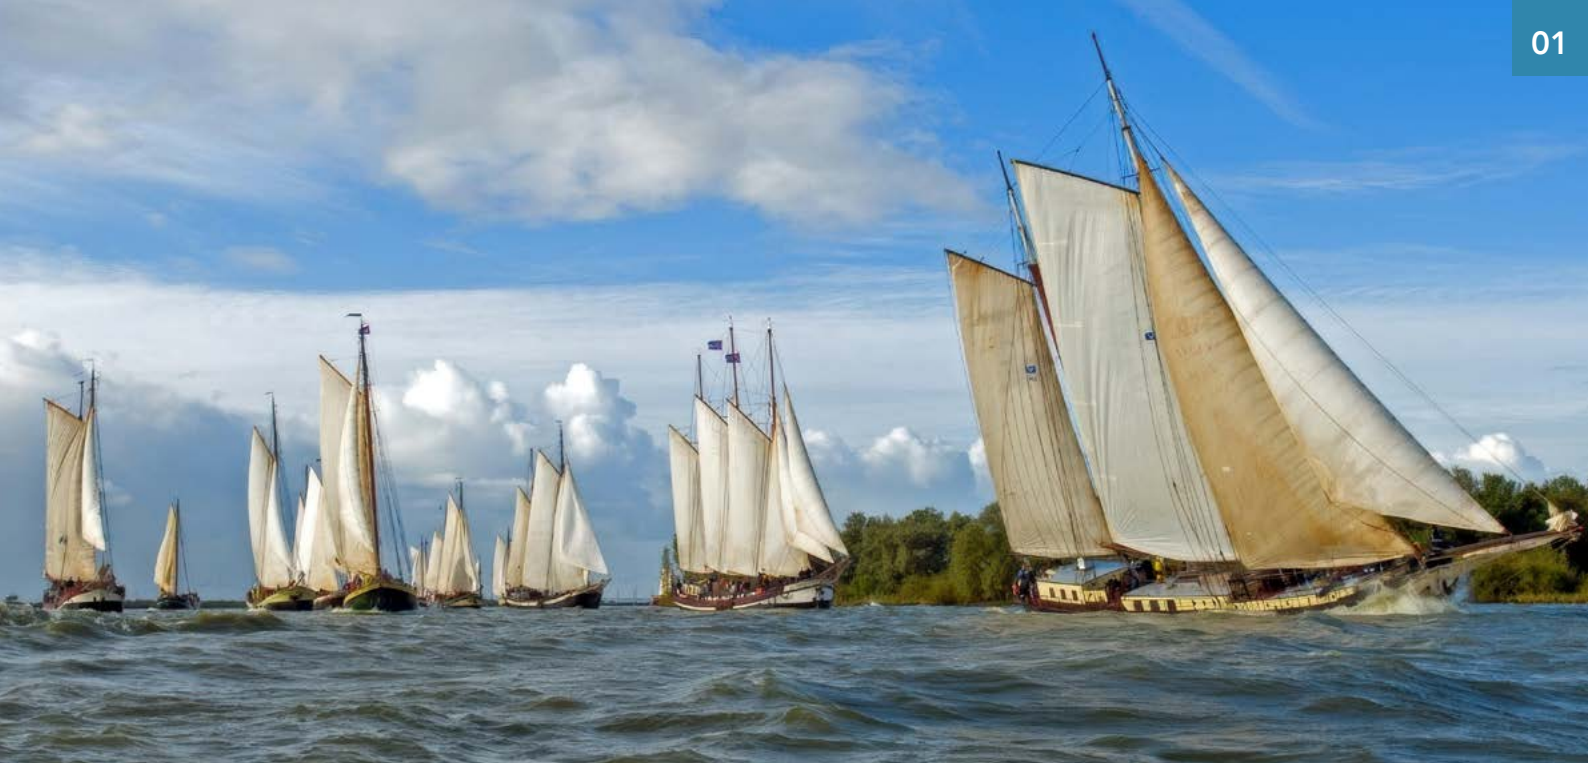
▲ Figure 1: Historic sailing fleet. (Source: Hajo Olij)

The Safety Board's investigation showed that the wooden mast had rotted through. This finding gave reason for the Safety Board to issue recommendations for improving safety on board vessels in the historic sailing ships fleet. The Board concluded that the sector had insufficient expertise regarding the safety of critical components such as wooden masts. Our investigation revealed that the accident involving the *Amicitia* was not an isolated incident. Serious wood rot was in fact common in the wooden masts of the historic sailing fleet.

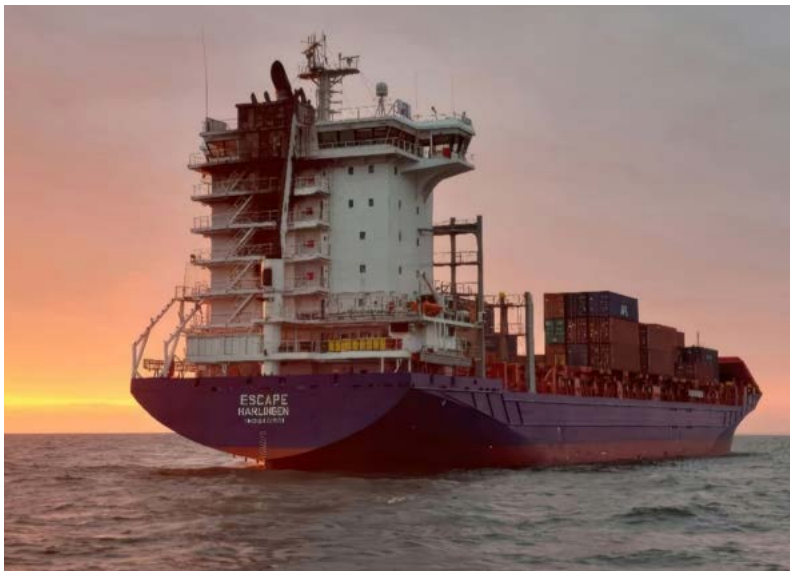
The fire on board the *Escape* started when the thermal oil system was being boiled out using the main engine exhaust gas boiler. The emergency generator's vents were closed, resulting in insufficient ventilation and the emergency generator overheating. As a result, the generator stopped and the ship's electricity supply failed. Without electricity, it was no longer possible to fight the fire, so the captain gave the order to abandon ship.

◀ Figure 9: *Escape*. (Source: Latvian Coast Guard)

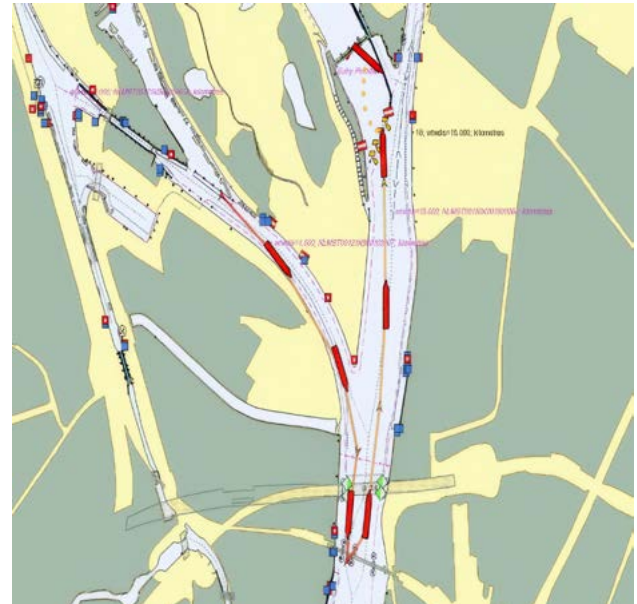
The vessel became trapped with its stern under the shipping opening of the weir, which initially led to a rise in the water level in the River Meuse. The salvage operation proved difficult. On 18 October, the vessel was successfully pumped empty and extracted from under the weir. The fact that the weir was open for almost a week caused the water level in the Meuse to fall considerably, causing problems for nearby houseboats and harbours. After the vessel had been removed, the weir could be closed again. The water level could then be restored, after which shipping traffic was able to resume on 19 October.

▼ *Figure 14: The route taken by the Humadivi (vessel not to scale). (Source: Marinetraffic.com with additions by the Dutch Safety Board)*

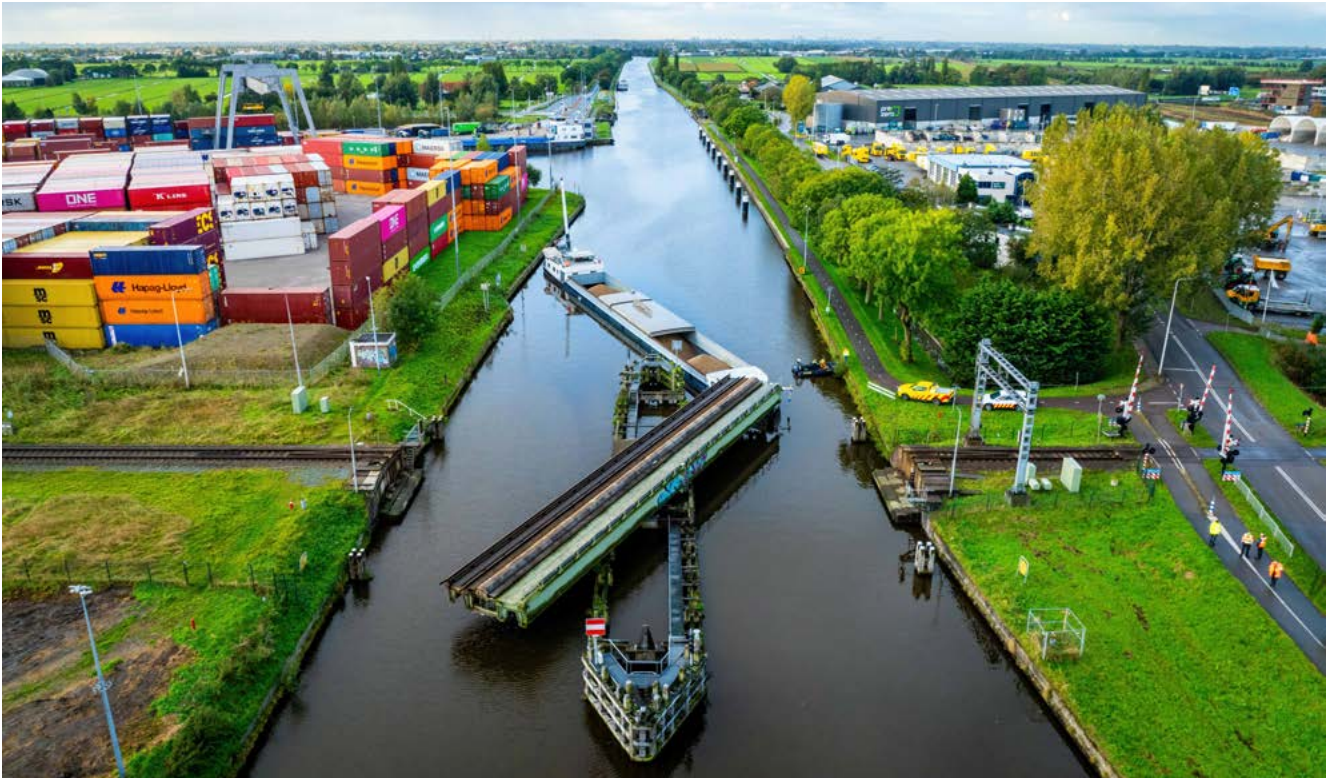
Inland vessel allides with railway bridge Gouwe, near Alphen aan den Rijn, 11 October 2024

The Dutch inland vessel Mordicus rammed the railway bridge over the River Gouwe near Alphen aan den Rijn at about 07:00. The occurrence took place because the swing bridge had been closed too early. The control post for the railway bridge is located some distance away from the bridge and makes use of cameras and a vessel tracking system. It was still dark when the Mordicus was supposed to pass the railway bridge. Before the inland vessel had passed the railway bridge, the skipper notified the control post about passing under the vertical lift bridge further down the River Gouwe. The bridge operator thought that this notification meant that the vessel had passed the railway bridge. The mechanism for closing the swing bridge was then activated.

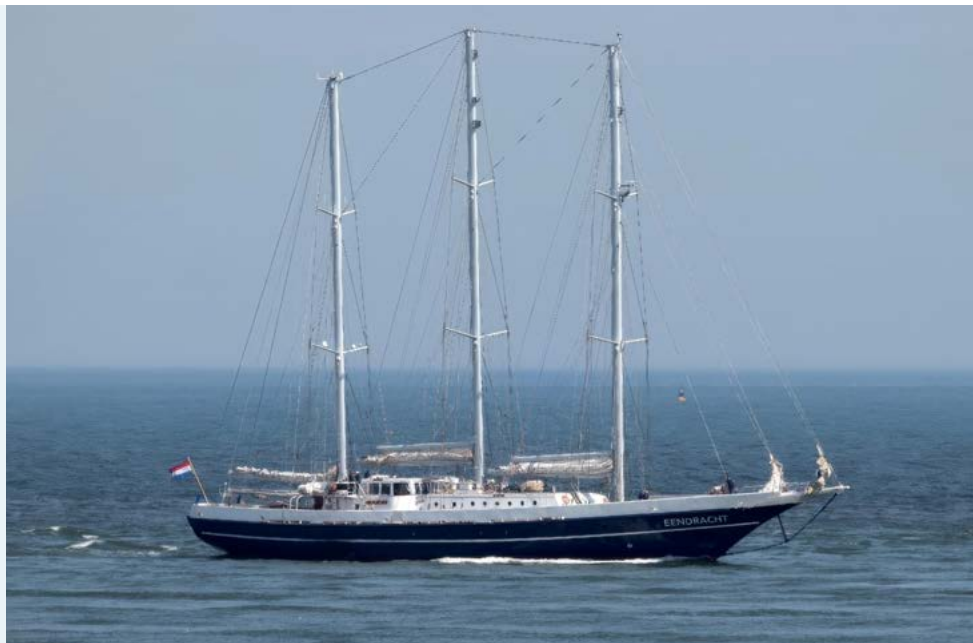
▼ Figure 37: Location on board where the crew member fell.
(Source: Stichting Eendracht)

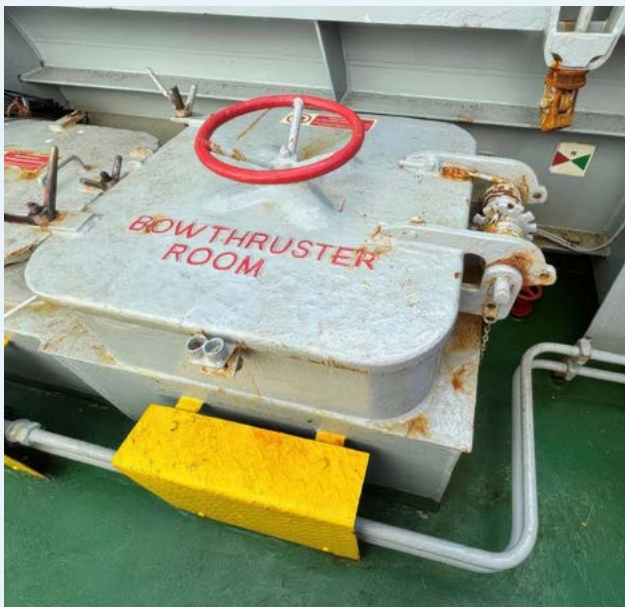
▼ *Figure 42: Hatch to the bow thruster room.*
(Source: Wagenborg)

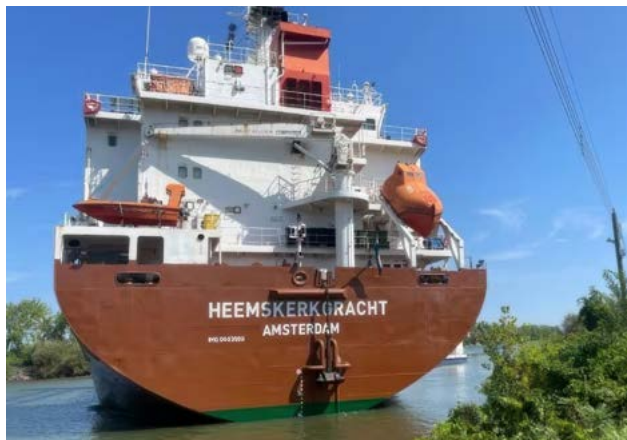
▼ *Figure 46: Heemskerckgracht in the South Shore Canal. (Source: Sharon Yonan Renold/CBC)*

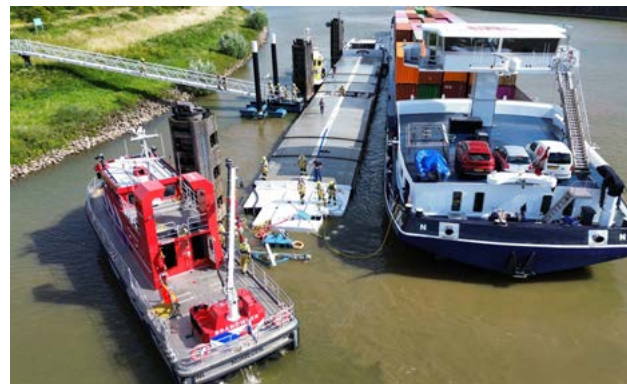
▼ *Figure 47: A fire service fireboat and a container ship around the Meggy. (Source: Persbureau Heitink)*

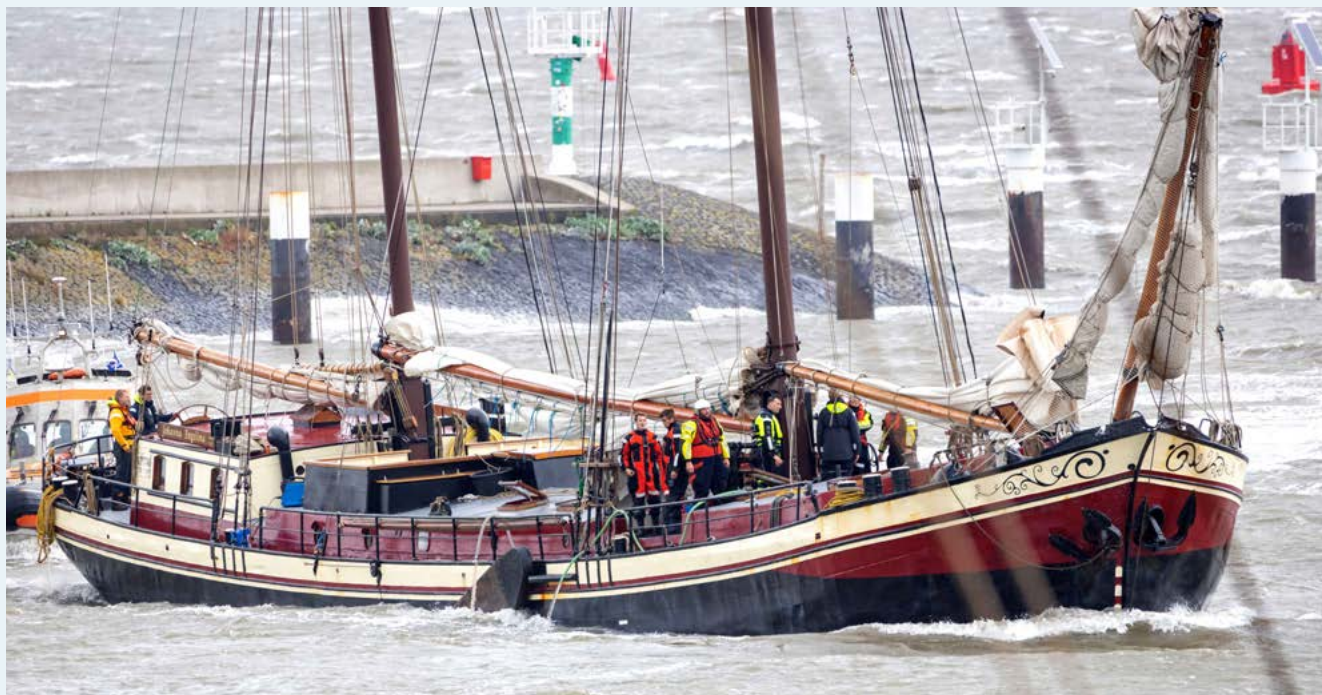
▼ *Figure 49: The charter ship *Johanna Engelina* enters the harbour at Harlingen, with the hoses from the immersion pumps visible on deck. (Source: Camjo Media)*

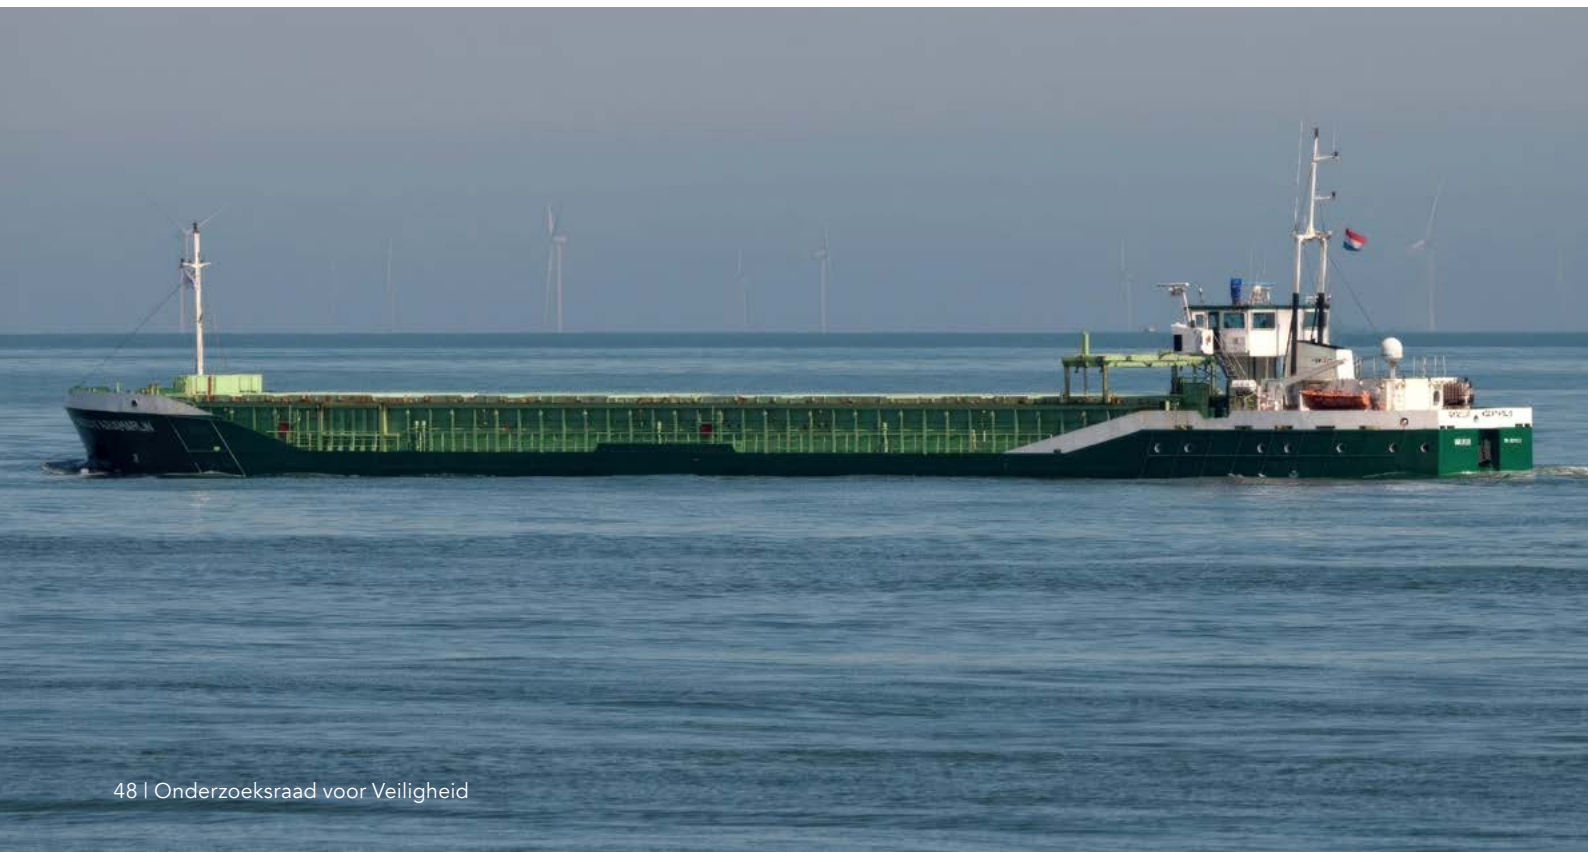
The Dutch cargo ship Rhoon C lost its rudder while travelling on the Ulvangen fjord off Sandnessjøen. The vessel was unable to proceed or manoeuvre under its own power and was therefore taken to Nesna in Norway accompanied by a tugboat. During docking, a broken rudder stock was discovered.

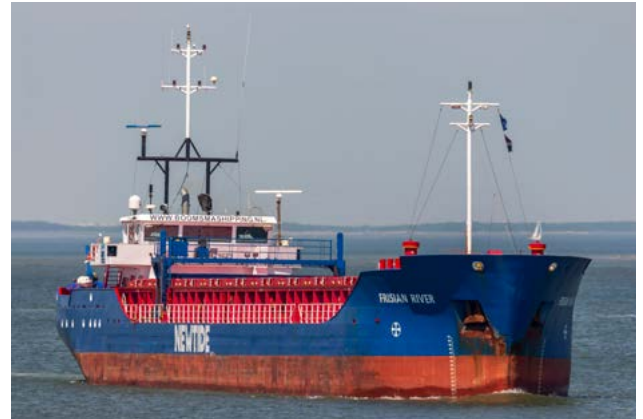
The Dutch cargo ship Frisian River sustained damage to its propeller while travelling on Dutch inland waterways between Roermond and Rotterdam. Upon arrival in Rotterdam, it was discovered that whenever the vessel was using its propeller, it lost approximately one litre of oil per hour. Because of the oil leakage near the propeller, the vessel was towed to a shipyard in Dordrecht by a tugboat.

▲ Figure 55: Frisian River. (Source: Marco Schoone)
