Quarterly Aviation Report

January - March 2025

Q1 2025

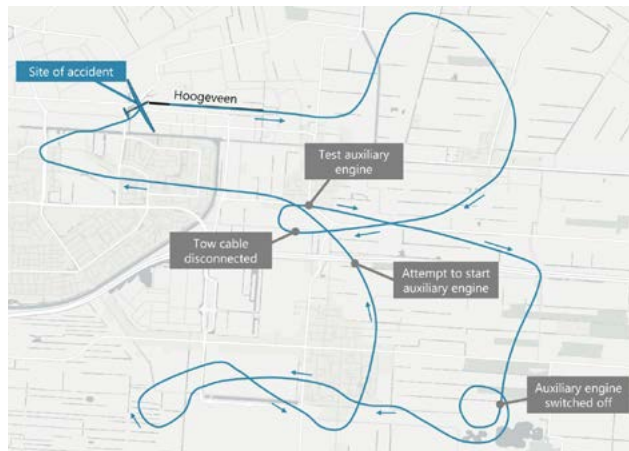
▲ The flight path of the Discus-2T. (Source: IGC-data and OpenStreetMap)

The pilot approached the circuit starting point from the southeast and at an altitude of approximately 315 metres decided to start the engine. Normally, the circuit is started at a height of 200 metres at the circuit starting point. The pilot extended the engine. His attempt to start the engine failed. Having arrived at the circuit, the pilot flew parallel to and slightly south of the downwind leg. He was higher than the standard circuit height and could thus turn in at any moment for a landing at the airfield. The pilot pressed the fuel pump control button for a long time and did not closely monitor his altitude and position relative to the airfield. When he realised this and stopped trying to start the engine, he turned back in diagonally towards the runway.

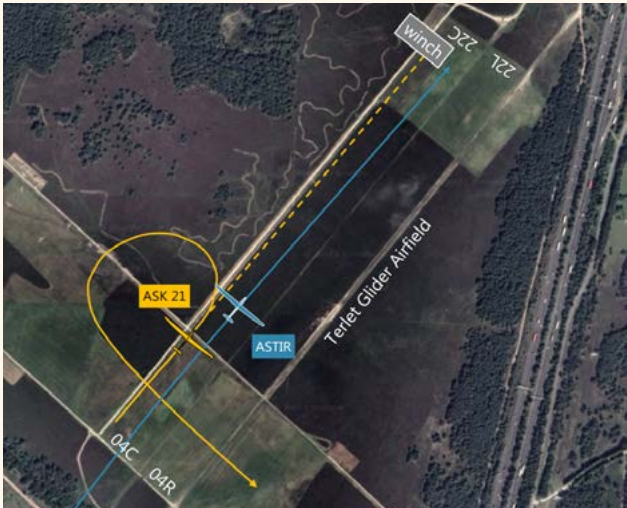
flying straight ahead and then landing was not possible due to the amount of space left for landing. He therefore made a 270-degree left turn and landed the aircraft safely crosswise on the section of Runways 04C and 04R used for landing.

The pilot of the Astir had observed the ASK 21, but estimated that the distance between the two aircraft was sufficient. He otherwise focused on the landing field and landed near the winch.

▲ Situation drawing. (Source: IGC-data and Google Earth)

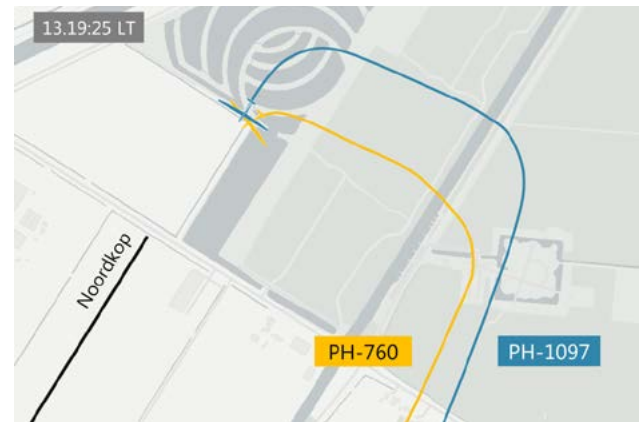
A joint radio check after landing showed that all the radios were working correctly. Why the pilot of the PH-760 did not hear the call from the PH-1097 is unknown.

▲ The flight paths of PH-1097 and PH-760. (Source: IGC-data and OpenStreetMap)

In the morning briefings, the club therefore emphasises once again the importance of flying a correct circuit, using the radio correctly, and ensuring that pilots pay proper attention when flying with passengers.

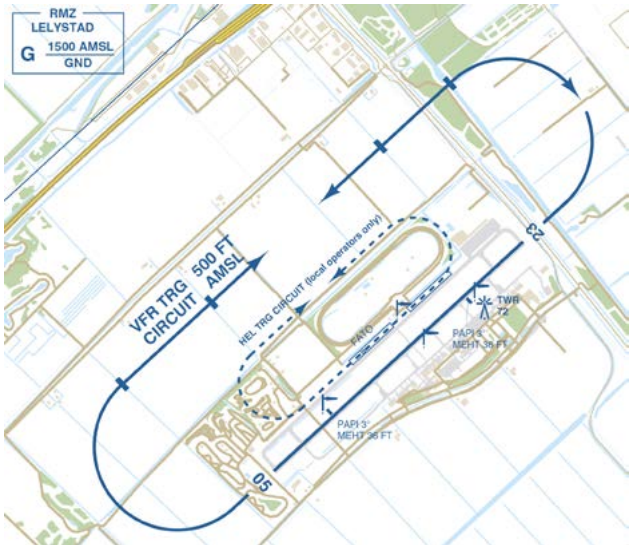
The pilot of the aeroplane, an AT-3, had made a landing on runway 23. During the landing, the aeroplane had bounced and the pilot had performed a go-around. The pilot stated that it had been cold, which had caused the aeroplane to quickly climb to 500 feet. His focus during this manoeuvre had been on the altitude and the circuit. Once the aeroplane had reached 500 feet, the pilot had made a turn to the right to the crosswind leg and flown through the helicopter training circuit.

As stated in the Aeronautical Information Publication, pilots must adhere strictly to the circuit dimensions as shown on the visual approach charts, unless instructed otherwise by air traffic control. Because the runway at EHLE is relatively long for single-engine aeroplanes, pilots may perhaps feel that they need to fly straight ahead for a long time before they can make the turn to the crosswind leg. This applies in

▲ VFR training circuit and (within it) the helicopter training circuit. (Source: AIP Netherlands)

particular to the VFR training circuit, which is at 500 feet AMSL. This height can already be reached above the runway, before the turn to the right can be initiated. There are circuit markings on the ground under the downwind leg. By flying over the first marking at the beginning of the downwind leg for Runway 23, sufficient separation from the helicopter training circuit is guaranteed.
