IMMEDIATE LANDING AFTER UNCOMMANDED CONTROL INPUTS

Identification number:	2011001
Classification:	Incident
Date, time ² of occurrence:	21 January 2011, 14.23 hours
Location of occurrence:	Rotterdam The Hague Airport
Aircraft registration:	PH-ULP
Aircraft model:	Eurocopter EC-135 T2
Type of aircraft:	Helicopter
Type of flight:	Helicopter Emergency Medical Service (HEMS)
Phase of operation:	Take-off
Damage to aircraft:	None
Cockpit crew:	Pilot and HEMS crewmember
Number of Passengers:	One
Injuries:	None
Other damage:	None
Lighting conditions:	Daylight

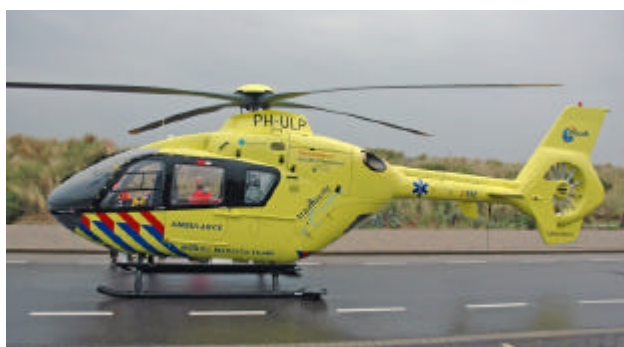
The PH-ULP is a Eurocopter EC-135 T2, built in 2004 and based at Rotterdam The Hague Airport. The certificate of airworthiness was valid until 24 September 2011.

Figure 1: PH-ULP Source [Frank Vorwerk / www.htdi-int.com](http://www.htdi-int.com)
